II. EXISTING CONDITIONS

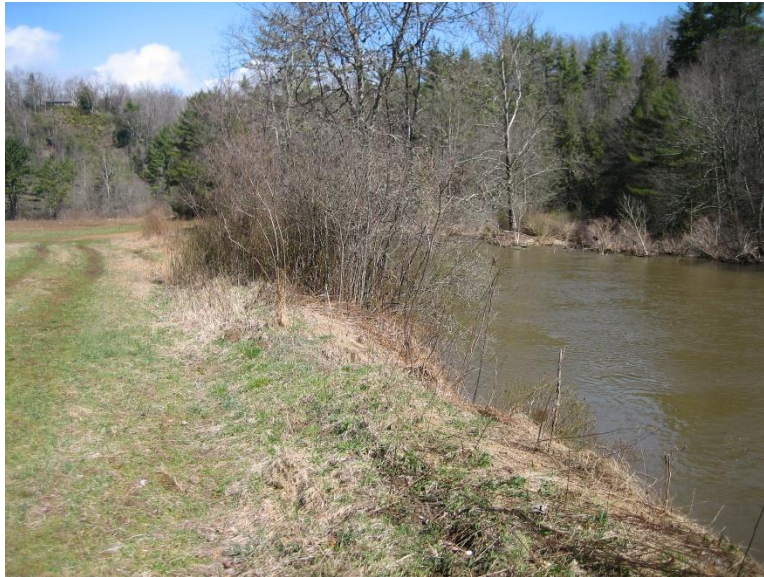
Most of Reach 1 flows through well-vegetated areas, and is laterally and vertically stable. An exception to this is 600 feet of the left bank which is steep, highly erodible, and adjacent to a field with minimal buffer (Photo 1). Additionally, minor bank erosion exists on the right bank at the outside of the large meander bend (Photo 2).

Photo 1: Reach 1, downstream view from adjacent field

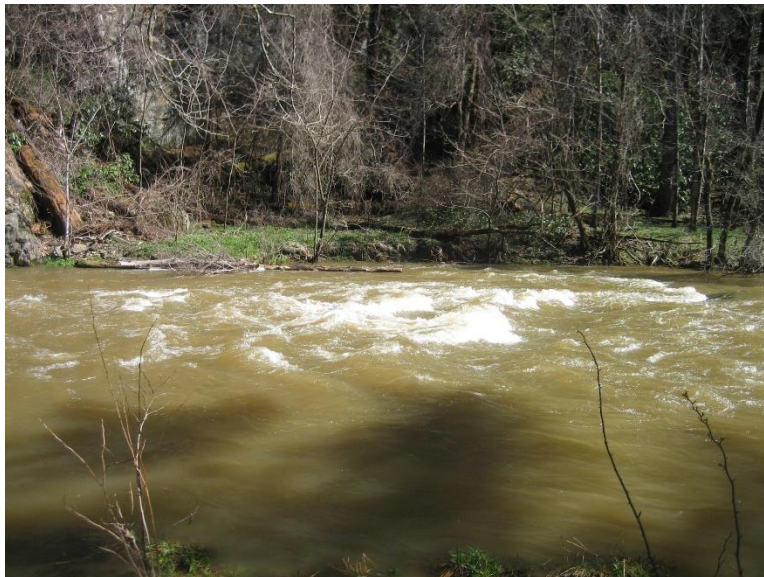
Photo 2: Reach 1, right bank erosion

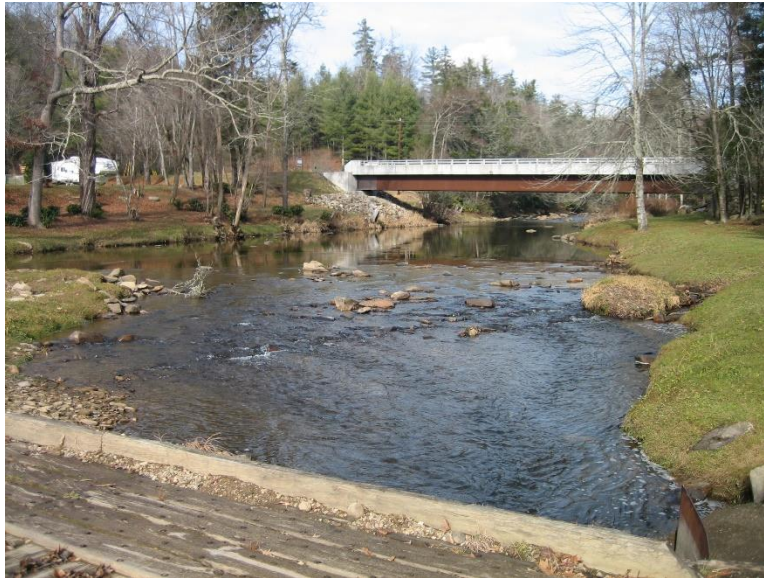
Reach 2 contains two bridges: one recently constructed and one several decades old. At the upstream bridge, riprap exists on the streambanks, though the bridge piers remain susceptible to scour at high flows. The downstream bridge was designed for use during times of low flow, and is currently not used at all, due to damage to the bridge deck. A nursery-related irrigation line is affixed to this low water bridge. Between the two bridges, streambanks are covered with mowed grass, and lack deep-rooted vegetation (Photo 3).

Photo 3: Reach 2, upstream view from low-water bridge

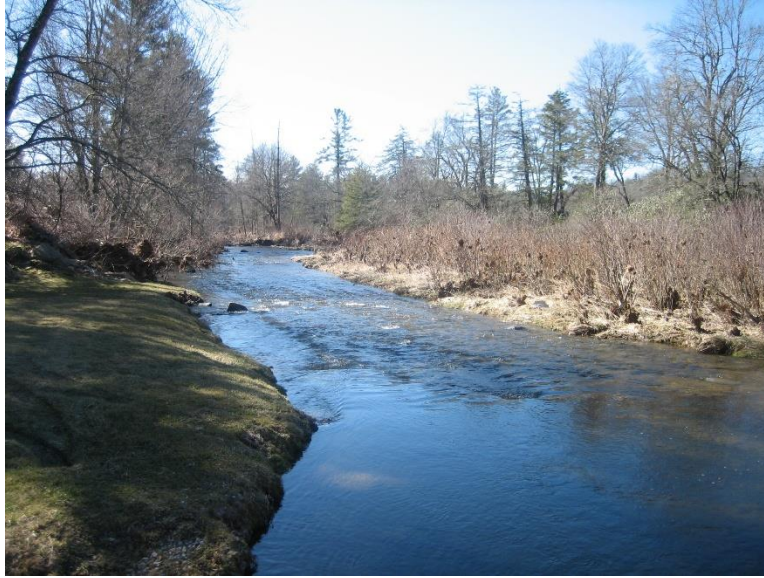
A large mid-channel bar (approximately 440 feet long and 28,000 square feet in area) exists downstream of the low-water bridge (Photo 4). The bar is primarily vegetated with tag alder (*Alnus serrulata*), with some areas covered by willow (*Salix* sp.) and sedges (*Carex* sp.).

Photo 4: Reach 2, downstream view from low-water bridge, mid-channel bar on right

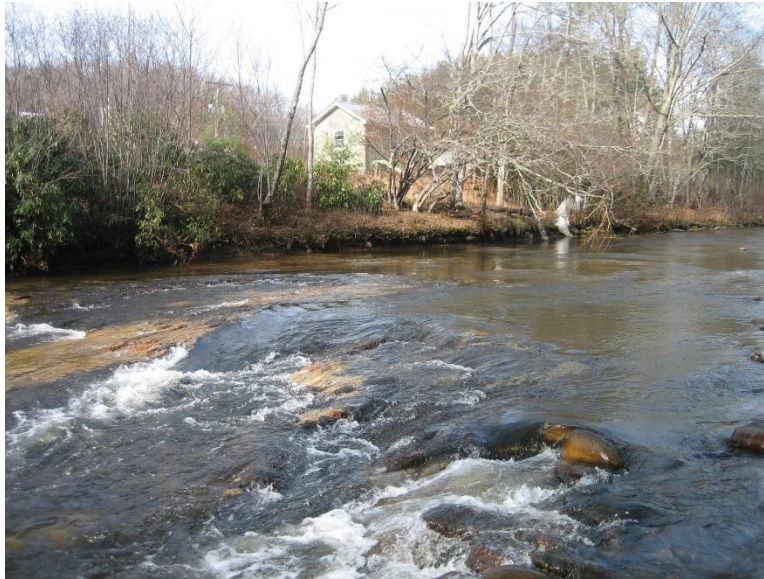
of the new bridge, and one downstream of a prominent bedrock ledge (Photo 5). This bedrock provides a vertical drop of 1.4 feet in the water surface, followed by 500 feet of flat water. A water intake for irrigation is located on the right bank upstream of the bedrock.

Photo 5: Reach 2, bedrock step with water intake just upstream

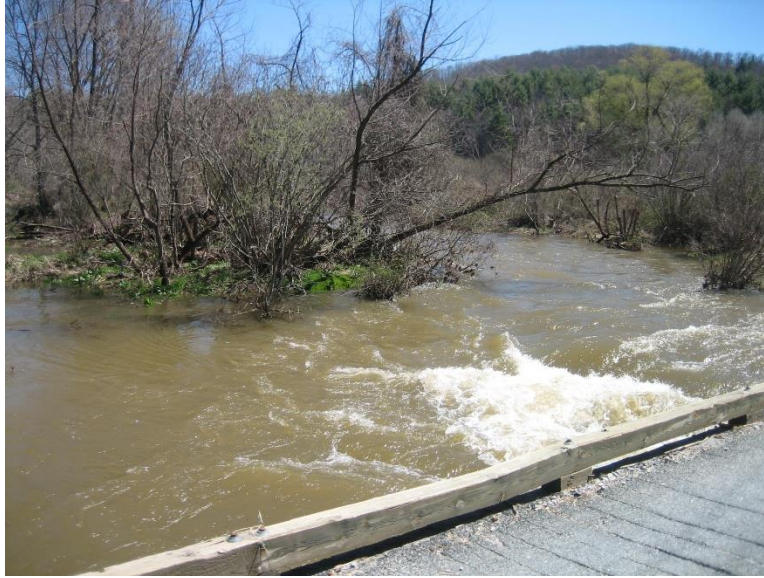
Most of Reach 3 is a multi-thread channel, with flow split around two large mid-channel bars. The upstream mid-channel bar begins near the upstream extent of Reach 3, with the lower bar ending at the Greene Road bridge, at the bottom of Reach 3 (Photo 6). Vegetation on the upstream bar is dominated by tag alder (*Alnus serrulata*), with the lower bar containing mixed hardwood trees.

Photo 6: Reach 3, upstream view of mid-channel bar from Greene Road bridge
