# **Stream Restoration Post-Implementation Annual Monitoring Report**

## **Year 1: 2012**

Project #10-0493:

“DuPont State Forest Lake Julia Outfall Stream Restoration”

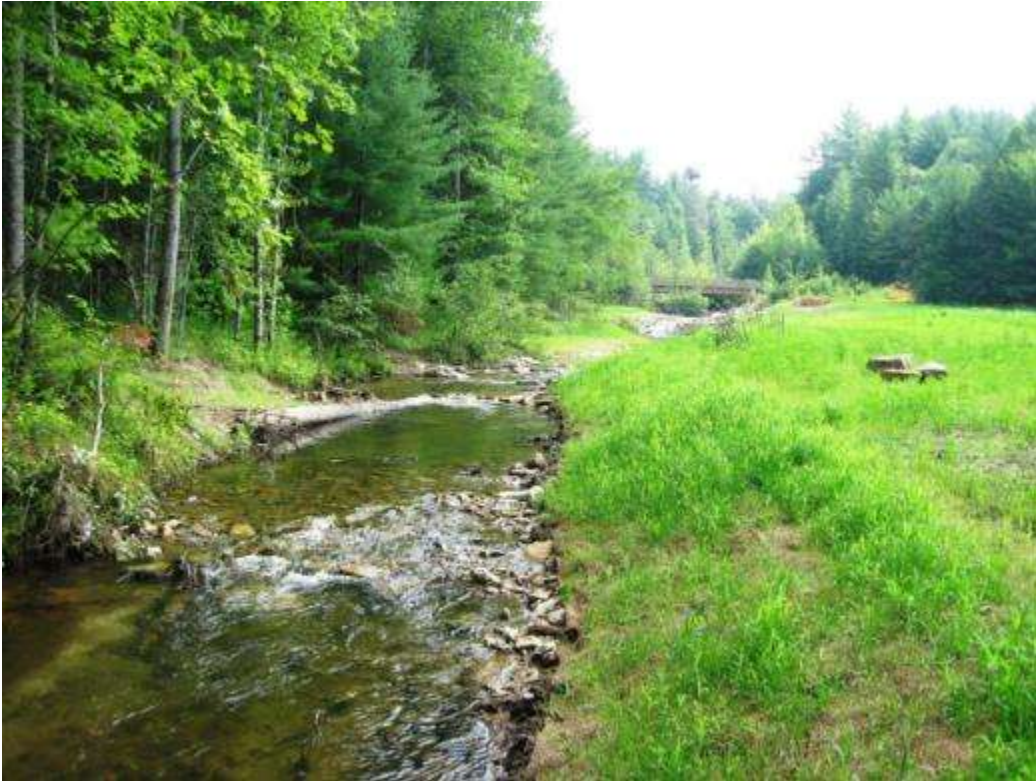
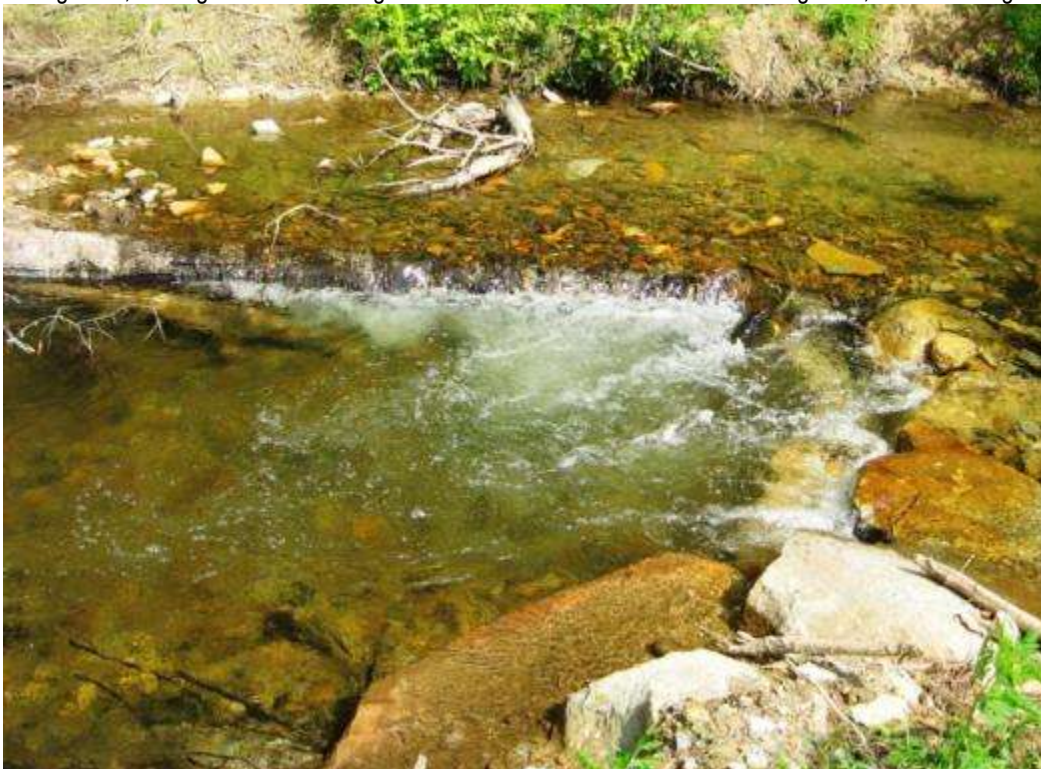
Both photos from June 2011: Above view looking upstream from the downstream end of the restoration work. A new riffle was installed in the foreground, and log vane in the background. Below view is a closer look at the log vane, while standing on the left bank.

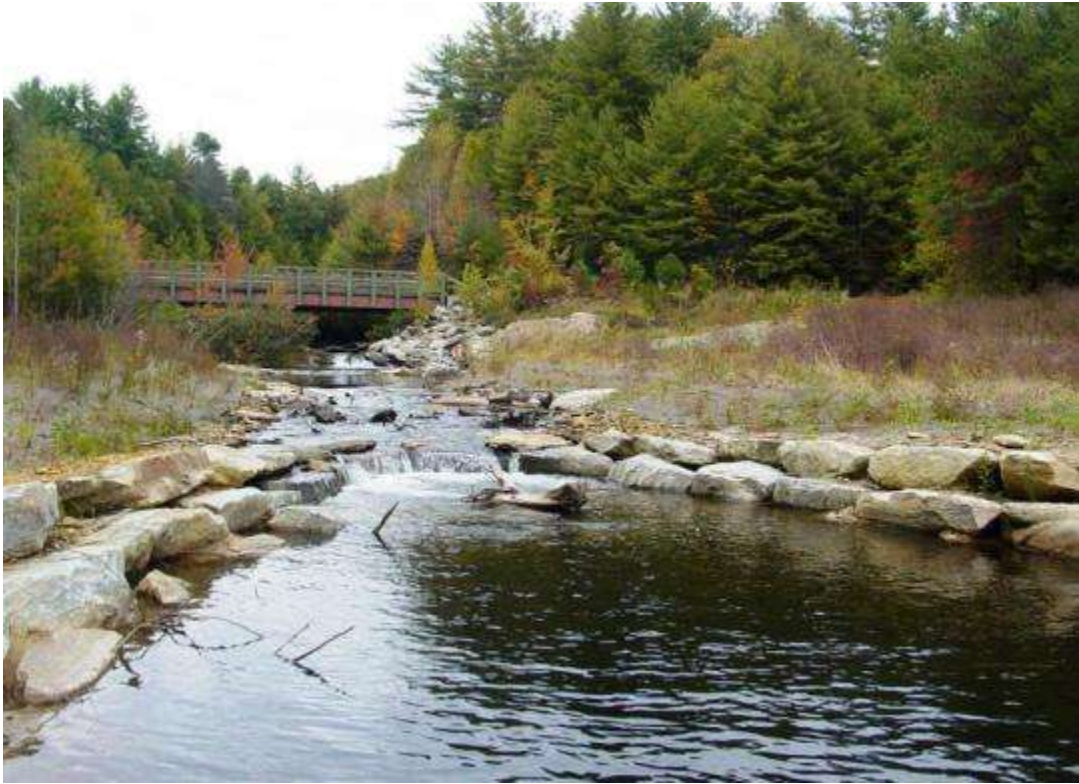
Above: Photo from October 2011. View looking upstream at one rock vane structure and its pool.

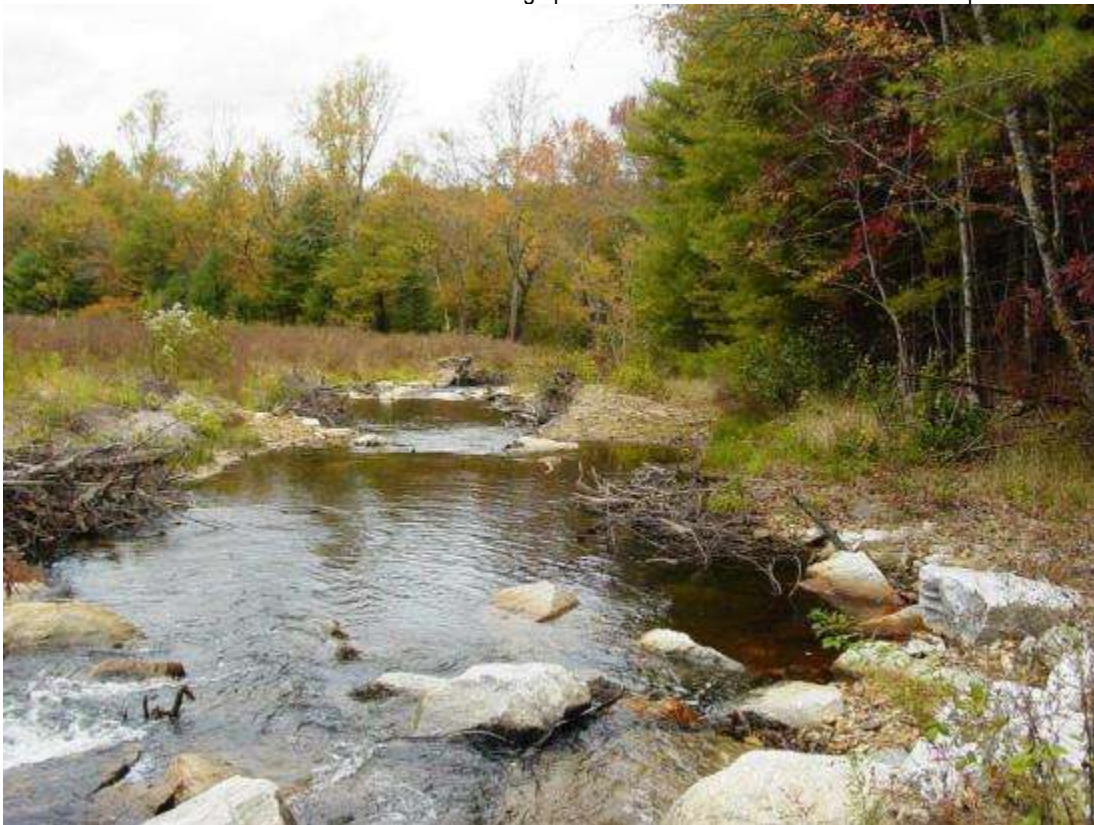
Above: Photo from October 2011. View looking downstream from riffle section, of a pool and additional structures.

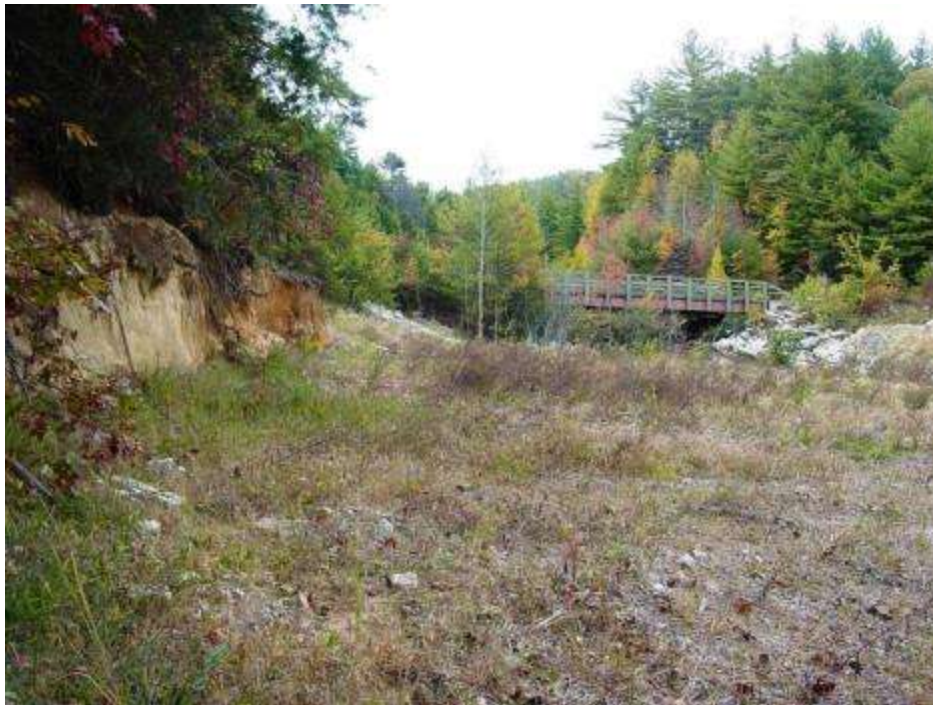
Photo October 2011. View looking upstream at location of former channel, against the backfilled embankment.

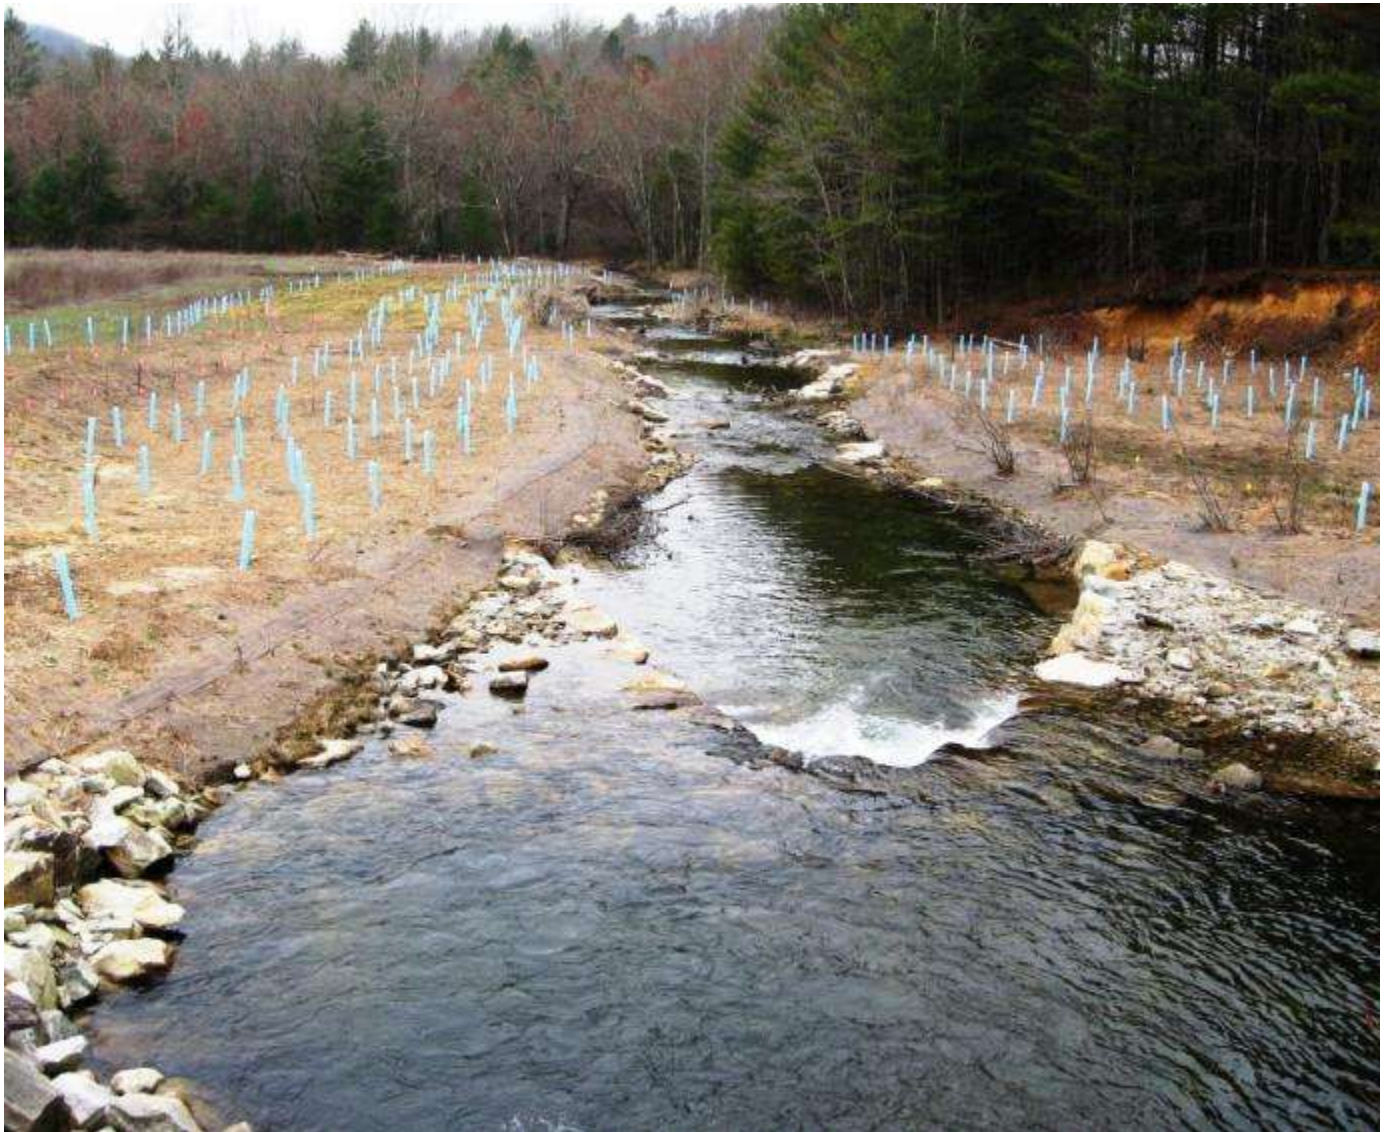
Photo from March 2012. View looking downstream from the Conservation Road bridge. Seedlings have been planted and shrouded by plastic tubes to protect them from wildlife browse.

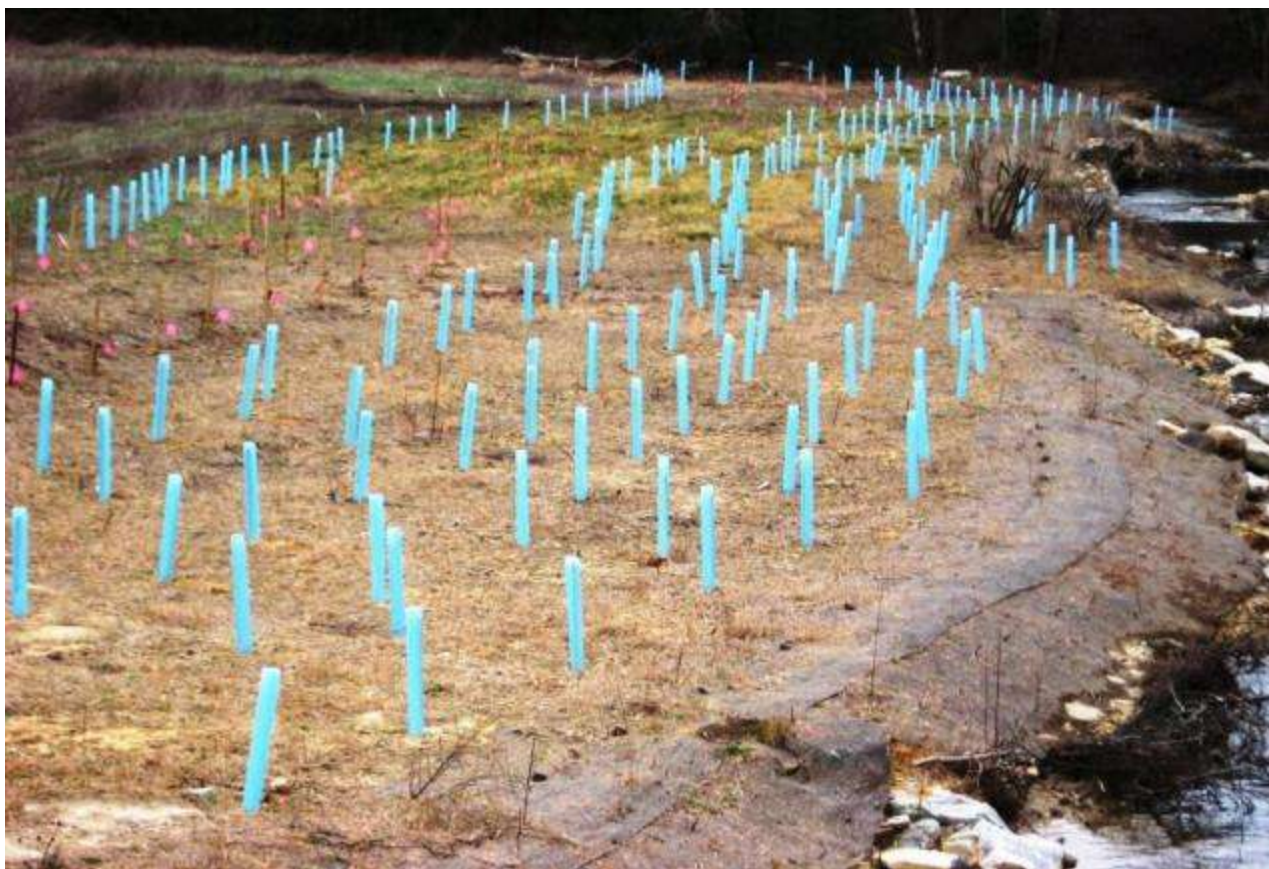
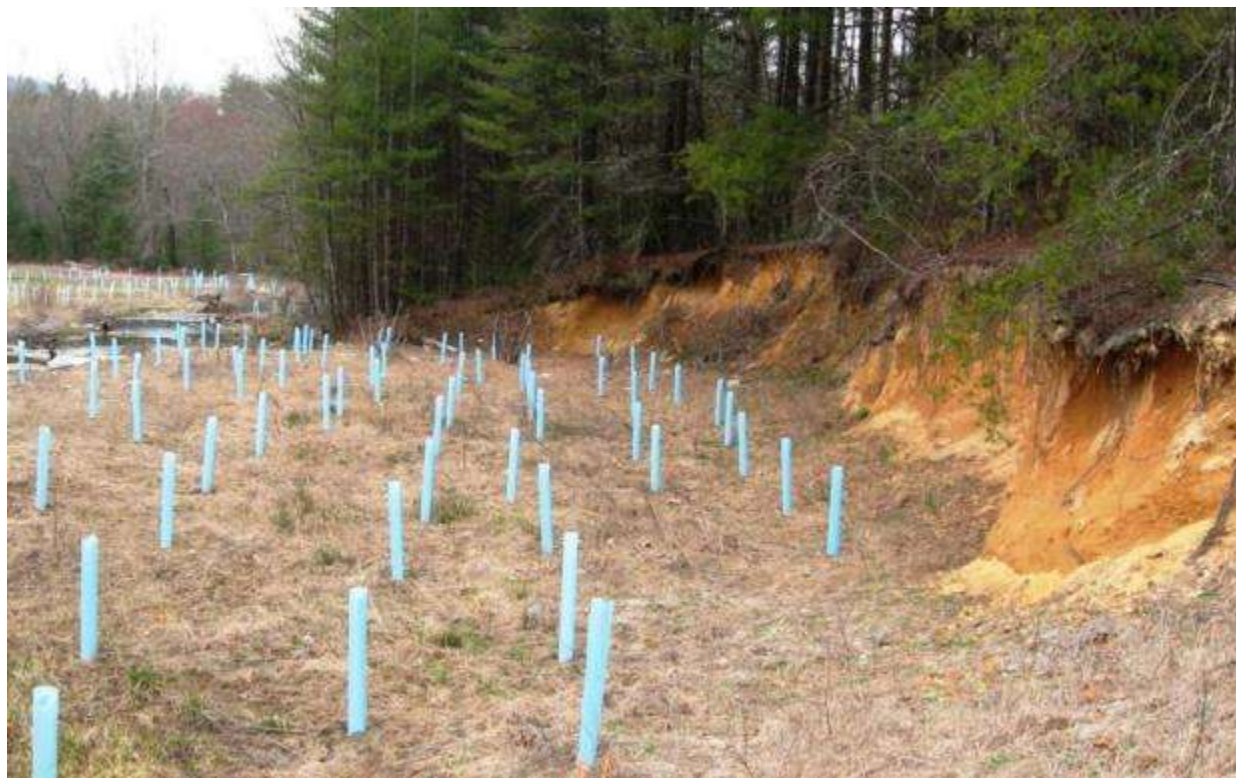
Both photos from March 2012: Above, left bank: showing seedlings planted out into the floodplain area; and below, right bank.
