Restoration and Stabilization along Lake Julia Outfall

Restoration work was done in May 2011

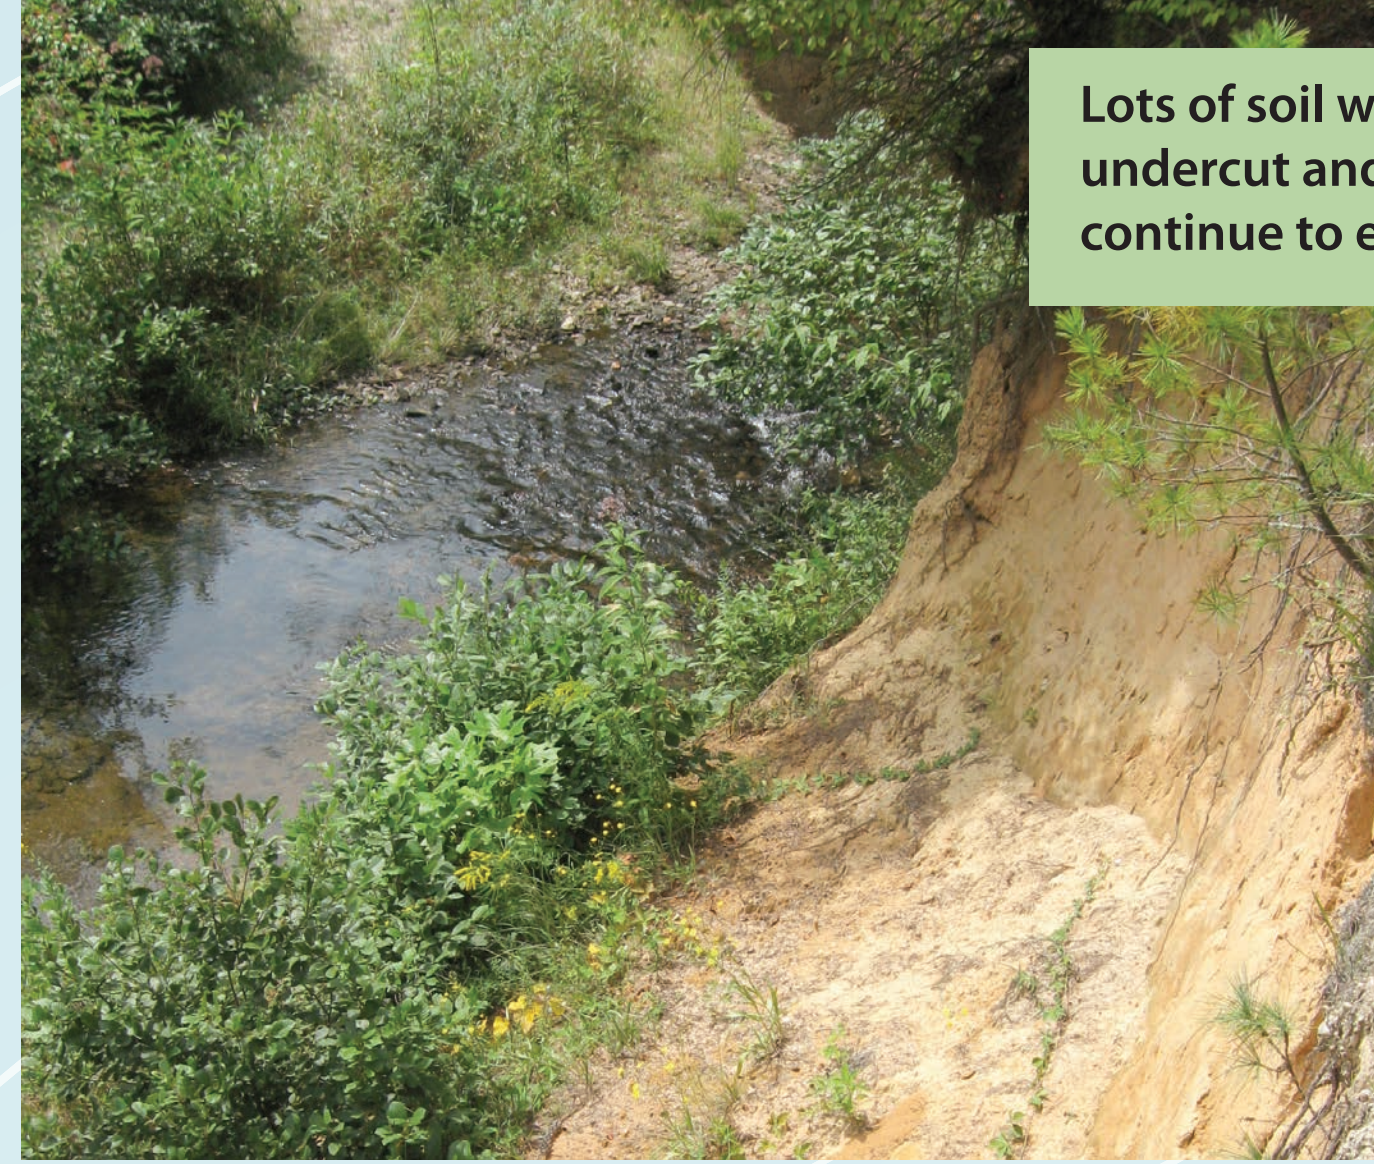
Lots of soil was washing into the stream. Trees were being undercut and falling down, causing the embankment to continue to erode

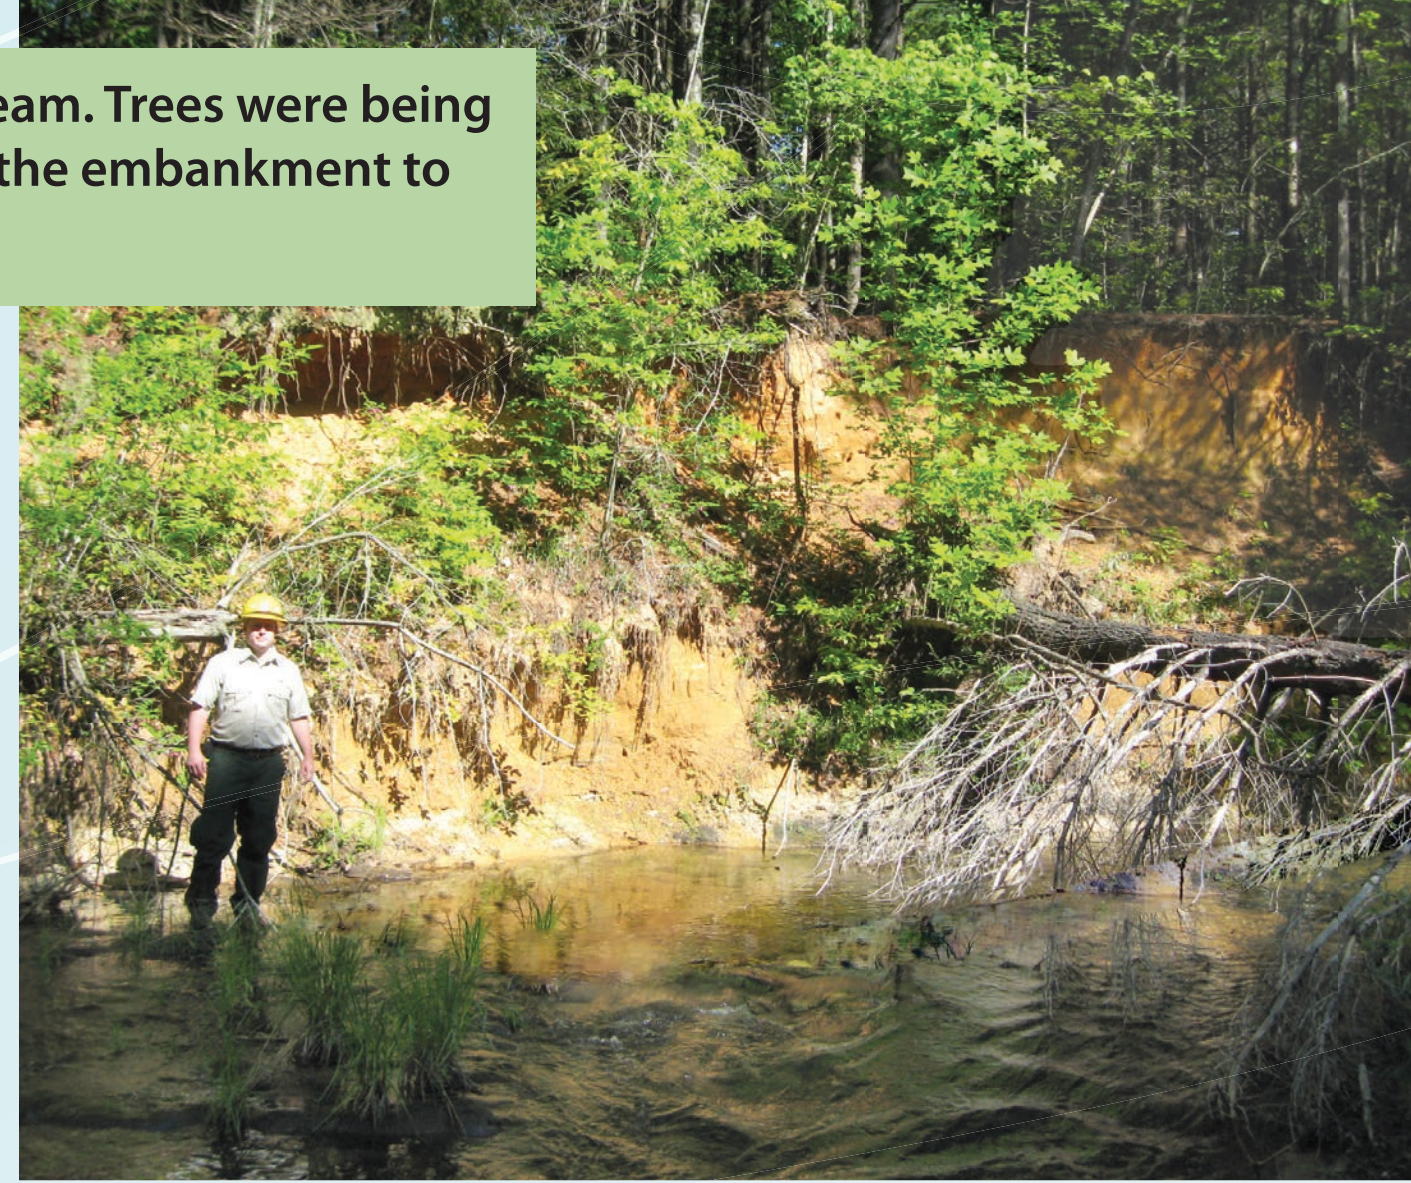
The old stream was created when Lake Julia was built in the 1960's. But, because this channel was not located in the naturally flat floodplain, the force of the water over time had cut away sections of the old embankment along the right-hand side.

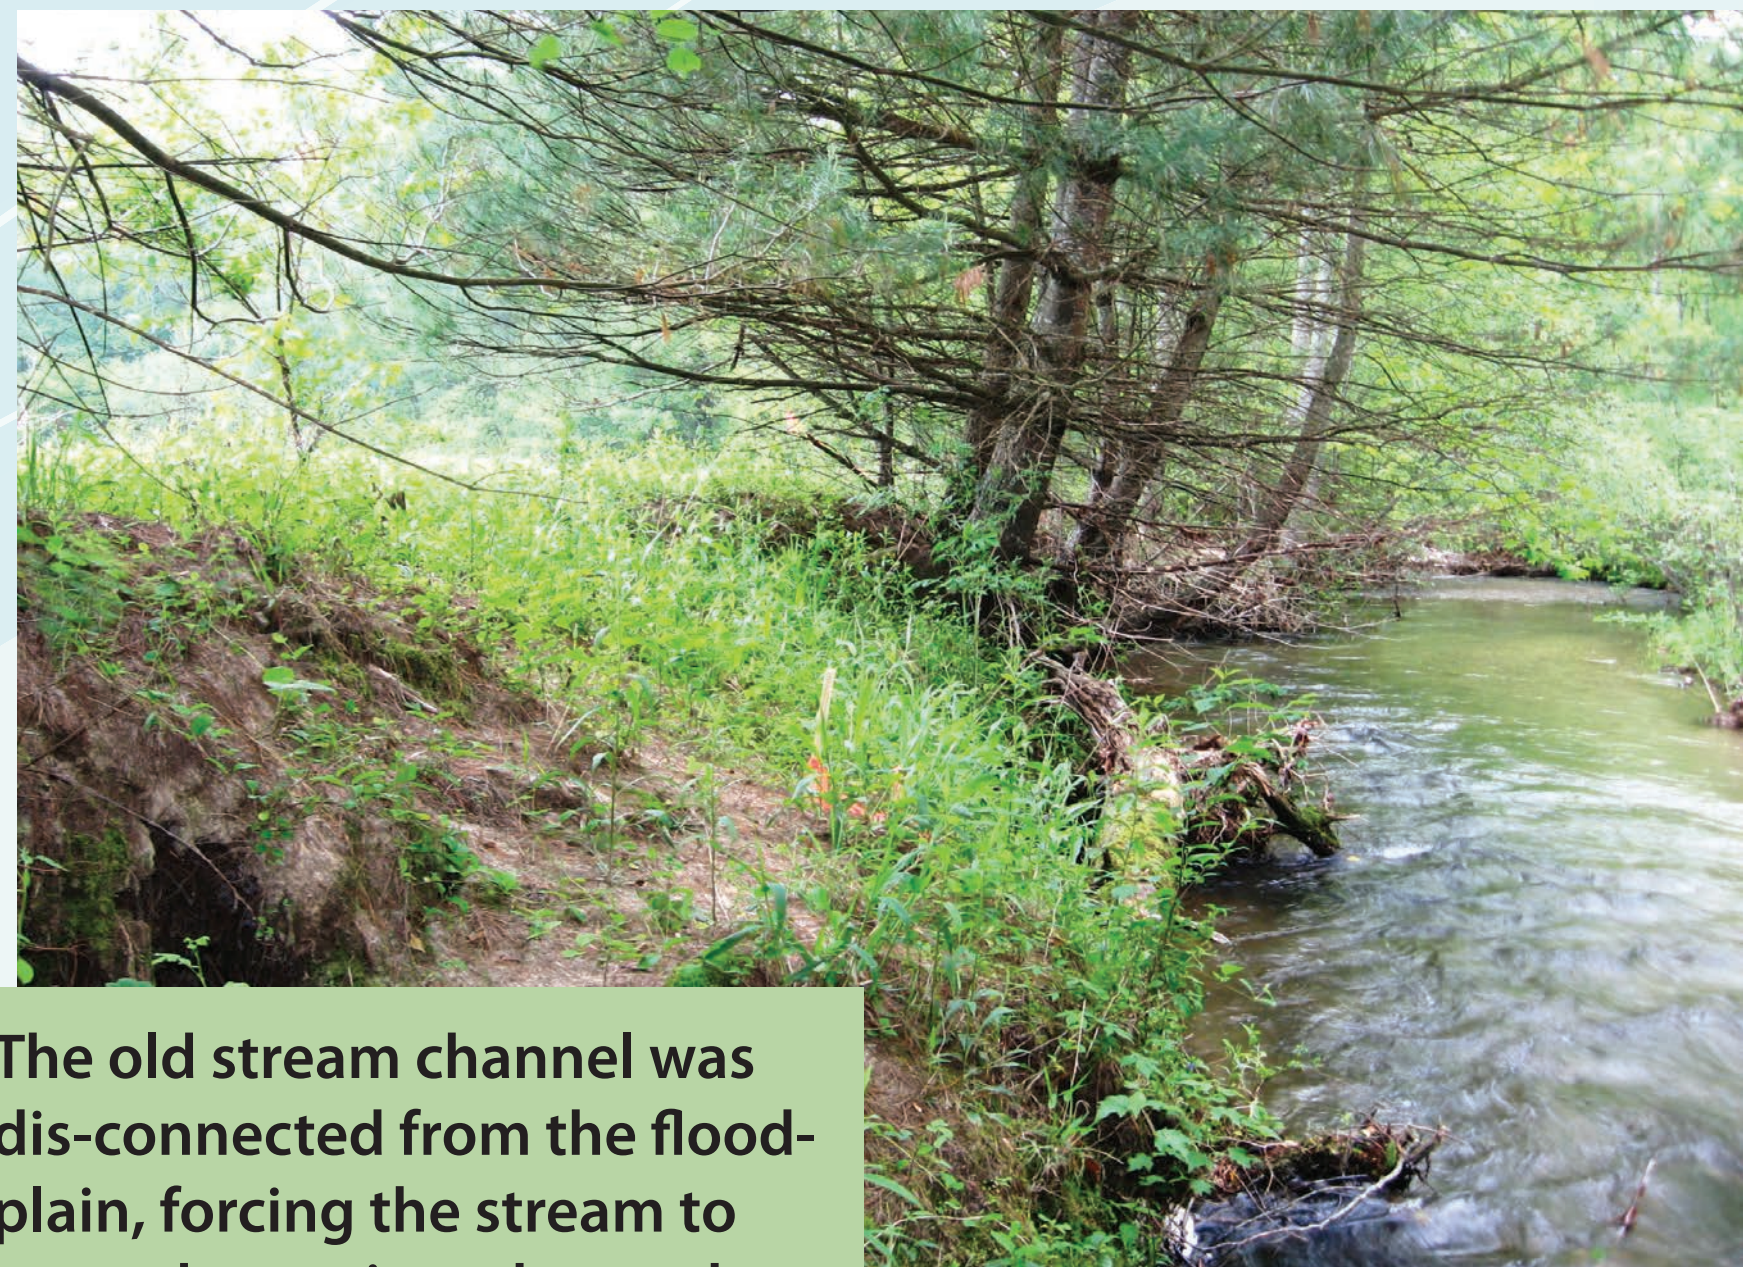
The old stream channel was dis-connected from the floodplain, forcing the stream to carve deeper into the earth.

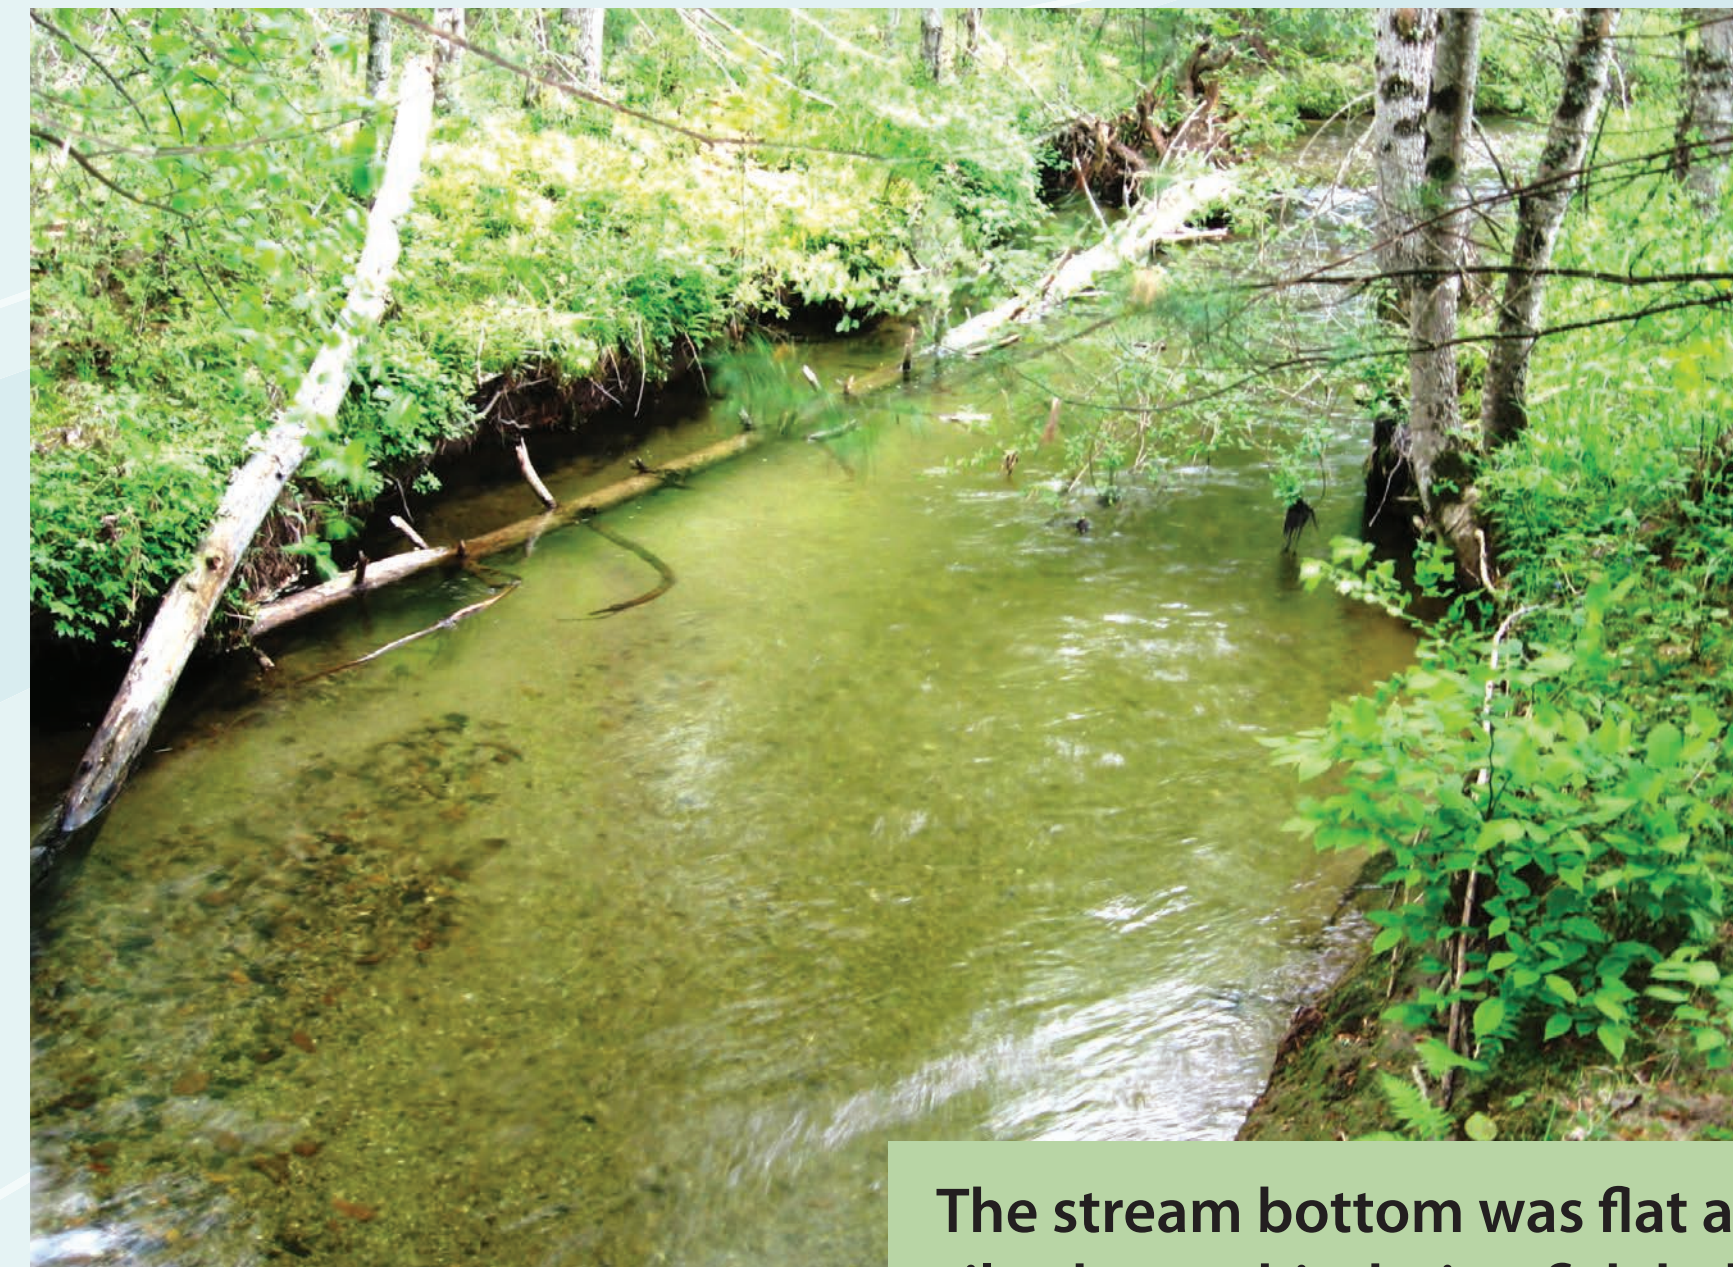
The stream bottom was flat and silted-over, hindering fish habitat.
