N.C. Division of Forest Resources

Stream Restoration Post-Implementation Annual Monitoring Report: Year 2 - 2010

For the N.C. Clean Water Management Trust Fund (CWMTF)
Project #2004A-411:
“Rendezvous Mountain Purlear Creek Stream Restoration”

January 2011
www.dfr.nc.gov

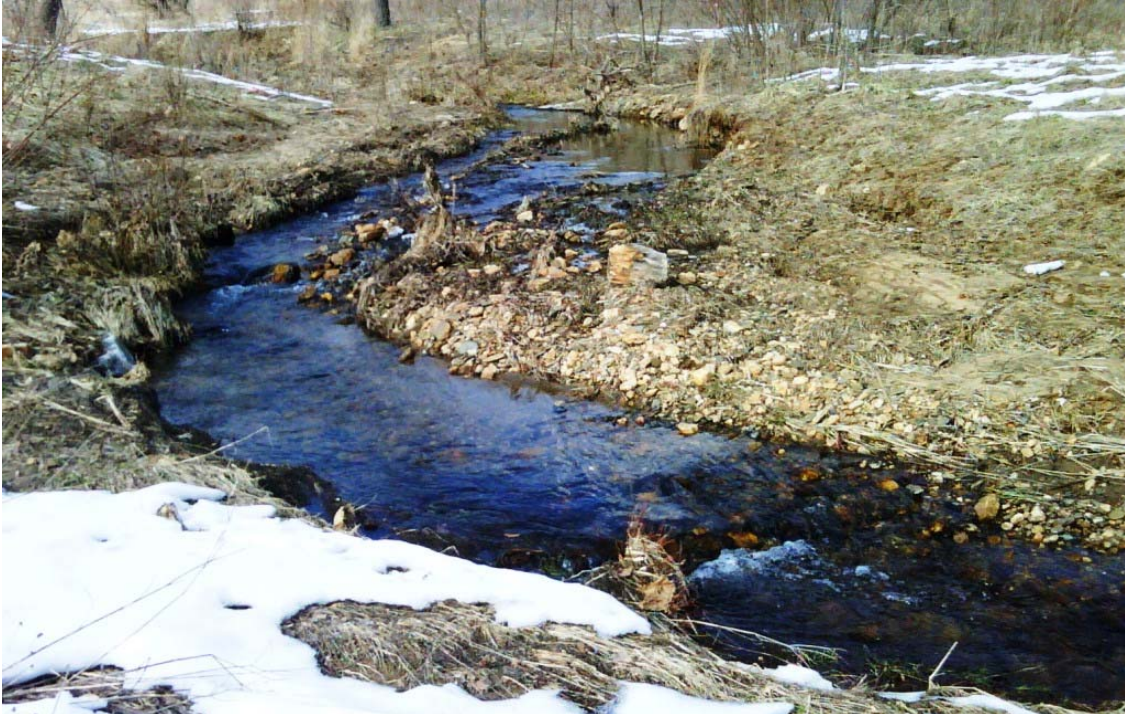
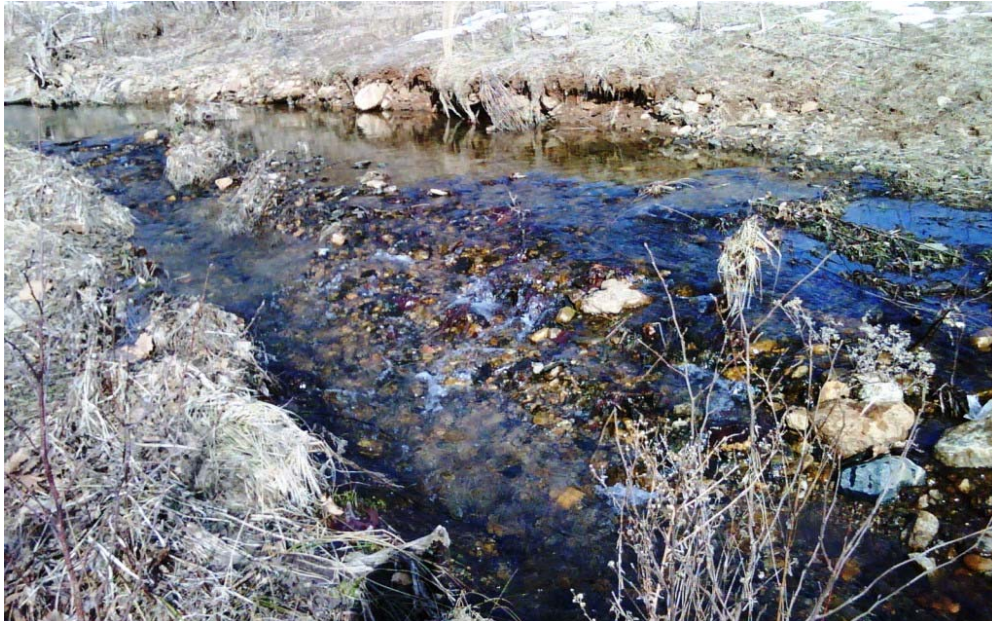
Overall morphology appears intact. No channel surveys were conducted in 2010, but are planned for 2011. Minor reconstruction of a meander bend within the restored stream was completed in April. The inside of the meander had been scoured away from high water flows, and a portion of the outer meander stream bank had also been scoured and partially undercut. Reconstruction work lowered the inside meander bench and deepened the pool within the bend. Erosion control (coir) matting was installed on the newly exposed soil and the area was successfully seeded with erosion control grass. Seed sources from nearby native mature hardwood trees are anticipated to provide woody vegetation regeneration.

Photo 1 above & Photo 2 below were taken in February 2010. They both show the partially scoured stream bank which required reconstruction. Photo 1 is looking upstream; Photo 2 was taken while standing on right bank.

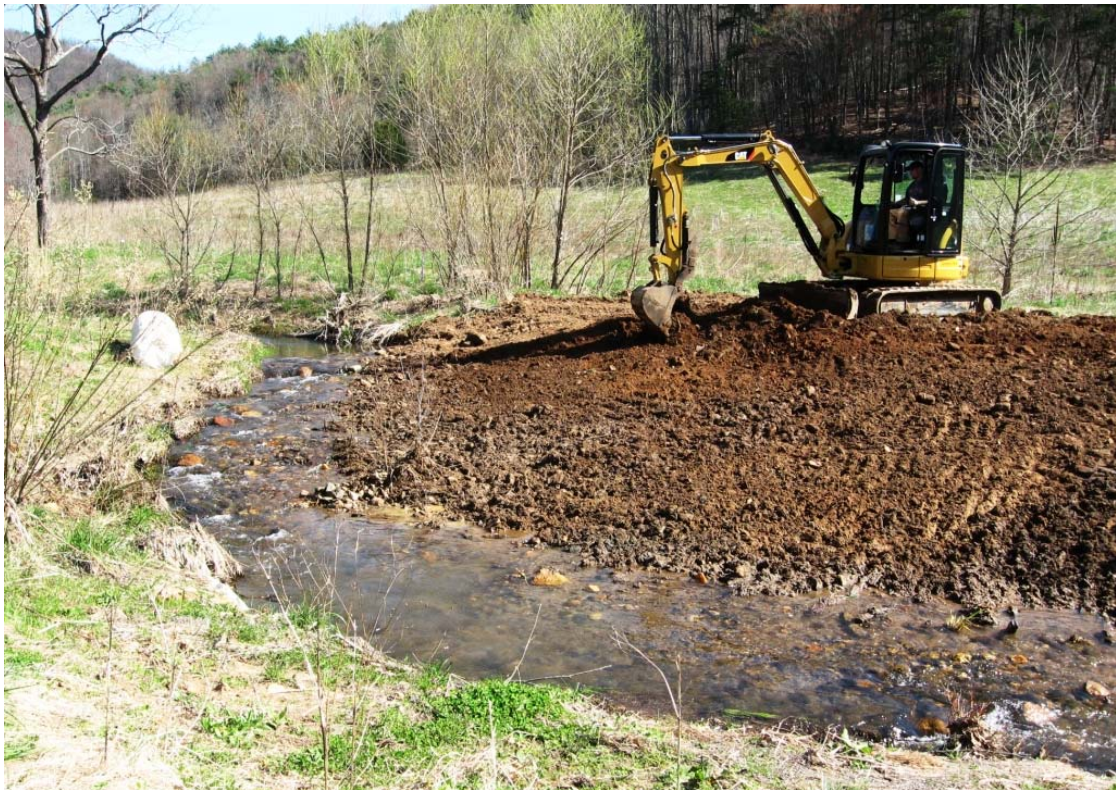
Photo 3: Reconfiguration of the stream's left bank is shown above, April 2010.

Reconstruction of a meander in the restored reach of the stream was conducted in April, along the transition area between the end of Phase 2 and the beginning of Phase 3. This work is further explained later in this report.

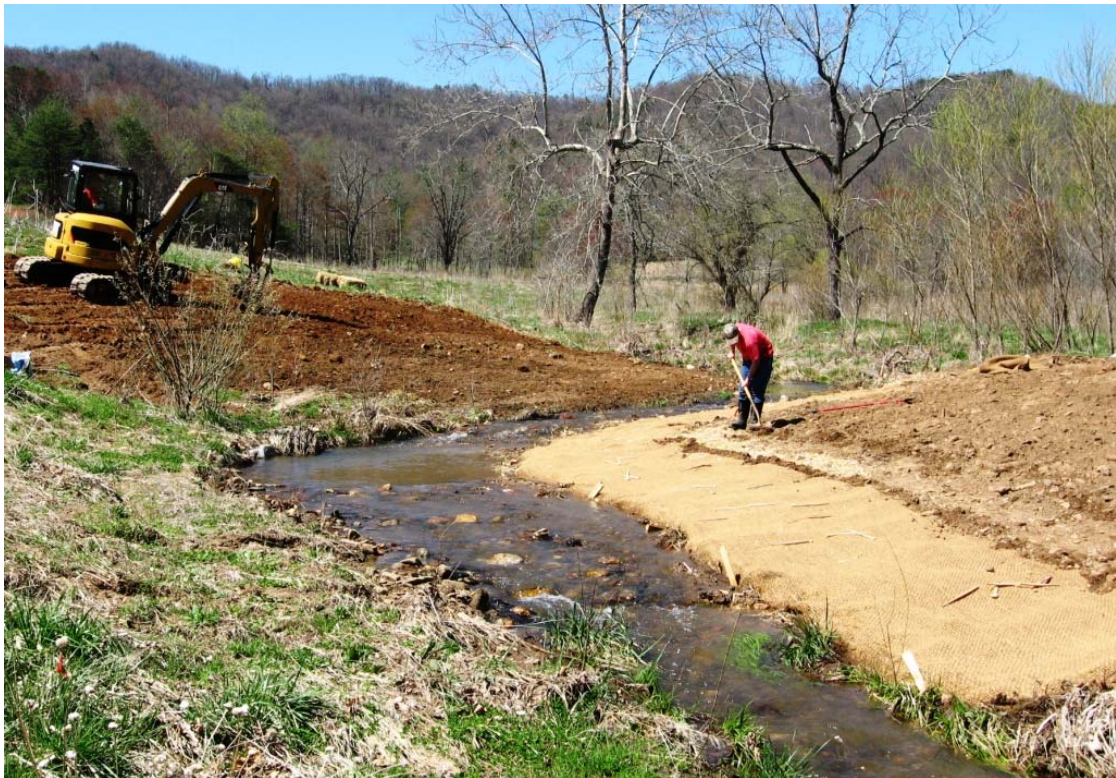
Photo 4: Stream left bank has been reconfigured, with the toe of the bank lowered in elevation and the slope reduced, allowing easier floodplain access by high water flow. Final grading and erosion control work is shown above, April 2010.

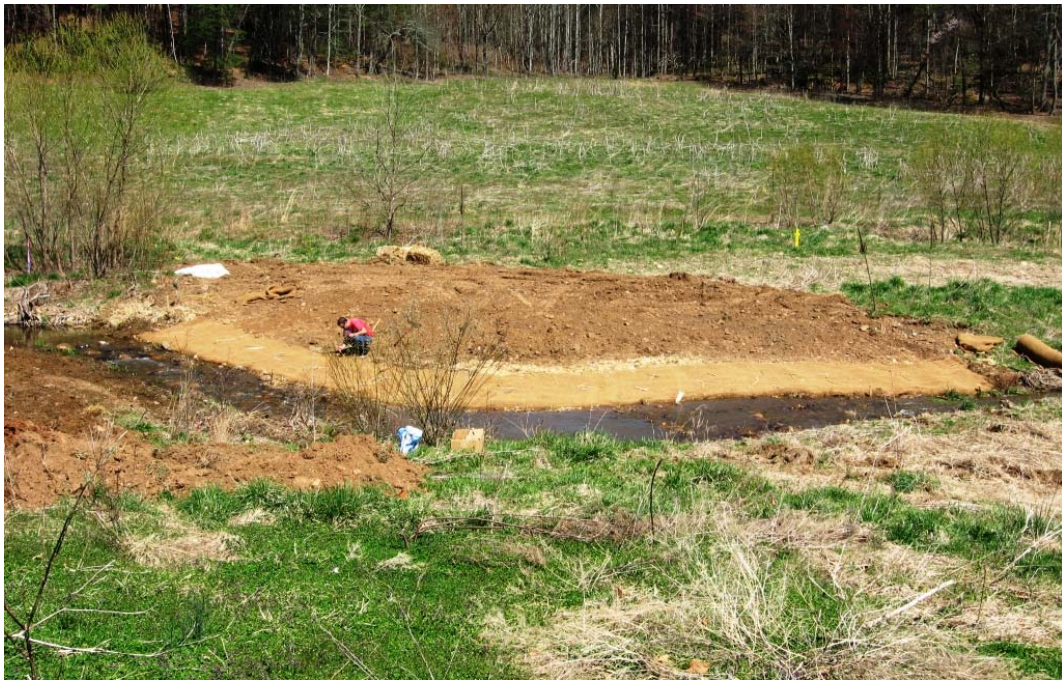
Photo 5: Overview of the stream repair work, April 2010.

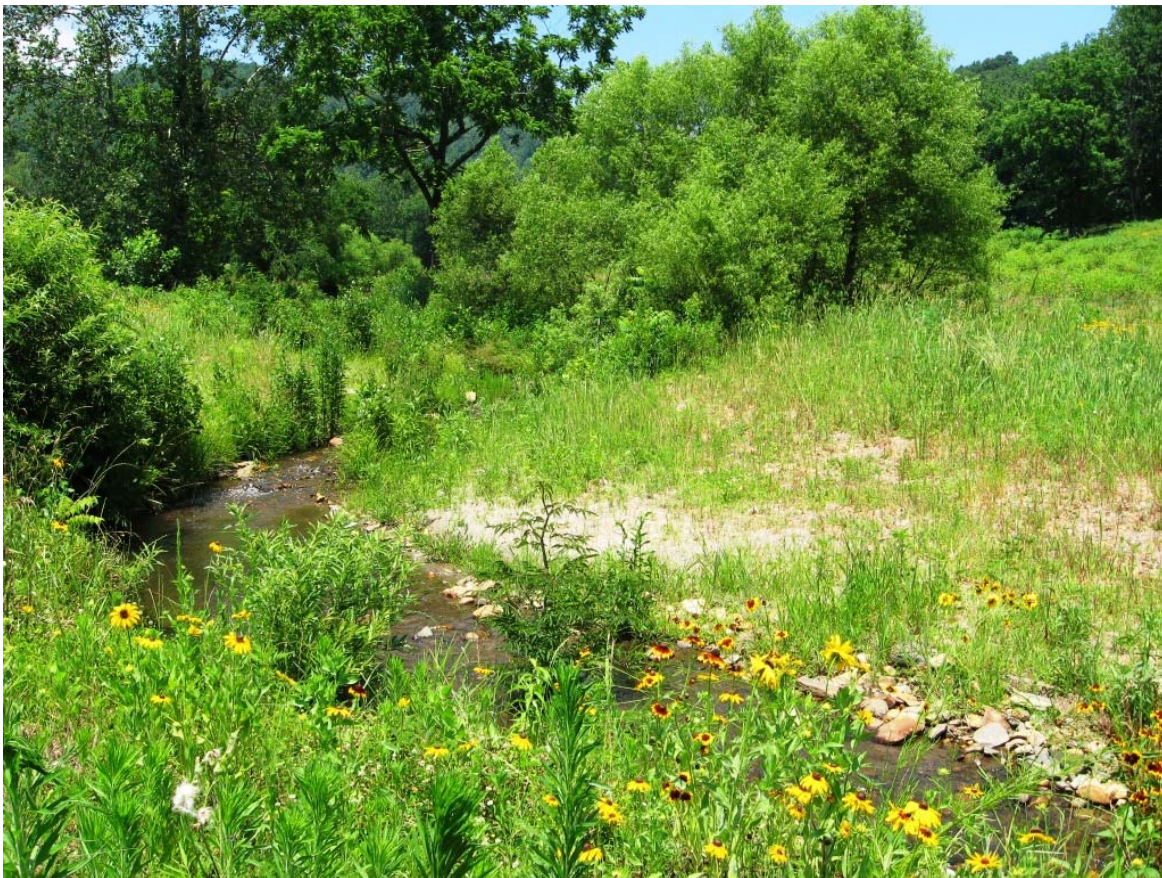
Photo 6: Repaired stream meander shown in August 2010.

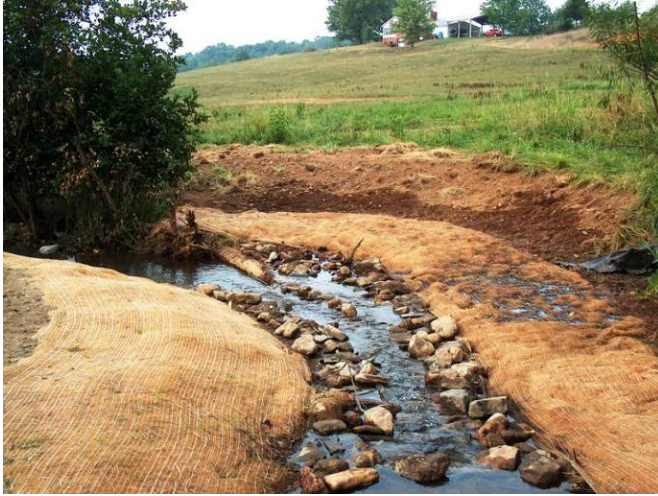
Photo 7: Phase 2, shown August 2007 during restoration.

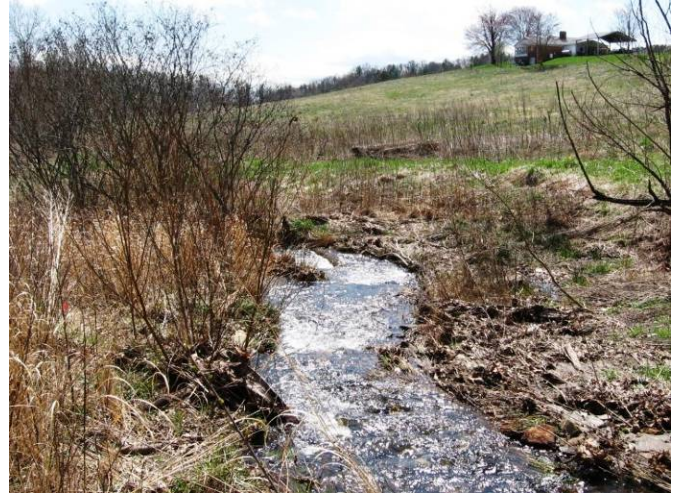
Photo 8: Same location, shown March 2010.

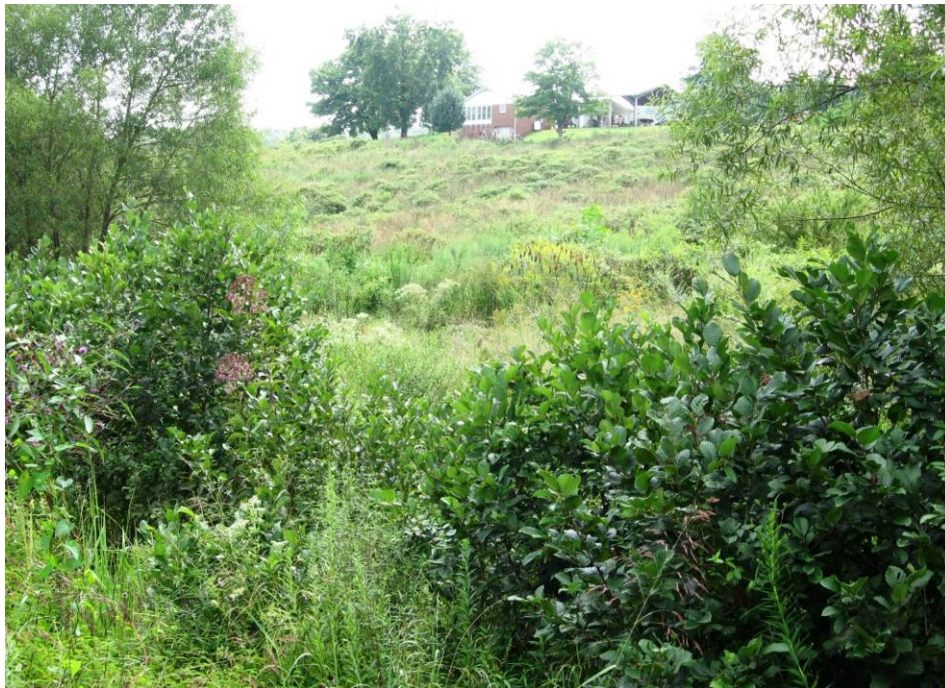
Photo 9: Same location, shown August 2010. Note the abundance of vegetation providing shade alongside the stream, including alder and black willow that were retained during restoration.

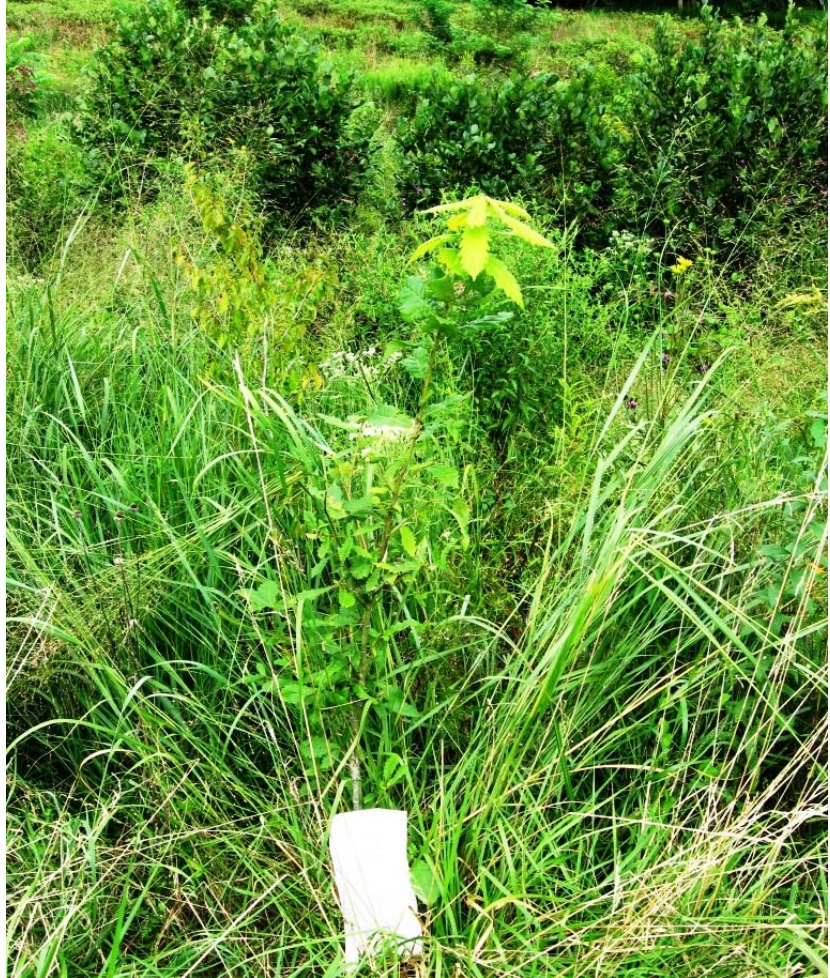
Photo 10: A swamp chestnut oak (*Quercus michauxii*) along Phase 2 shown in August 2010, 2½ years after planting.

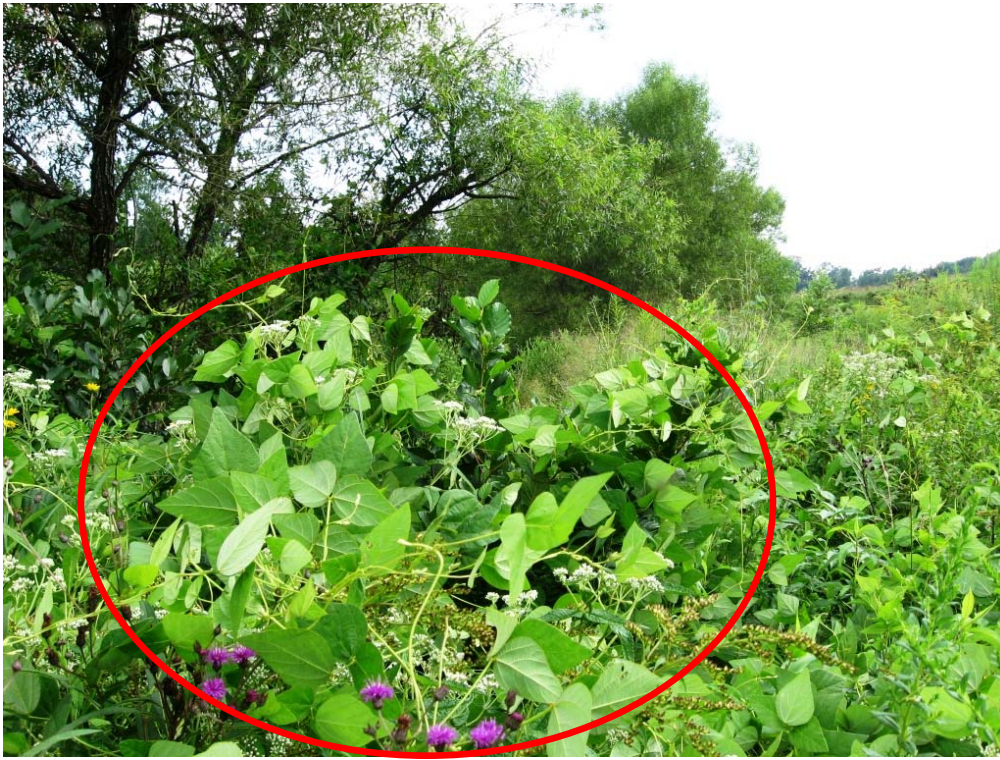
Encroachment of kudzu (*Pueraria montana*) into areas of Phase 2 and Phase 3 is disheartening, as this invasive species was not existent on the site prior to the restoration or reconstruction work. The source of the kudzu has not been identified. During the winter of 2011 attempts will be made to physically remove as much of the kudzu as possible via hand-digging. Follow-up herbicide treatments will be made as needed to keep the invasive plant in check. Additional nearby infestations of other invasive plants (*Ailanthus altissima*, Tree of Heaven and *Microstegium vimineum*, Japanese stiltgrass) will require monitoring to assure they do not impede upon the restoration site. Invasive species control should prove an ongoing challenge.

Photo 11: Kudzu (circled) along a section of Phase 2 on the right bank, shown in August 2010.

A new, but relatively minor infestation of invasive species (kudzu, *Pueraria montana*) was identified along sections of Phase 2 and Phase 3. Control work will begin in the winter of 2011 with attempted removal of the invasive plant matter. The source of this invasive species has not been identified, as this species was not present on the site prior to the restoration work.

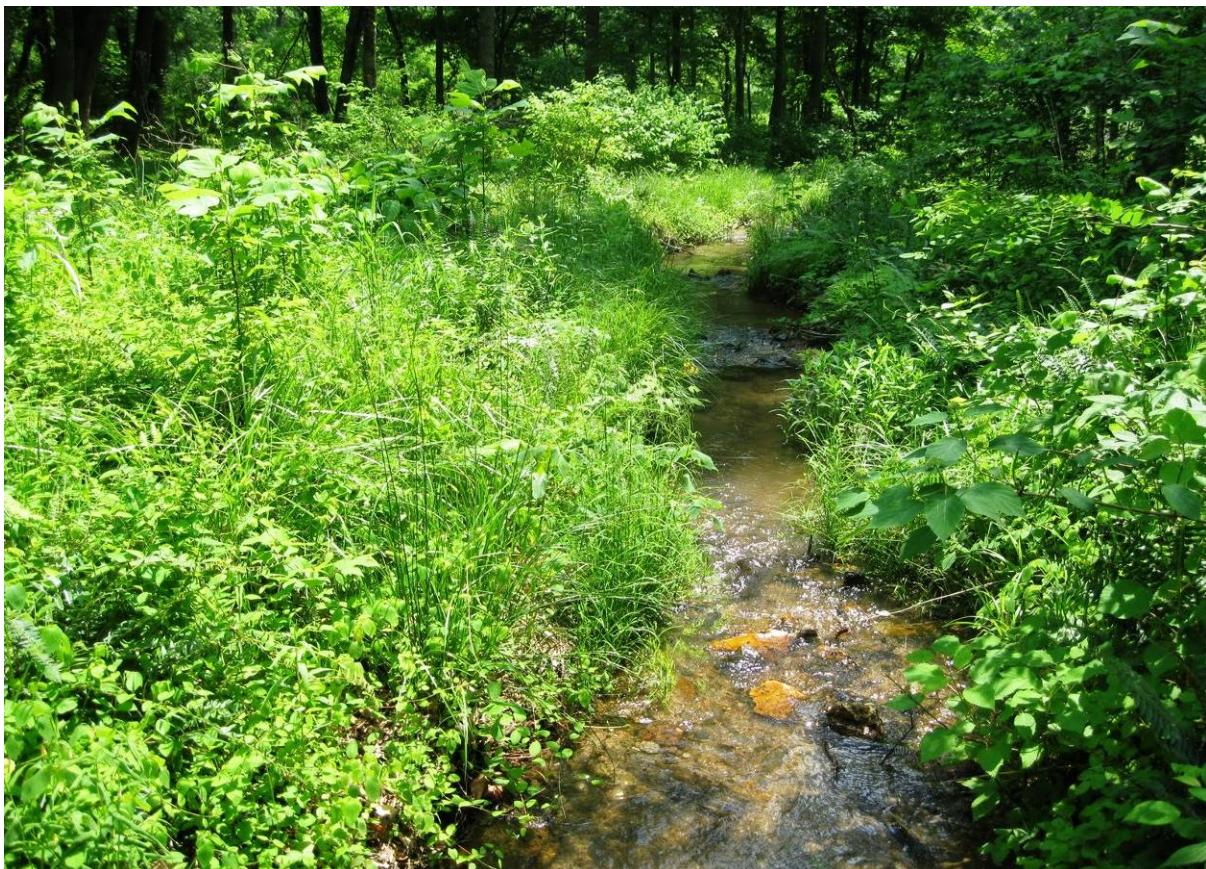
Photo 12: Phase 1 (UT) looking downstream in May 2010. Note abundant woody vegetation growth.
