Timber Harvest Effects on Water Quantity and Quality in the North Carolina Piedmont: Paired Watershed Study Summary

Water Resources Branch
North Carolina Forest Service
N.C. Department of Agriculture and Consumer Services
Raleigh, NC

Eastern Forest Environmental Threat Assessment Center
Southern Research Station
USDA-Forest Service
Raleigh, NC

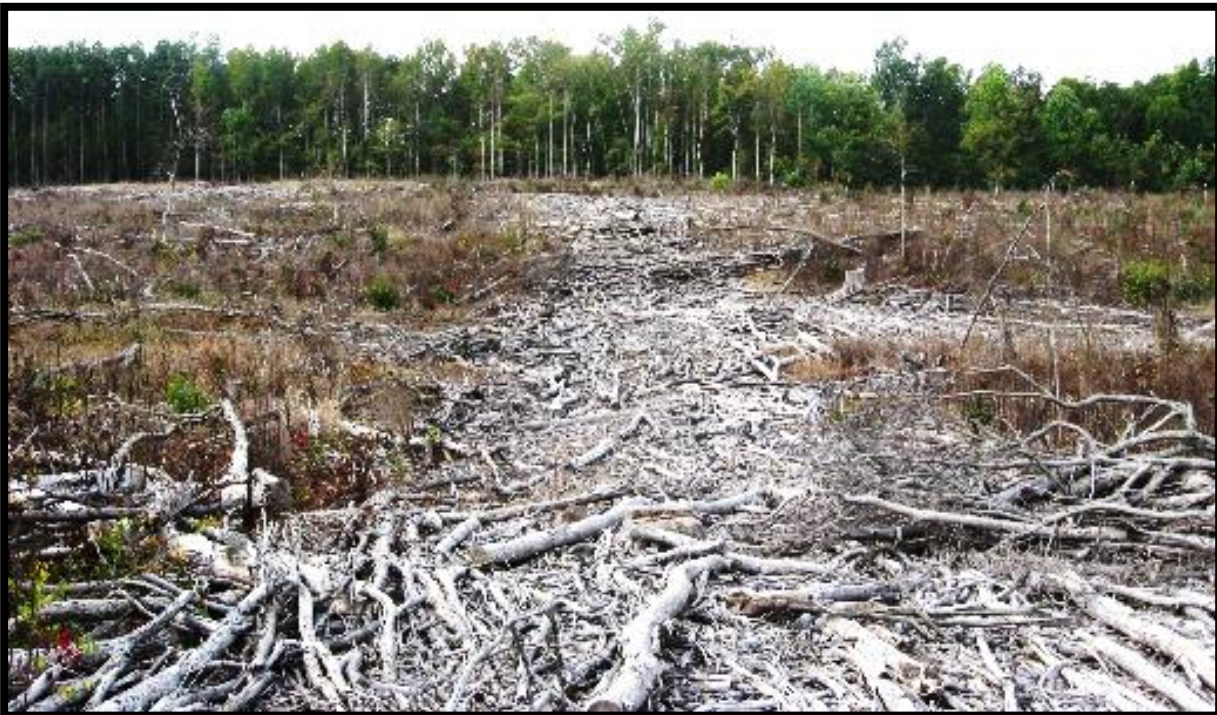
Figure 4. A main skid trail on the UF1 site, looking towards the log deck. Residual tree material (“slash” or “laps”) was applied on top of the skid trails throughout the logging operation.

No stream crossings were used on any timber harvest. The number, extent, and width of primary skid trails was kept to the minimum needed to harvest the site. In addition, the loggers were encouraged to re-distribute leftover treetops, branches, and unusable woody materials back across their main skid trails, as the logging progressed (Figure 4). This BMP is especially useful on areas of sloping terrain or when the skid trail is nearby to the stream buffer zone. This practice is intended to minimize soil compaction / rutting, reduce soil exposure, and lessen the risk of accelerated erosion. Each logger implemented this BMP; and it was especially visible in the UF1 watershed (Figure 4) where the logger had more residual woody debris available to distribute and pack down upon the main skid trails. Other BMPs employed during the study harvest included minimizing logging deck size, locating the deck away from surface water, and minimizing the size and extent of main skid trails.

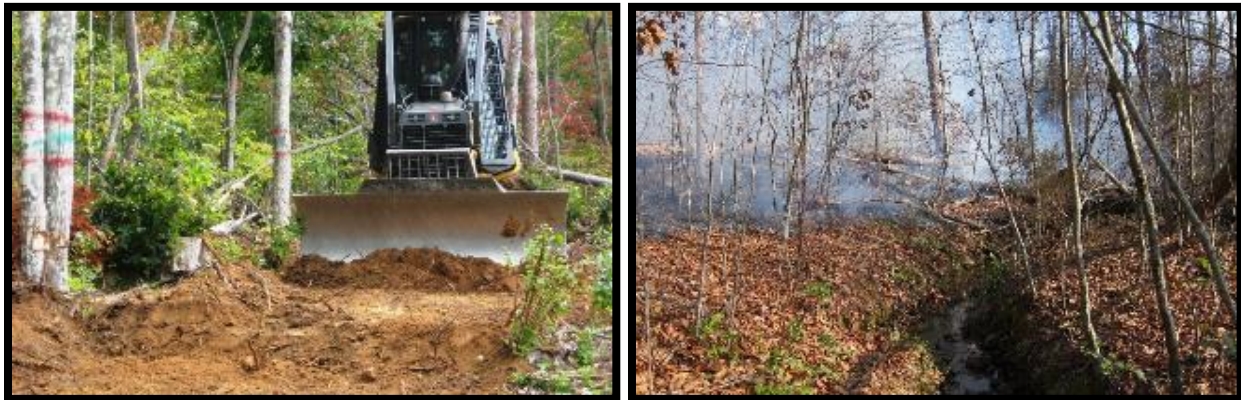
Figure 7. Installation of a fire control line around the perimeter of the UF1 site (right); the operator is installing a waterbar on the fire line. Site prep burn backing out from the Neuse Buffer Rule Zone on the UF1 site

- Application of a prescribed-fire / site-preparation burn to help remove excessive logging debris and vegetative growth (Figure 7). The fire was initiated from alongside the stream in each watershed, and allowed to back-burn out from the stream's edge, through the NBR Zone, and into the cutover. No damage to residual timber within the NBR Zone was observed after the prescribed fire.

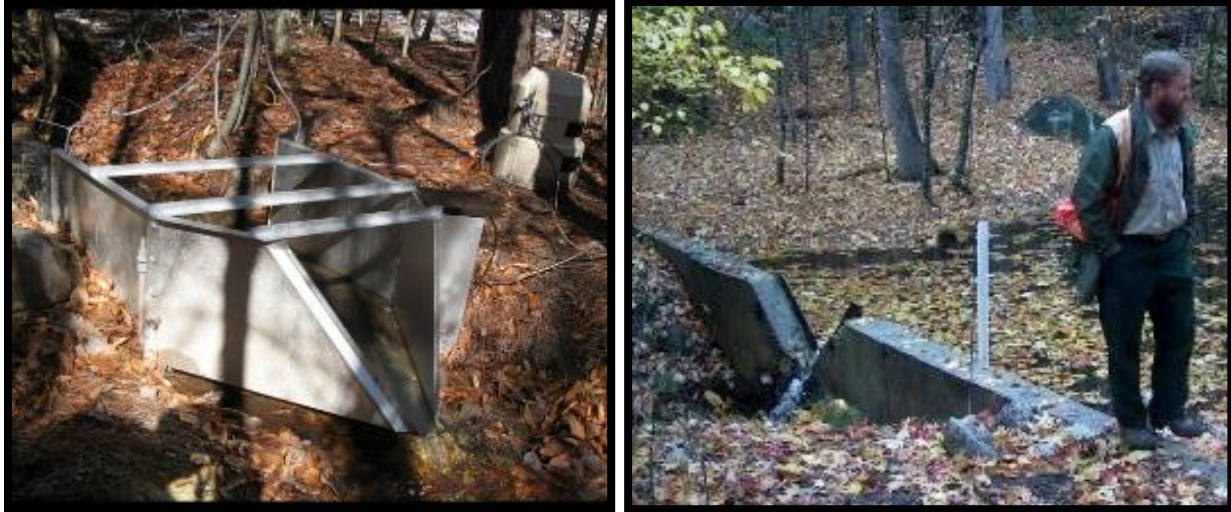
Figure 8. A flume and automated water sampler (left picture). A weir on the outlet of HFW1 (right picture).

Flow control structures, such as flumes and weirs, are necessary to obtain accurate, near-continuous discharge measurements. A 2-H flume was used as the flow control structure at the outlet of HF1, HF2, UF1 and UF2 and a 90° V-notch weir was used at the outlet of HFW1 and HFW2 (Figure 8). Stream discharge rate (ft³/sec, or cfs) was then recorded every 10 minutes by a Sigma™ 900 Max water sampler with a depth sensor. Precipitation (mm) was measured separately in a nearby open area at HF and UF using Hobo™ Data Logging Rain Gauge-RG3.

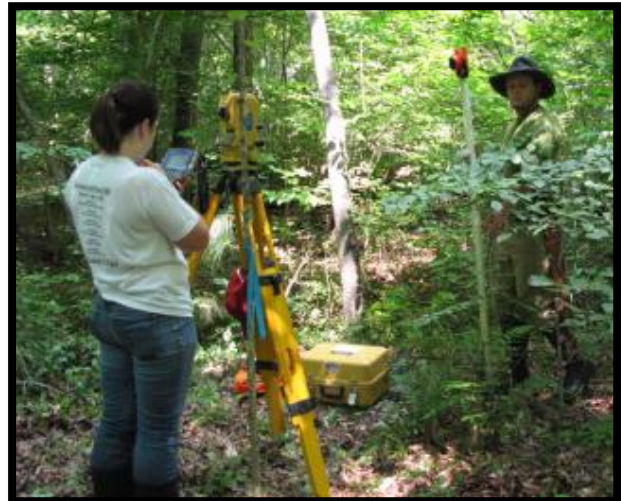
Figure 9. David Jones of NCFS (right) and a student from NCSU conduct geomorphic stream survey on one of the watershed streams.

Channel geomorphology surveys were taken at three cross sections in the watersheds during both preharvest and postharvest periods (Figure 9). The stream survey protocol in general followed the *Stream Channel Reference Sites: An Illustrated Guide to Field Technique, USDA Forest Service General Technical Report RM-245* with some modification to capture features unique to these watersheds. The USDA-FS and NCFS worked in conjunction with the NCSU Department of Biological and Agricultural Engineering to complete the stream surveys. Data processing and figures showing stream cross sections during the monitoring period were completed by staff of the NCFS.

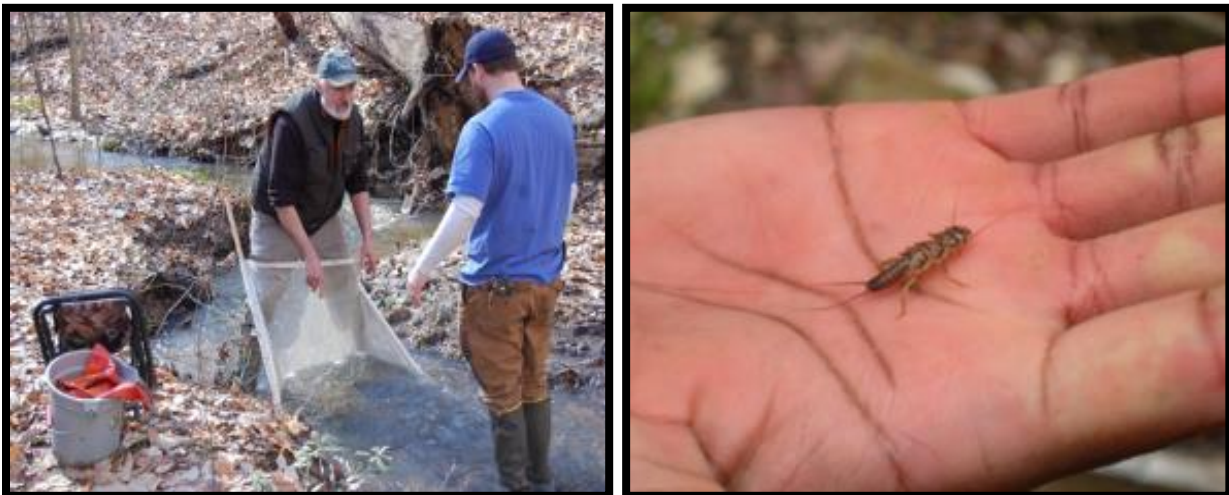
Figure 10. Dr. Dave Penrose of Watershed Science LLC and an assistant sample for aquatic insects (left). A stonefly (*Plecoptera spp.*), which is an indicator of excellent water quality (right).

Nine benthic macroinvertebrate surveys were completed following the semi-qualitative methods outlined by NCDENR-Division of Water Resources (DWR) Biological Assessment Unit (2006) Qual4 method. This method (Figure 10) employs the use of a kick net, sweep net, leaf packs, and visual samples when sampling each stream (NCDENR, 2012). Benthic macroinvertebrate communities were sampled biennially in each study watershed in the preharvest (2 samples) and postharvest (7 samples) periods under both growing and non-growing seasons. Once samples were collected and the organisms identified, the relative abundance (rare, common, or abundant) of each taxon and its corresponding pollution tolerance values were used to calculate diversity indices and an overall bioclassification for each sample. Benthic macroinvertebrate samples were field sorted and sent to Watershed Science, LLC to be identified to the lowest possible taxonomic class. A numerical biotic index and categorical bio-classification were determined according to the NCDENR-DWR 2006 standard qualitative method. Additional analysis of functional feeding groups (FFGs) was also performed to determine if there were changes to trophic-level community structure. FFGs can be used to determine if there's an overall shift in food sources, physical, or chemical conditions in the stream.

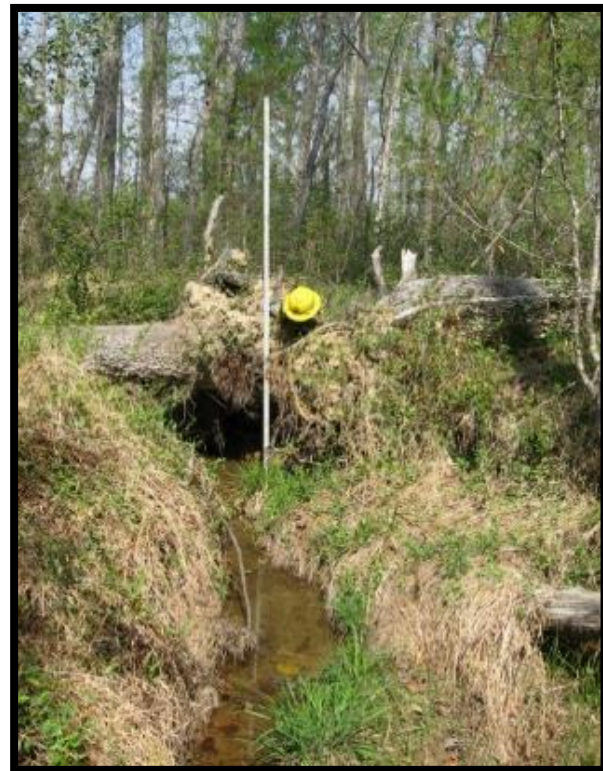
Figure 16. Two conjoined 15" DBH sweetgum trees blown down in nearly opposite directions on left-bank of stream edge in Neuse Buffer Rule Zone of UF1. Photo taken April 2013.

In total, the NBR Zone of UF1 had approximately 36% (24 of 66) of its stream edge trees blown down from these windstorms. After the blowdown, there was no measurable change in the TSS concentrations from UF1 stormflow water samples when compared with the other treatment watersheds (HF1 and HFW1) that did not experience the windstorm disturbance. A field examination in April 2013 of the UF1 site showed that the trees did not blow down in any consistent direction. There was no evidence of twisting damage to the trees that would indicate a tornado. The bole of most all of the wind-thrown trees were intact and were not split or broken. The speculation is that either down-burst winds or storm-induced directional gusts caused the wind disturbance. Of the 12 wind-thrown trees that were assessed on that field exam, the trees were blown down at multiple compass reading directions between a 50° reading and a 230° reading, with each tree laying at a unique compass reading direction. In fact, two large conjoined/forked sweetgum trees blew down in nearly exactly opposite directions (150° difference) from each other, with one tree laying across and over the stream channel and the other tree laying outwards, pointing away from the stream channel (Figure 16).

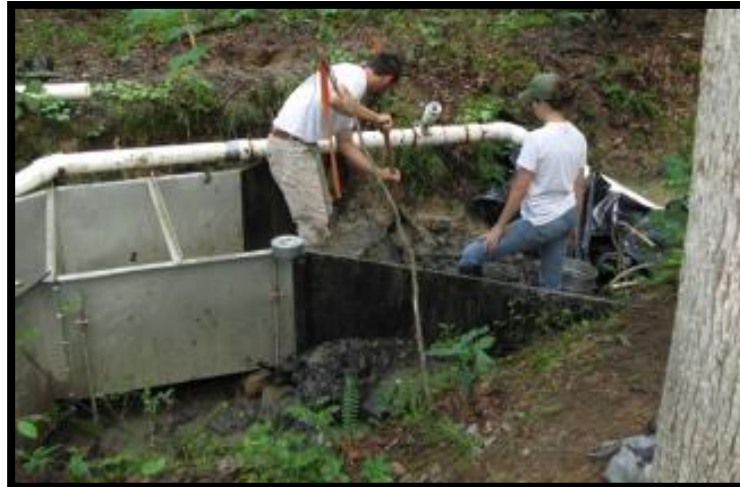
Figure 17. Concrete being added to the entry throat of a flume to keep the streamflow from bypassing under or around.

- Could have done a better job of recognizing the soil erodibility of each watershed, at the location where the 2-H flumes were installed, and more closely supervised the installation of the flumes by the contractor. After some of the first few stormflow events, stream water began to undermine the apparatus on the UF site. Quick action was taken to plug the gaps and assure that no stream discharge bypassed the flume for the remainder of the study (Figure 17).

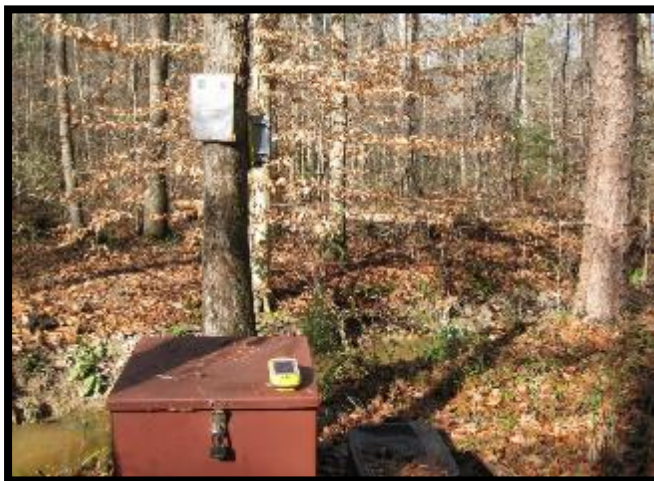
Figure 18. An informational sign and protective containment box on one of the watershed study sites.

vandalism, or theft of any equipment. For three of the sites, the NCFS fabricated a heavy steel containment box with a locking lid to house the automated water sampler (Figure 18). This box kept the sampler out of site and protected from potential vandalism or theft.

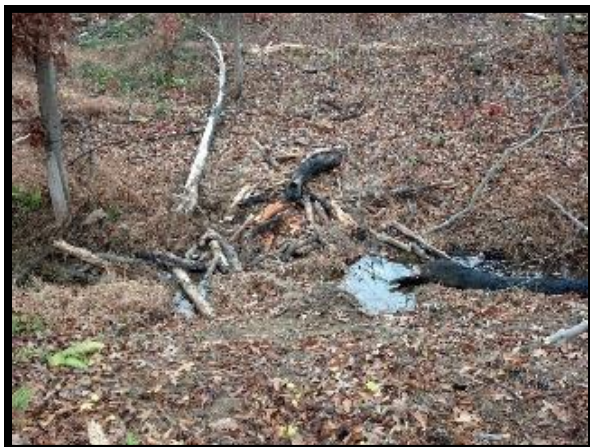
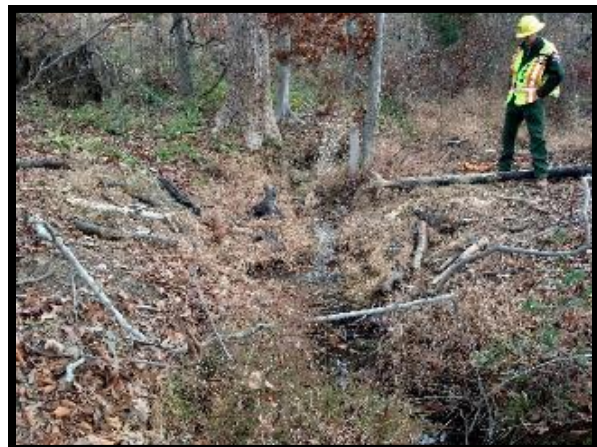
Figure 20. Unauthorized crossing of the stream on the UF1 site (left). The same crossing after debris removal and vegetation material was applied to cover the exposed soil.

In the late Fall of 2012, the UF Forest Manager was notified by a contractor, after the fact, of an exploratory mission by the contractor who was hired by the federal government to locate potential unexploded ordnance in the area immediately surrounding an active military installation, which abuts the UF watershed site. The contractor operated a small mobile piece of equipment (believed to be a tracked skid-steer loader or similar machine) on transects across the property, and drove the machine through the UF1 NBR Zone and crossed the stream in at least two locations that could be identified. The impact to the NBR Zone and the stream were considered minimal by NCFS personnel after inspecting the site soon after notification was received. On one crossing, a small area of soil was exposed on the left bank, and coarse woody debris was partially obstructing stream discharge (photos below). Dead grass stems were applied to the exposed soil and the woody debris was removed by hand. The other crossing did not require remedial work.

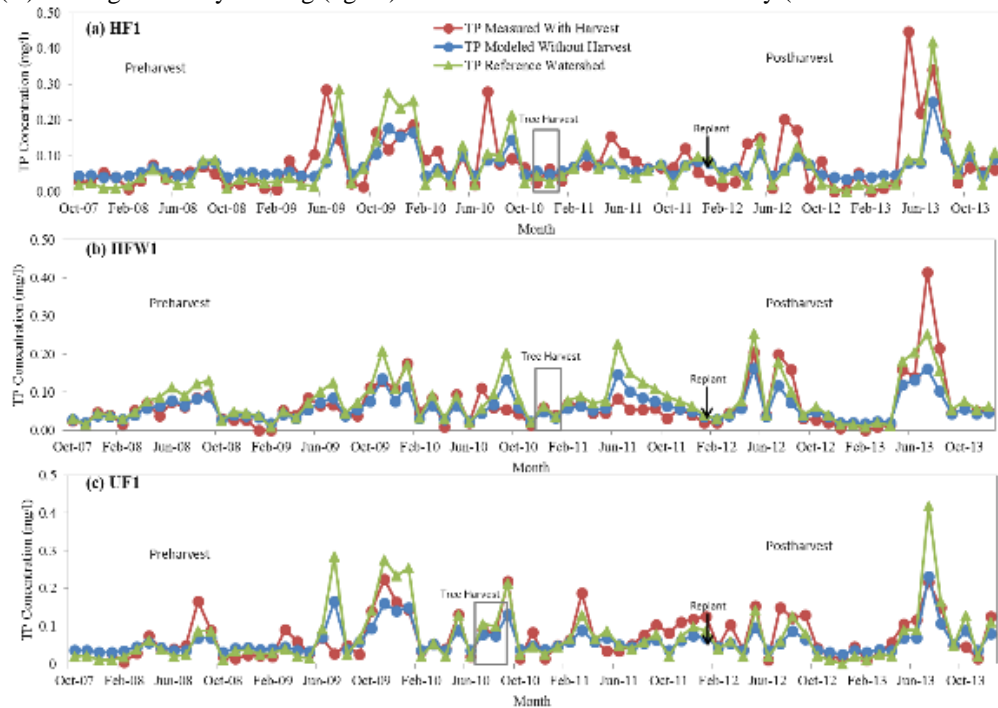
(B) Average monthly concentration (mg/L) of TP for the duration of this study (includes both baseflow and stormflow).

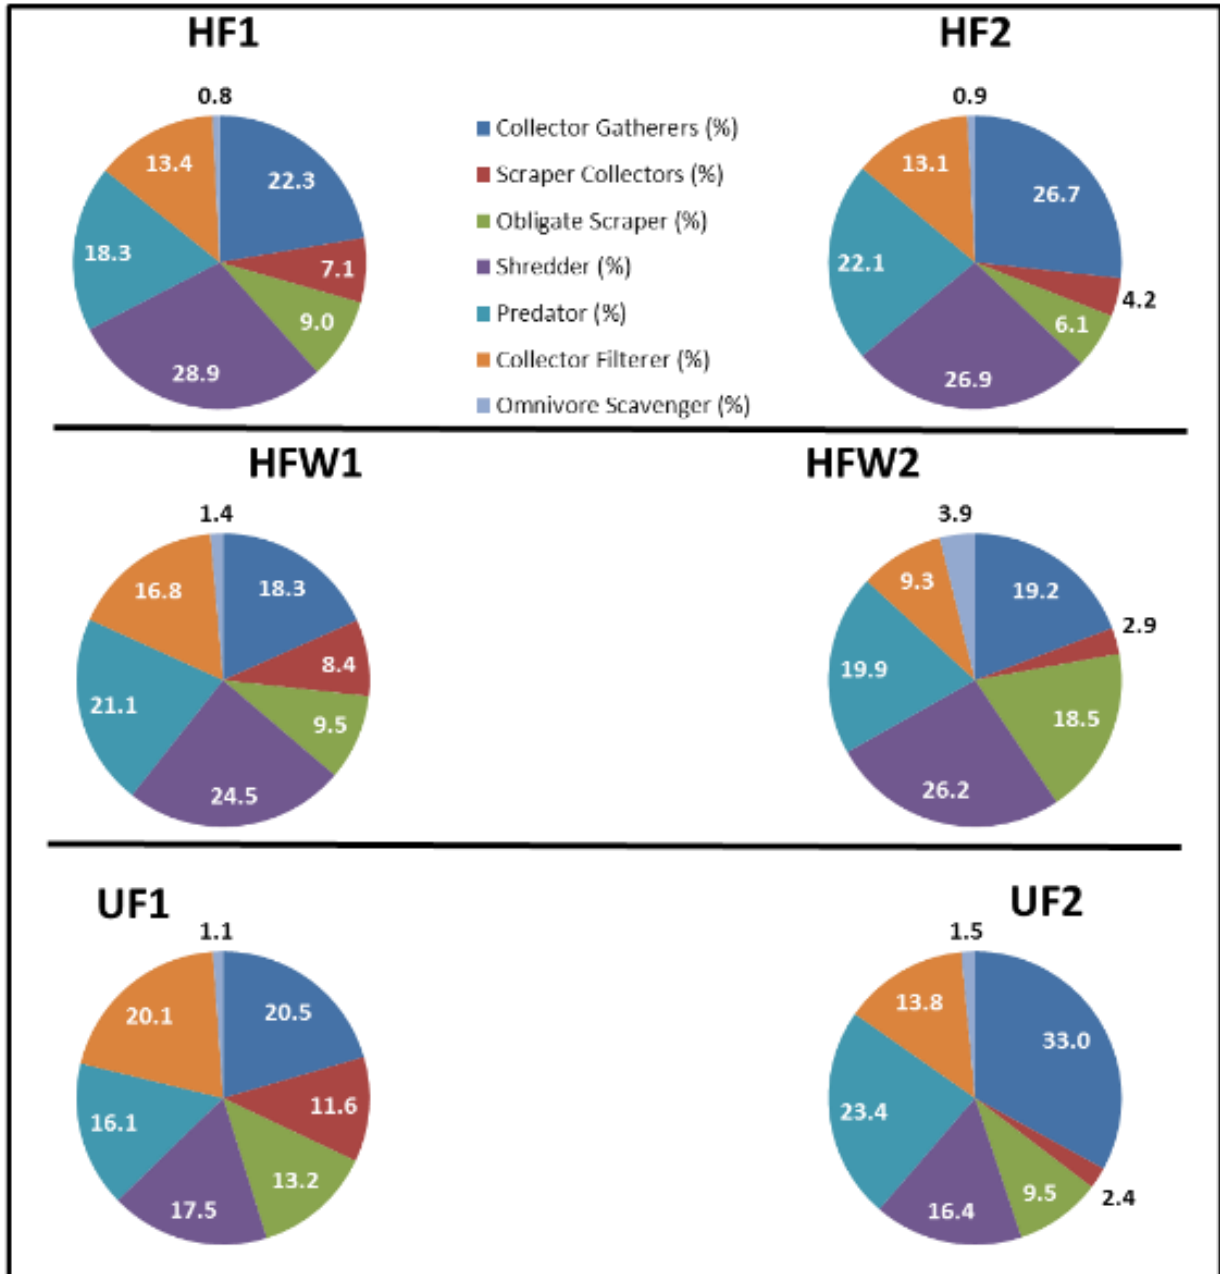
Appendix M. Mean functional feeding group (FFG) percentages of sampled insects for each watershed during postharvest period.
