North Carolina
Division of Forest Resources

North Carolina Forestry BMP Implementation Survey Results 2006-2008

Final Report

North Carolina Forestry BMP Implementation Survey Results 2006 – 2008

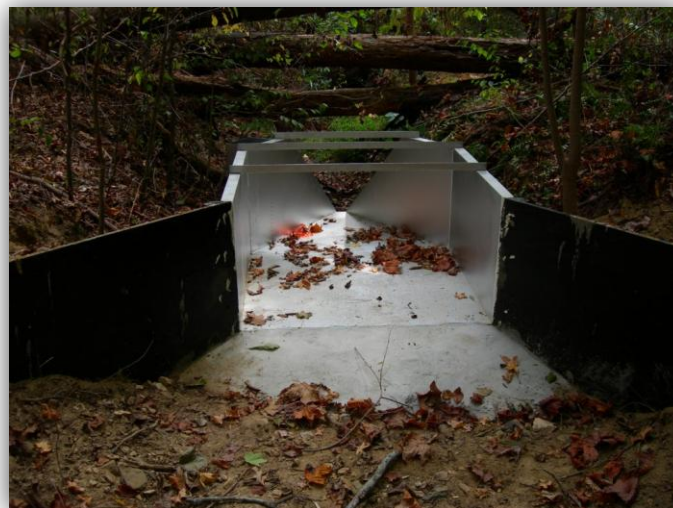
During the drought, many streams that typically flow year round were without water. This H-flume is located on a perennial stream in the Piedmont of North Carolina and was installed to monitor streamflow and water quality as part of the NC BMP Effectiveness Monitoring Watershed Study (www.dfr.state.nc.us/water_quality/BMP_effectiveness_study.htm).

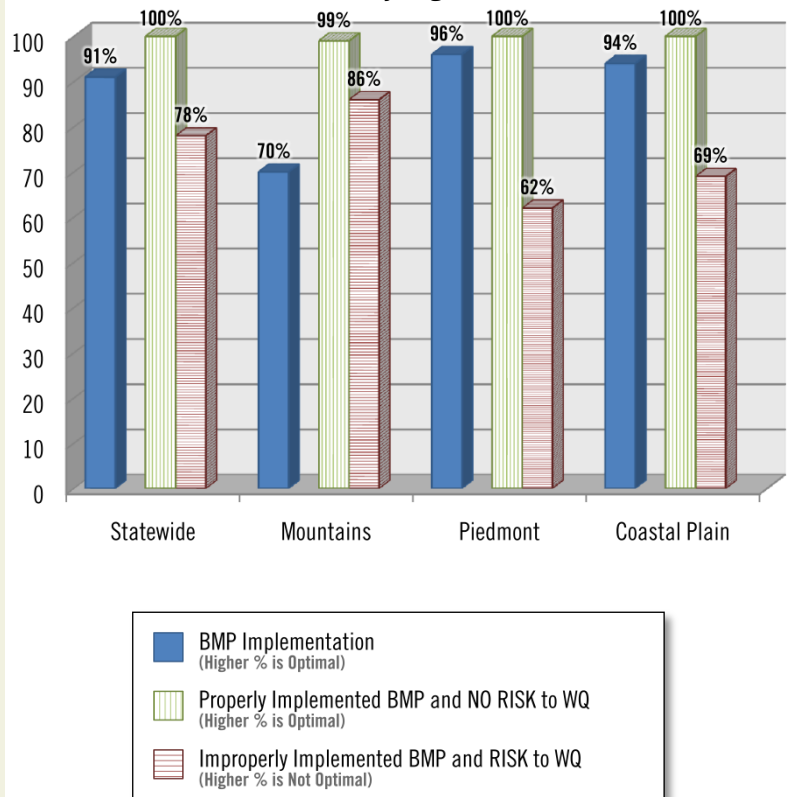
Figure 4. Implementation of BMPs for Streamside Management Zones by Region

When applicable, 91 percent of the BMPs for SMZs were properly implemented statewide. The Piedmont had the highest implementation (96%) followed by the Coastal Plain (94%) and Mountains (70%) (Figure 4). When compared to the previous survey, implementation of BMPs for SMZs increased in all regions.

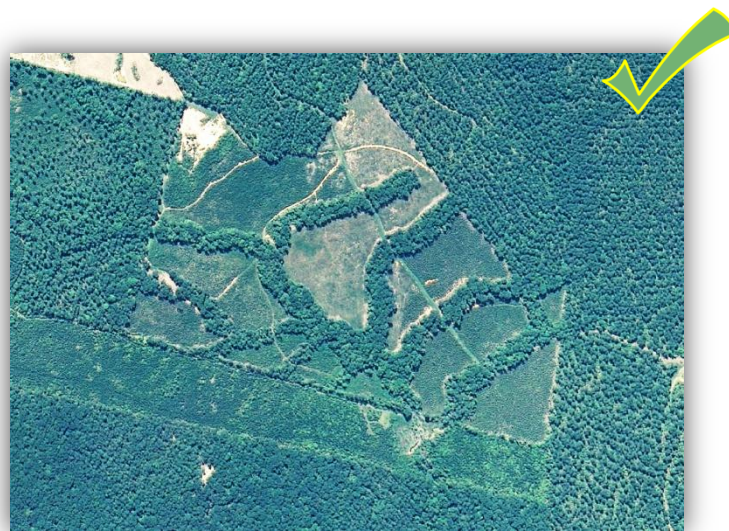
Aerial photograph illustrating properly implemented BMPs for SMZ width along streams in the Piedmont of North Carolina.

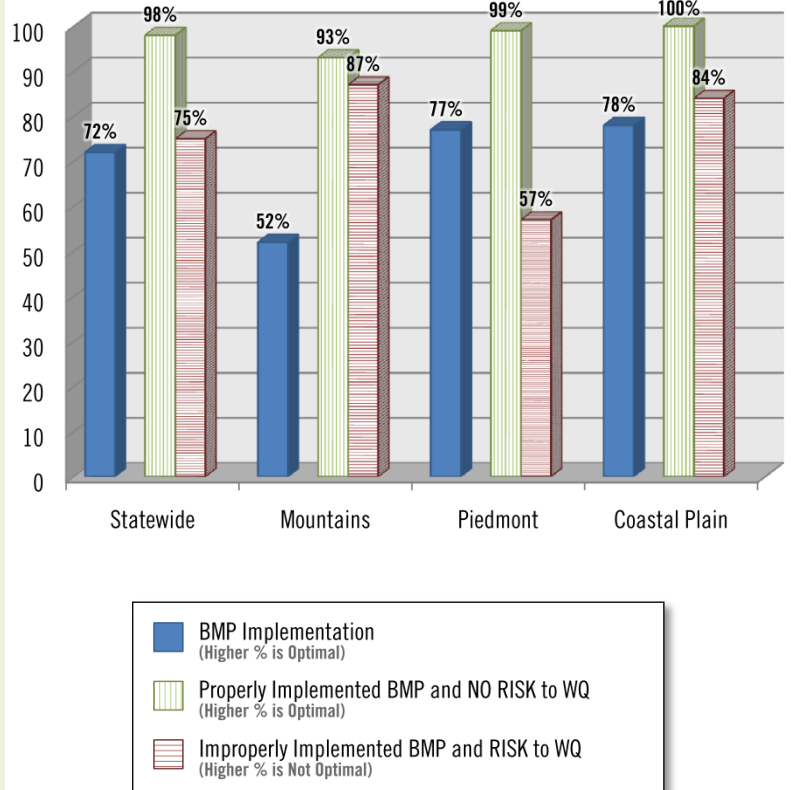
Figure 5. Implementation of BMPs for Stream Crossings by Region

When applicable, 72 percent of the BMPs for stream crossings were properly implemented statewide. The Coastal Plain had the highest implementation (78%) followed by the Piedmont (77%) and Mountains (52%) (Figure 5). When compared to the previous survey, implementation of BMPs for stream crossings increased in all regions.

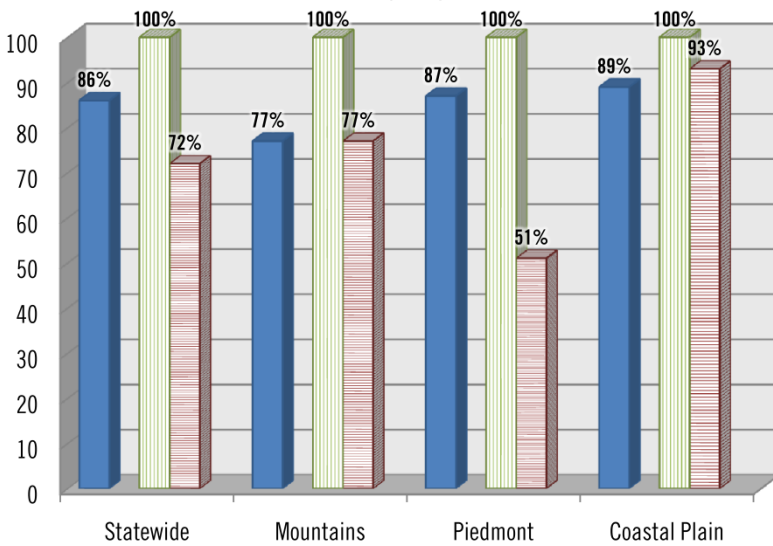
Figure 6. Implementation of BMPs for Debris Entering Streams by Region

When applicable, 86 percent of the BMPs for debris entering streams were properly implemented statewide. The Coastal Plain had the highest implementation (89%) followed by the Piedmont (87%) and Mountains (77%) (Figure 6). When compared to the previous survey, implementation of BMPs for debris entering the stream decreased in all regions.

- ✓ BMP implementation for debris entering streams was 86 percent statewide, 77 percent in the Mountains, 87 percent in the Piedmont, and 89 percent in the Coastal Plain (Figure 6).

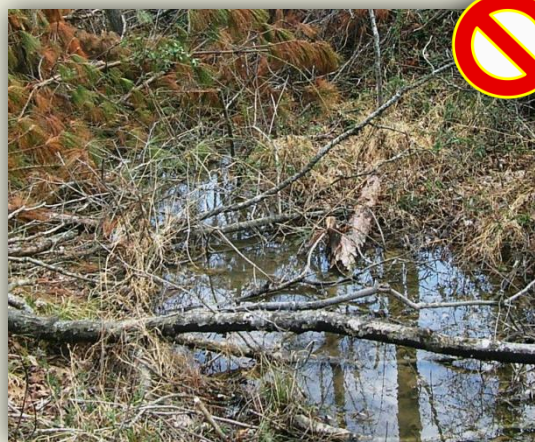
This picture illustrates non-implemented BMPs for debris entering streams. The stream is severely obstructed by tree tops and limbs.

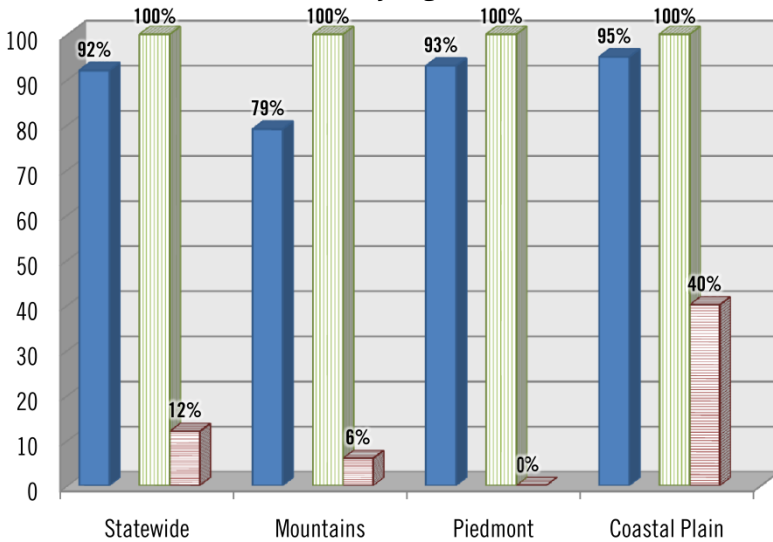
Figure 7. Implementation of BMPs for Waste Entering Water by Region

When applicable, 92 percent of the BMPs for waste entering water were properly implemented statewide. The Coastal Plain had the highest implementation (95%) followed by the Piedmont (93%) and Mountains (79%) (Figure 7). When compared to the previous survey, implementation of BMPs for waste entering water did not change for the statewide average, decreased for the Mountains and Piedmont, and increased in the Coastal Plain.

- ✓ BMP implementation for waste entering water was 92 percent statewide, 79 percent in the Mountains, 93 percent in the Piedmont, and 95 percent in the Coastal Plain (Figure 7).

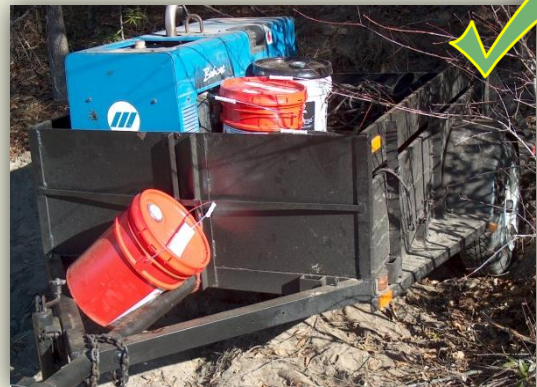
This picture illustrates well implemented BMPs for preventing waste from entering water. Equipment fluid is stored outside the SMZ and off the ground.

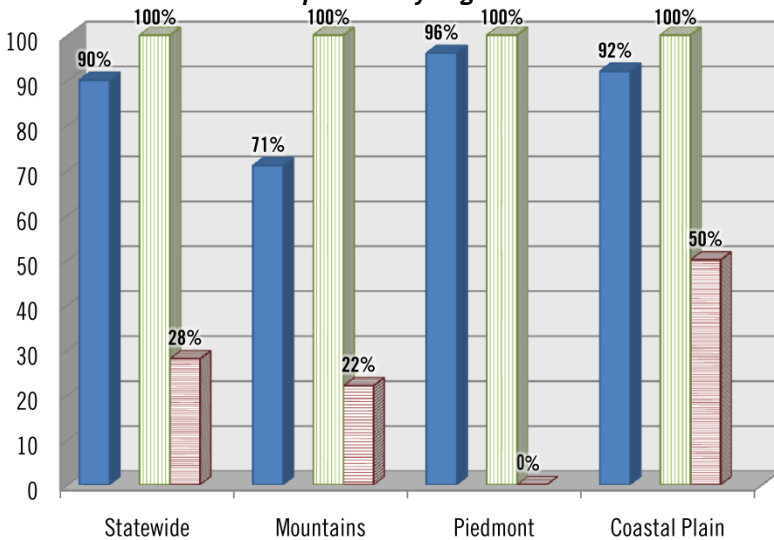
Figure 8. Implementation of the BMP for Stream Temperature by Region

When applicable, the one BMP for stream temperature was properly implemented 90 percent of the time statewide. The Piedmont had the highest implementation (96%) followed by the Coastal Plain (92%) and Mountains (71%) (Figure 8). When compared to the previous survey, implementation of the BMP for stream temperature increased in all regions, with the exception of the Mountains, where it decreased.

- ✓ BMP implementation for stream temperature was 90 percent statewide, 71 percent in the Mountains, 96 percent in the Piedmont, and 92 percent in the Coastal Plain (Figure 8).
- ✓ When the BMP for stream temperature was properly implemented statewide, there was no risk to water quality 100 percent of the time. Conversely, when the BMP was not implemented, it resulted in a risk to water quality 28 percent of the time (Figure 8).
- ✓ When evaluating the BMP for stream temperature, a risk to water quality was most frequently observed when the BMP was not implemented in the Coastal Plain followed by the Mountains and Piedmont (Table 10).
- ✓ As discussed in Section 3.2.1 of this report, only 10 percent of the surveyed SMZs were observed to have lost more than 25 percent stream canopy cover (shade) as a result of the timber harvest.

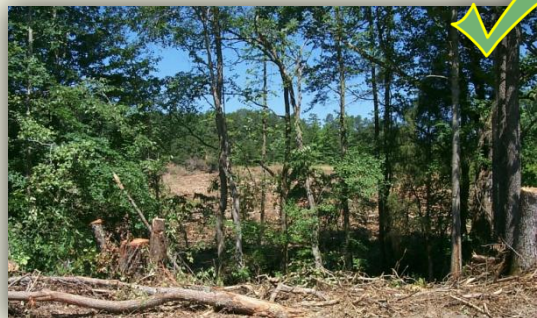
This SMZ in the Piedmont of North Carolina provides adequate shade to the stream, preventing adverse stream temperature fluctuations.

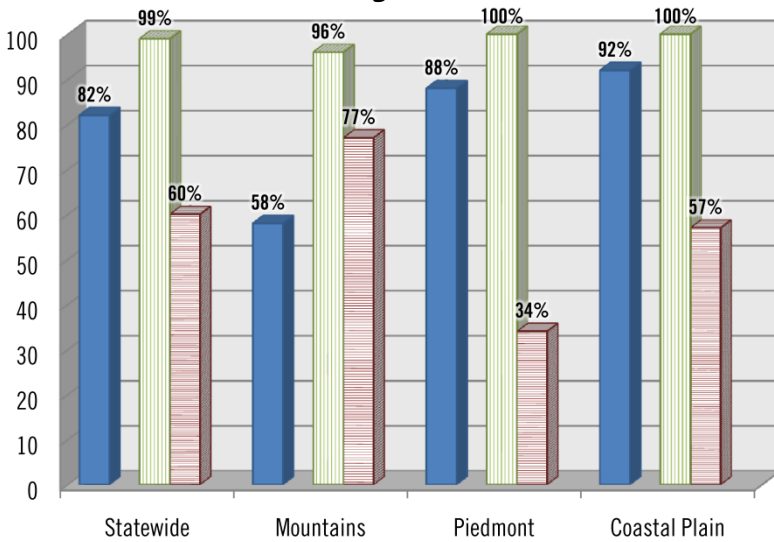
Figure 9. Implementation of BMPs for Skid Trails by Region

When applicable, 82 percent of the BMPs for skid trails were properly implemented statewide. The Coastal Plain had the highest implementation (92%) followed by the Piedmont (88%) and Mountains (58%) (Figure 9). When compared to the previous survey, implementation of BMPs for skid trails increased in all regions.

- ✓ BMP implementation for skid trails was 82 percent statewide, 58 percent in the Mountains, 88 percent in the Piedmont, and 92 percent in the Coastal Plain (Figure 9).

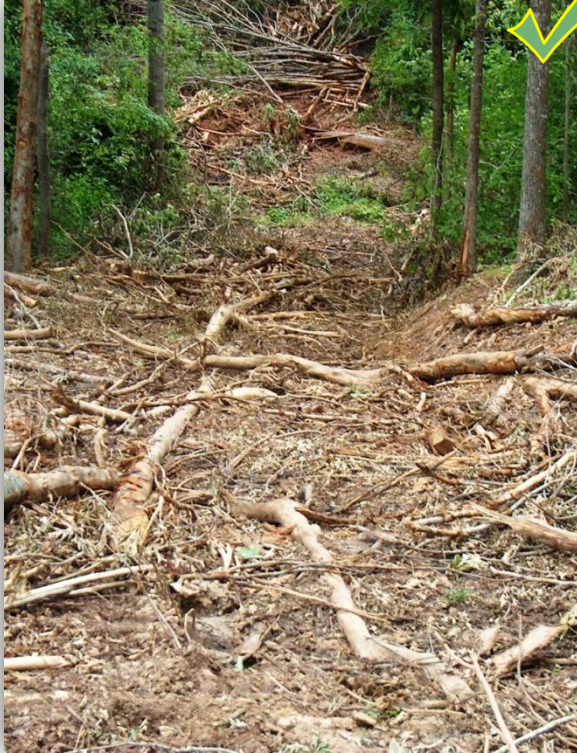
Applicable BMPs for skid trails are well implemented in this picture. Logging slash is matted as the skid trail slopes down toward a stream crossing; providing sufficient ground cover to prevent runoff, erosion, and sedimentation.

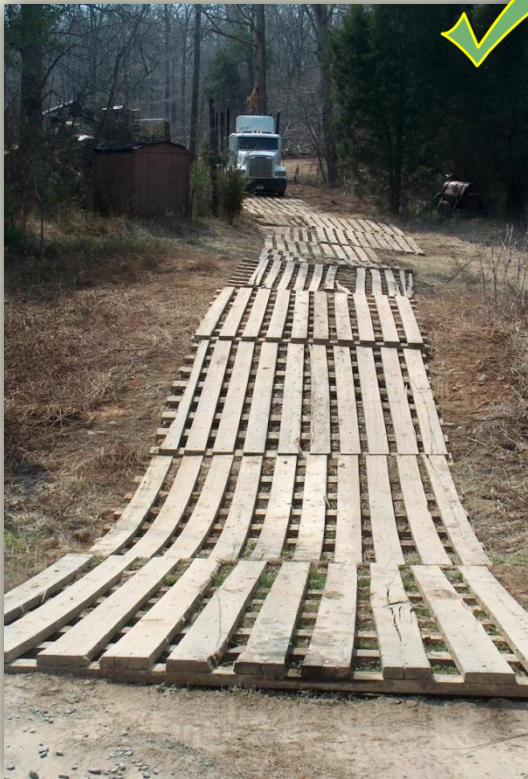
Wooden mats used within the first 100 feet of a public access road can prevent loose sediment from being deposited on the public road surface. While this BMP is designed to reduce nonpoint source pollution runoff, it also helps reduce traffic hazards.

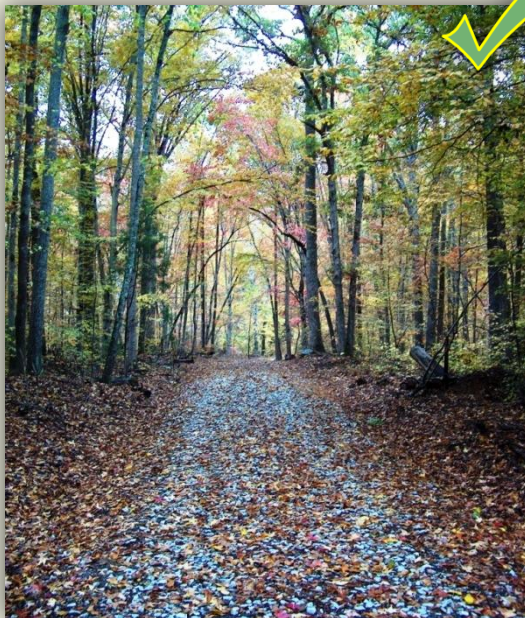
This forest access road is well maintained and has a stable surface of crushed stone that helps to control runoff.

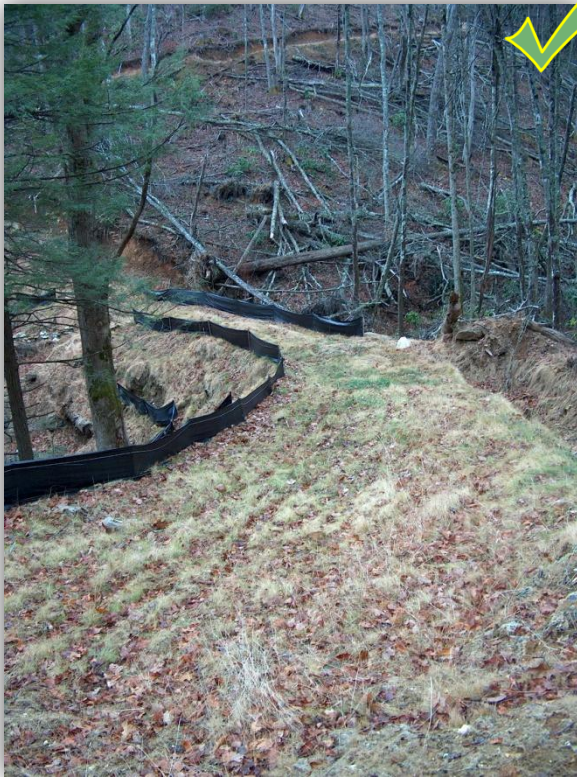
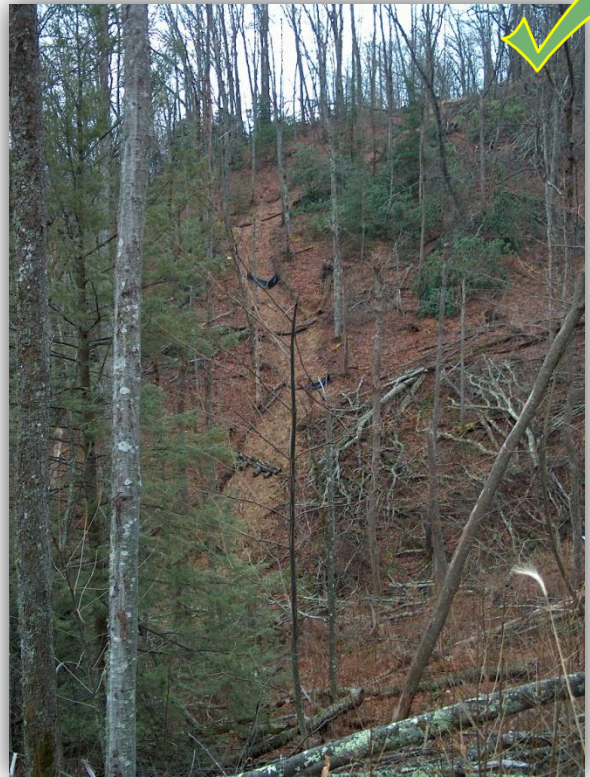
These pictures show well implemented BMPs for rehabilitation along skid trails in the Mountains. In both examples, the ground was seeded and mulched. Silt fence was installed as needed to slow runoff and reduce erosion.
