Stream Restoration Post-Implementation Annual Monitoring Report:

Year 4 - 2012

For the N.C. Clean Water Management Trust Fund (CWMTF)
Project #2004A-411:
“Rendezvous Mountain Purlear Creek Stream Restoration”

February 2013

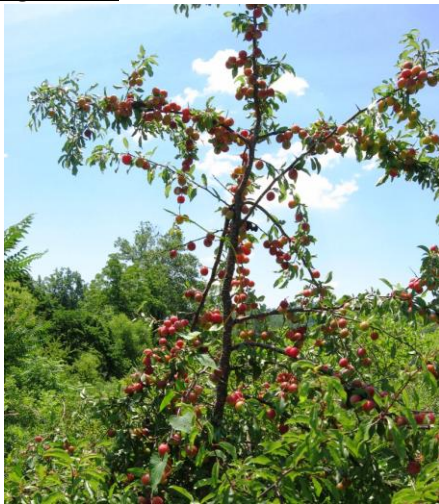
Tree growth remains abundant and there continues to be a diversity of tree species within the riparian corridor. Growing-season shade from trees and woody shrubs appears to be increasing both in area and length along the stream corridor. This past year, the wild plum (*Prunus americana*) trees that were planted in 2008 produced an abundant crop of fruit (photo at left, June 2012); even to the extent that tree limbs broke off from the weight of the fruit.

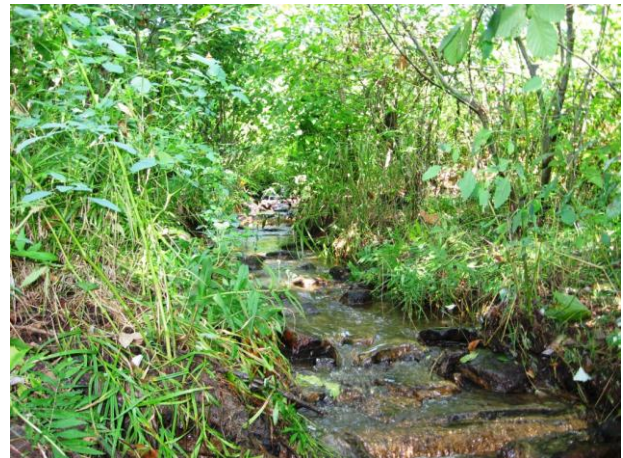
Photo at right taken August 23, 2012 shows a close up view of the stream channel within the unnamed tributary and adjacent vegetation within the riparian corridor.

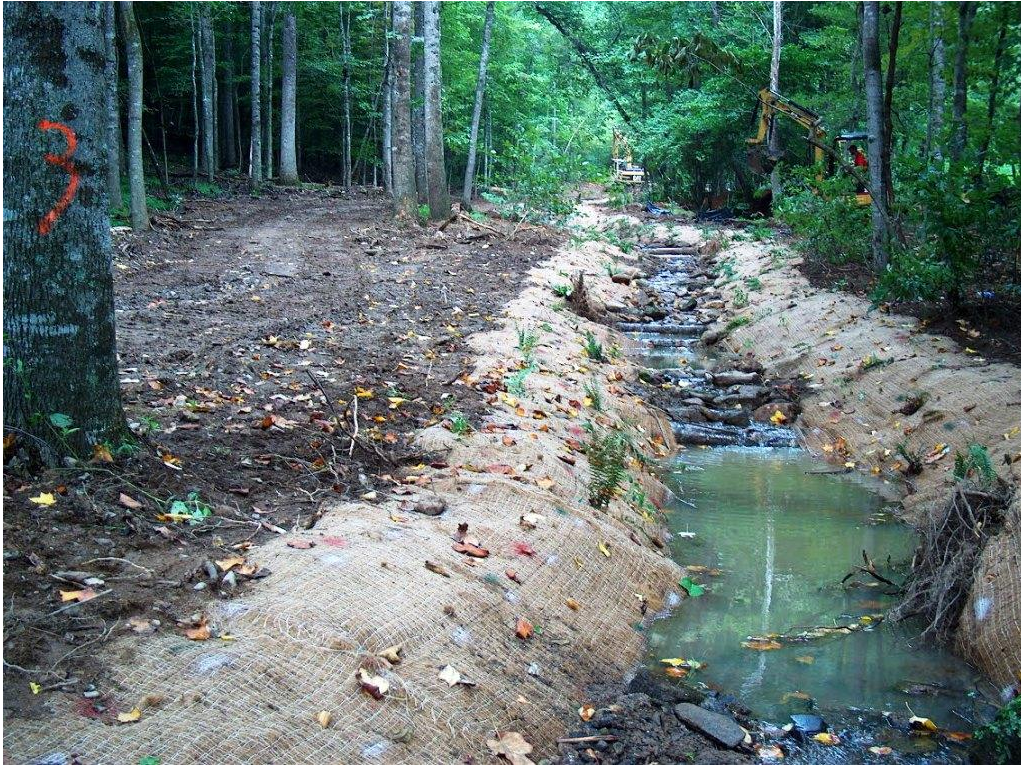
Un-Named Tributary, Phase 1:

Top photo was taken August 2006, soon after water was turned into the newly constructed channel.

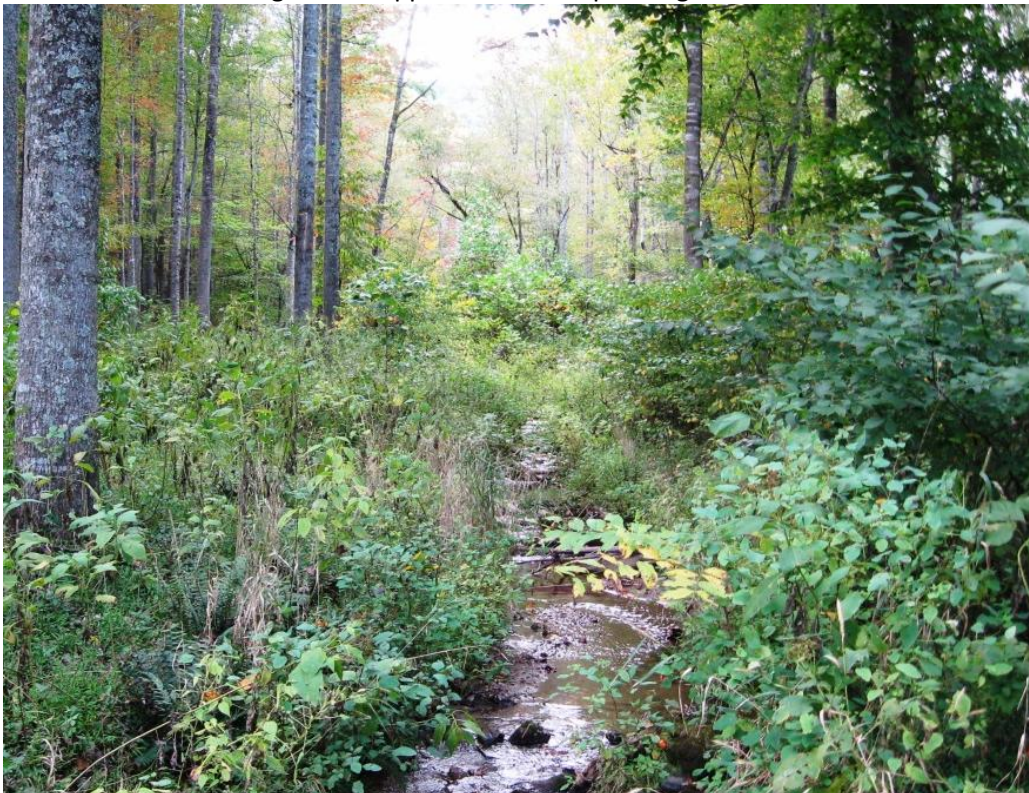
Bottom photo was taken October 2012. While overall vegetation height growth is limited from the mature forest overstory canopy, the trees and shrubs have completely filled-in the lateral extent of the disturbed area. An abundance of native seedlings have supplemented the plantings that were installed after restoration.

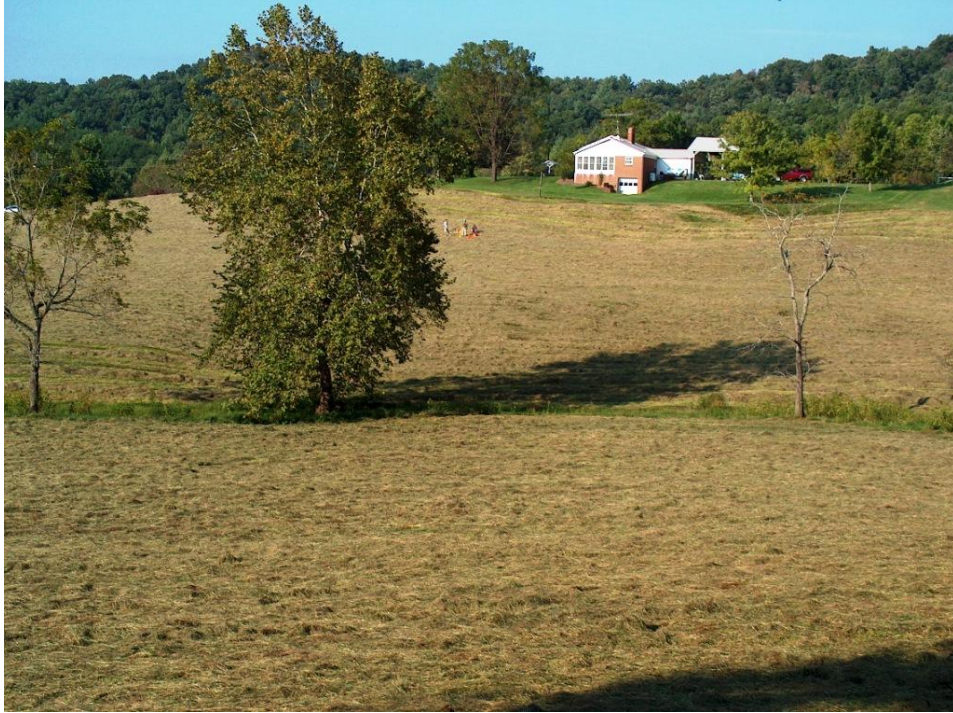
Purlear Creek mainstem, Phase 2:

Top photo was taken September 2004, prior to any restoration work. A protected riparian corridor is functionally non-existent. The entire parcel was cultivated as a hay pasture prior to acquisition.

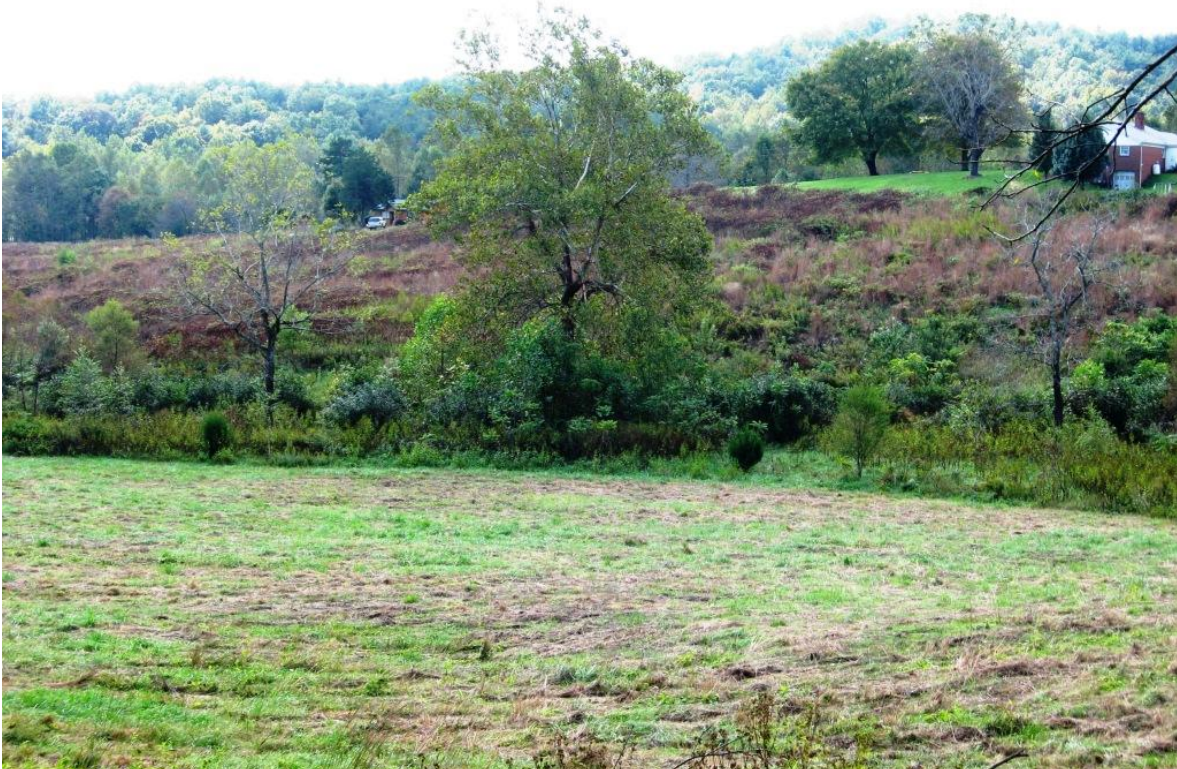
Bottom photo was taken October 2012. Privately-owned property seen in the foreground is still cultivated for hay. However the property line now extends out beyond the stream's centerline to ensure permanent protection on both sides of the riparian corridor as State Forest property. Note the growth of vegetation along the restored stream and early-successional vegetation upland habitat on the opposite side of the stream.

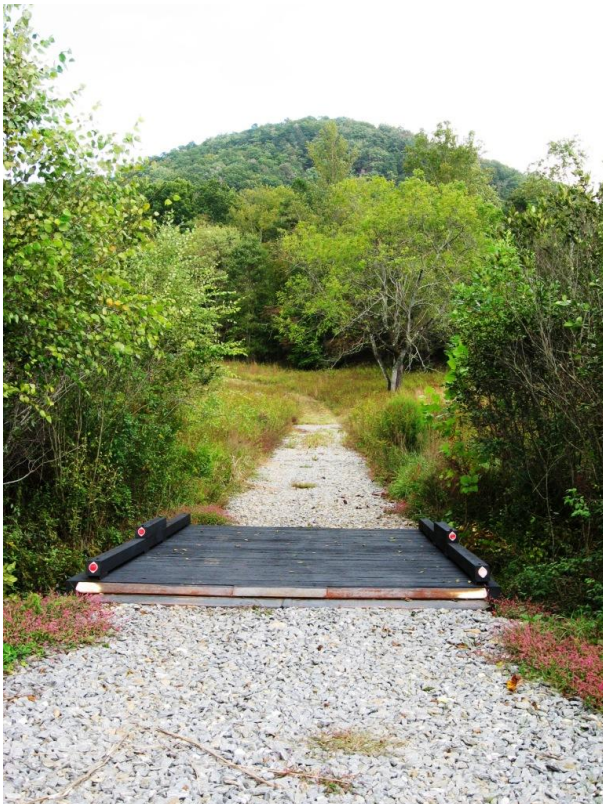
Photo at left from October 2012 shows the completed bridge crossing. Road approachways received ample stone aggregate to dissipate surface runoff and prevent sedimentation.

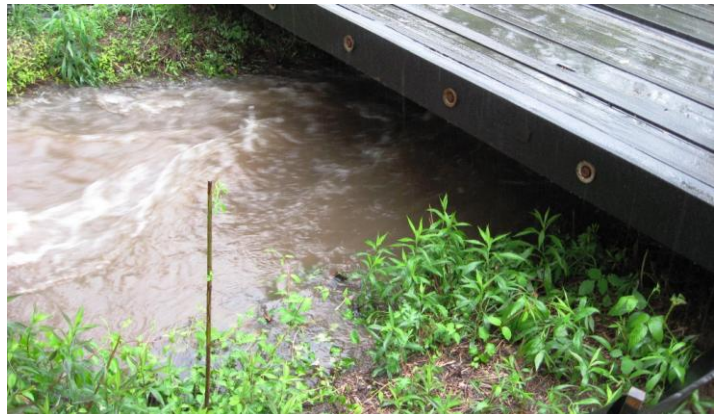
Photo above from April 2012 during a bankfull event at the bridge crossing. The crossing provides ample vertical and lateral clearance for accommodating normal bankfull flow while still allowing NCFS to fully access the State Forest.
