District Project Highlights

Brunswick Marsh Sill/Living Shoreline Project

Boone's Neck

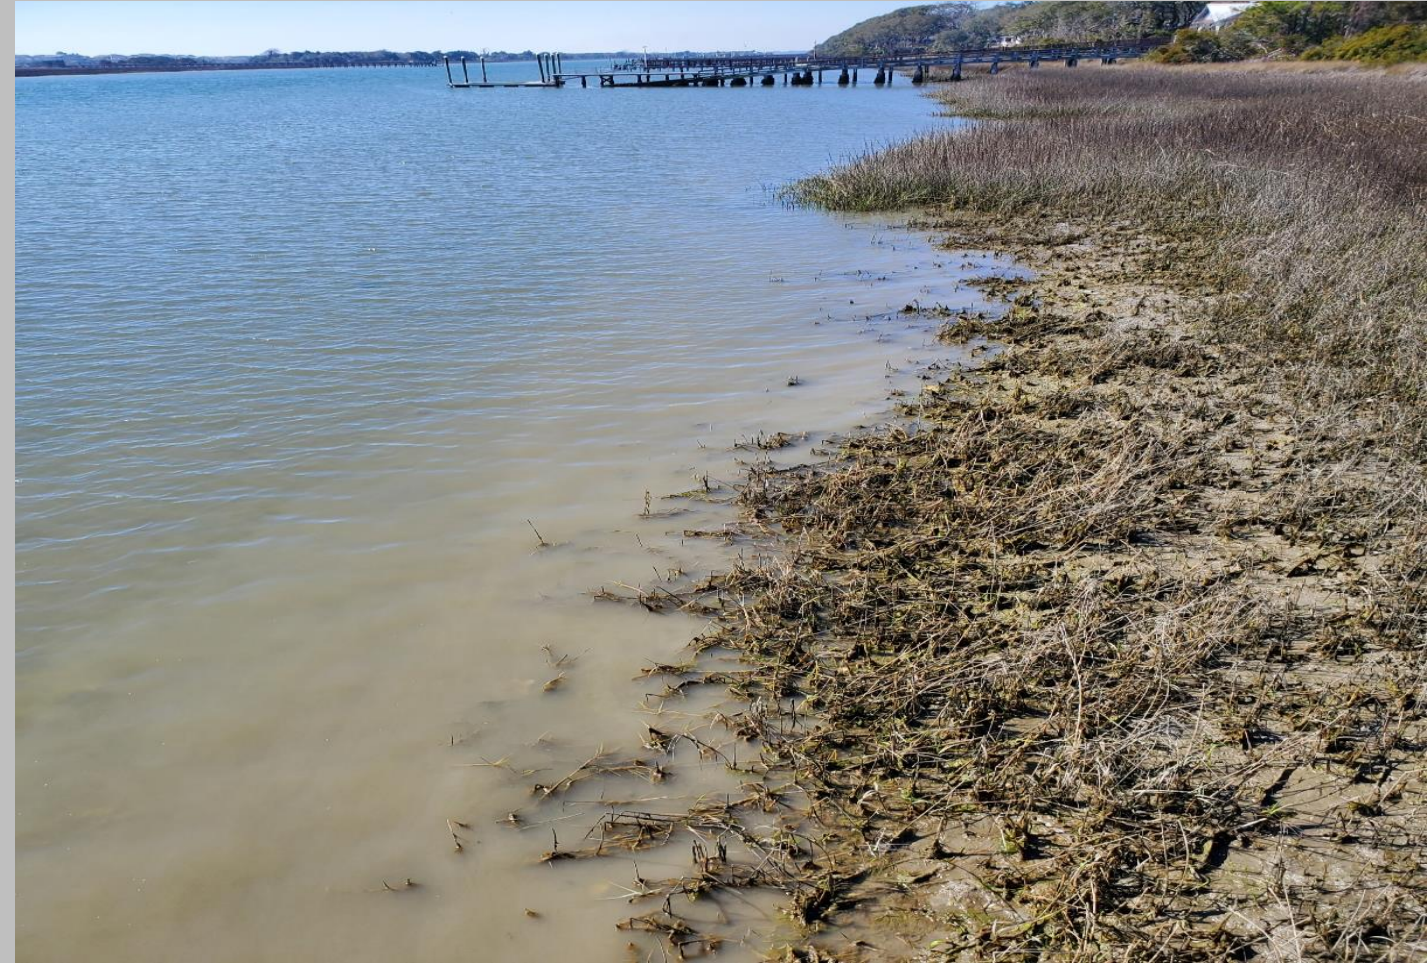
Photo showing the increased turbidity due to excessive erosion. Note the photo is taken at a relatively calm time with limited wave action

- Impaired waters
- Shellfish/High Quality Waters
- Significant erosion
- Loss of shore and marsh grasses
- Significant increased turbidity

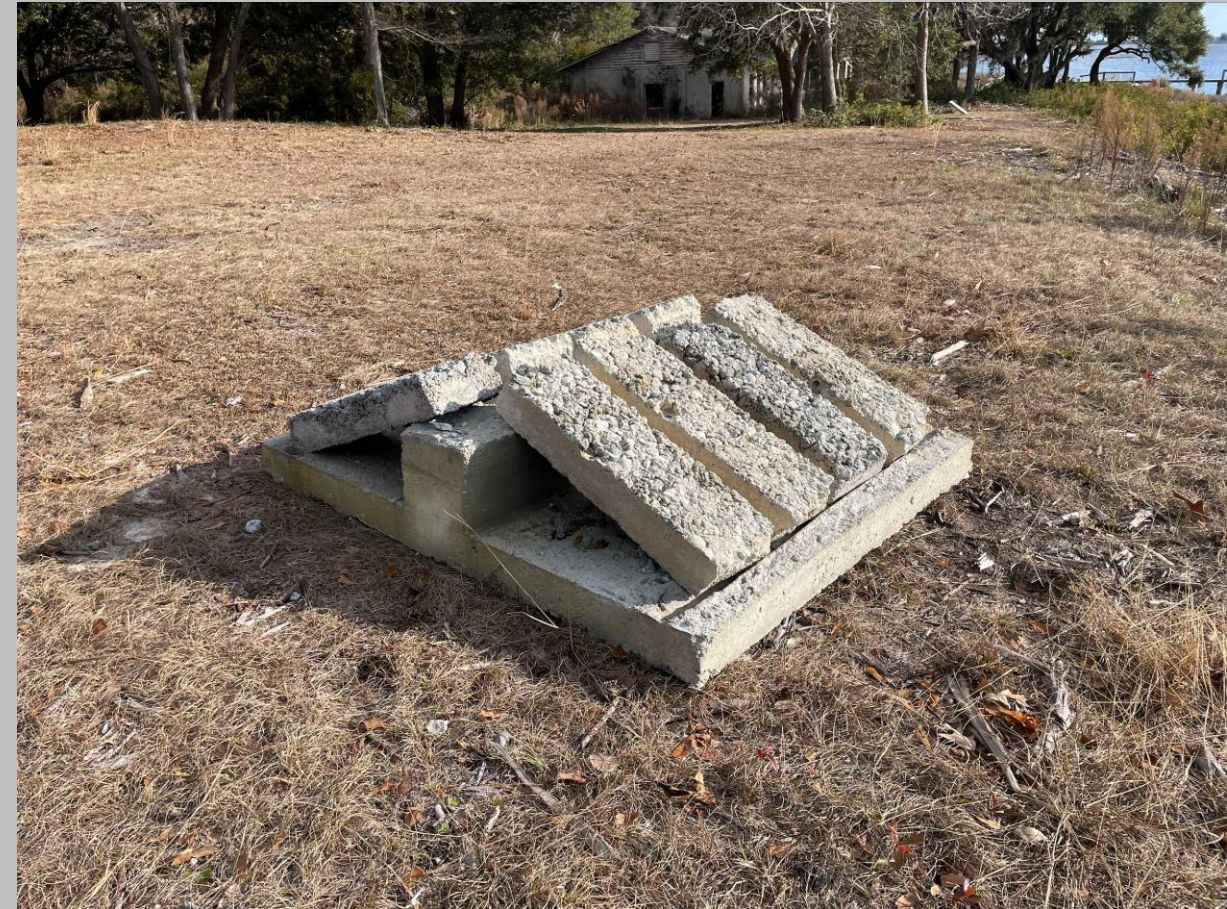
This photo shows the foundation and breakwater slabs used on the marsh sill/living shoreline project

- A variety of materials are now available for breakwater systems
- This photo shows a proprietary system called "Quick Reef"
- The highly textured surface allows oyster larvae/spat to attach and grow
- The breakwater grows with the spat/oysters
- The breakwater used is based on the energy system specific to the site conditions

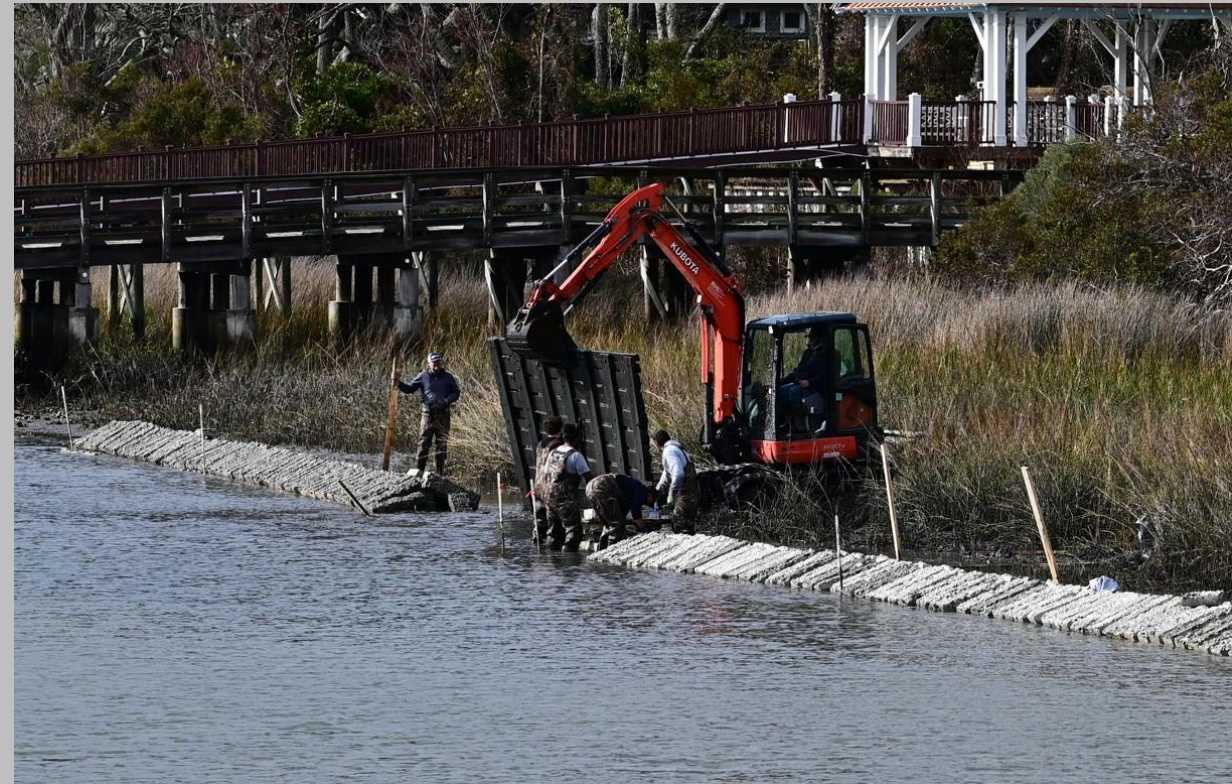
Skid steer removing a mat so the workers can lay the foundation slabs

- The Quick Reef breakwater slabs are laid flat as a foundation with one slab on each side laid at ~15 to 30 degree angle
- Mats are used under the skid steer to protect the existing marsh grasses
- Each slab weighs ~75 pounds
- They are installed at 1-foot below mean high tide with breaks every 100-feet for fish passage

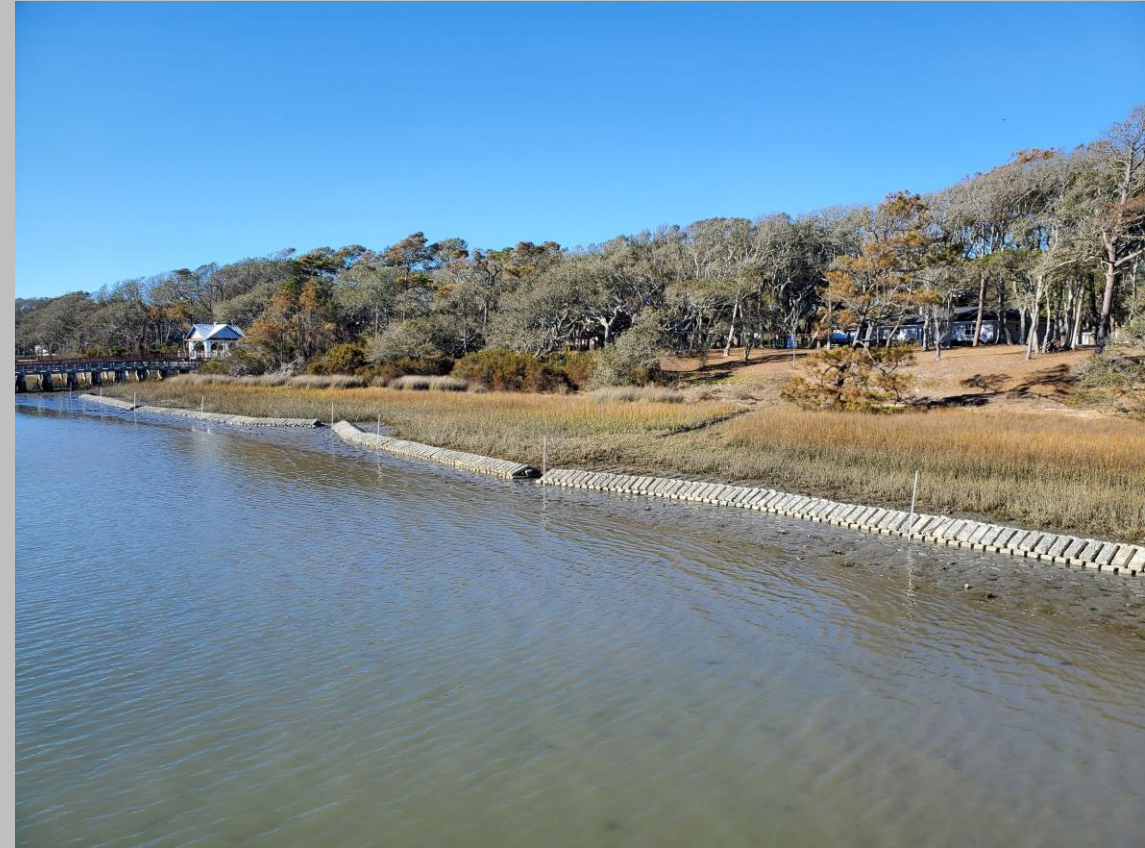
Photo at low tide showing placement of the breakwaters/sills on the landscape

- The completed breakwater/marsh sill shows the breaks every 100-feet for fish passage
- These breaks are required by the CAMA permit
- The sills can be no more than 30-feet from the shore for a general CAMA permit
- Markers are also placed for a visual hazard marker for boats

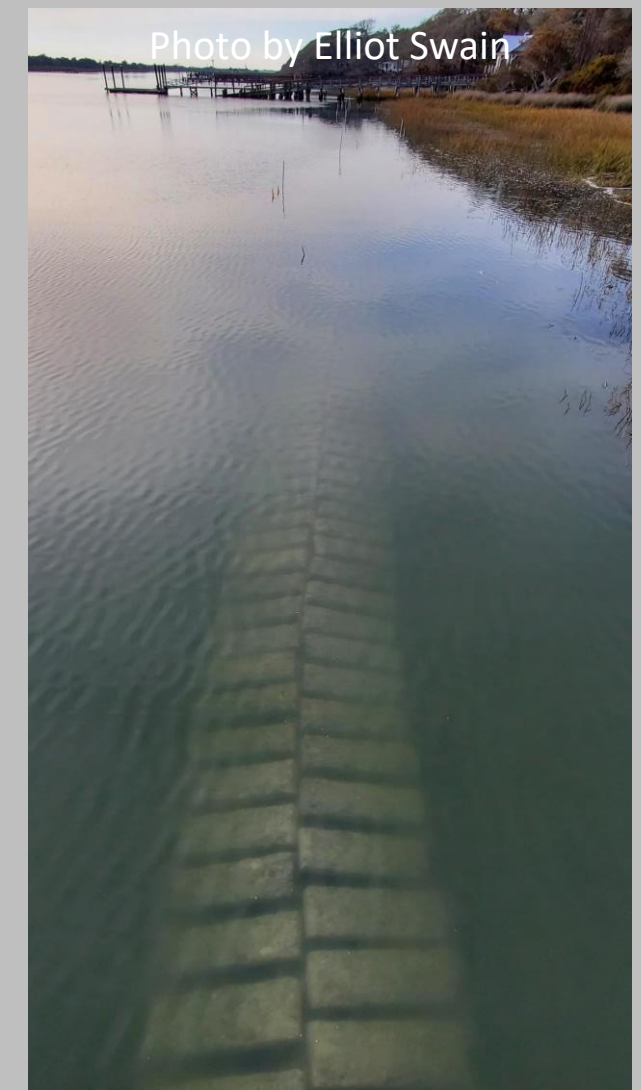
Photo at high tide showing breakwaters completely inundated

- Breakwaters are inundated 1-foot at high tide by design on low to moderate energy systems
- This allows for additional fish/marine passage
- The breakwater still serves to dissipate wave energy
- Hazard markers still visible

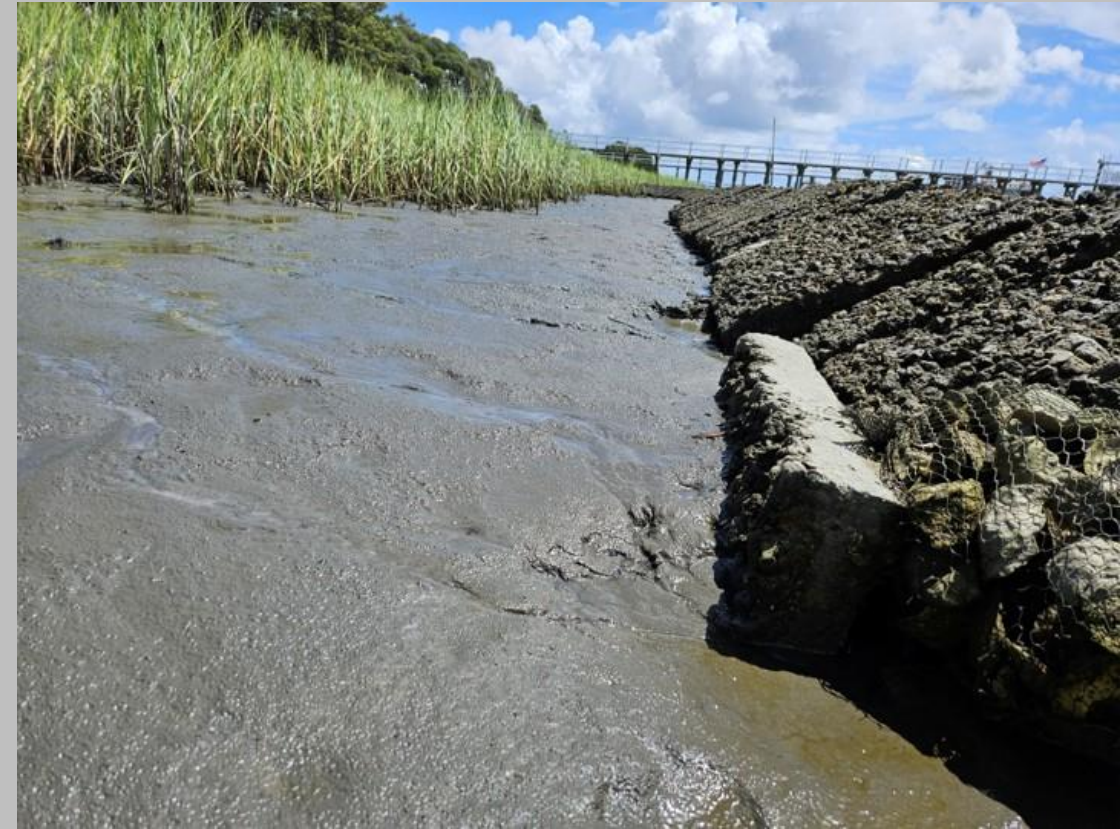
Low tide photo showing the accretion building behind the breakwaters. Mature and maturing oysters, grasses readying as the muck builds

- Photo taken approximately 8-months after completion
- Excellent oyster growth on the breakwaters
- Excellent accretion/accumulation of “marsh muck” and soil behind the breakwater
- Erosion minimized and contained in the appropriate marsh dynamic
- Marsh habitat restored and increased

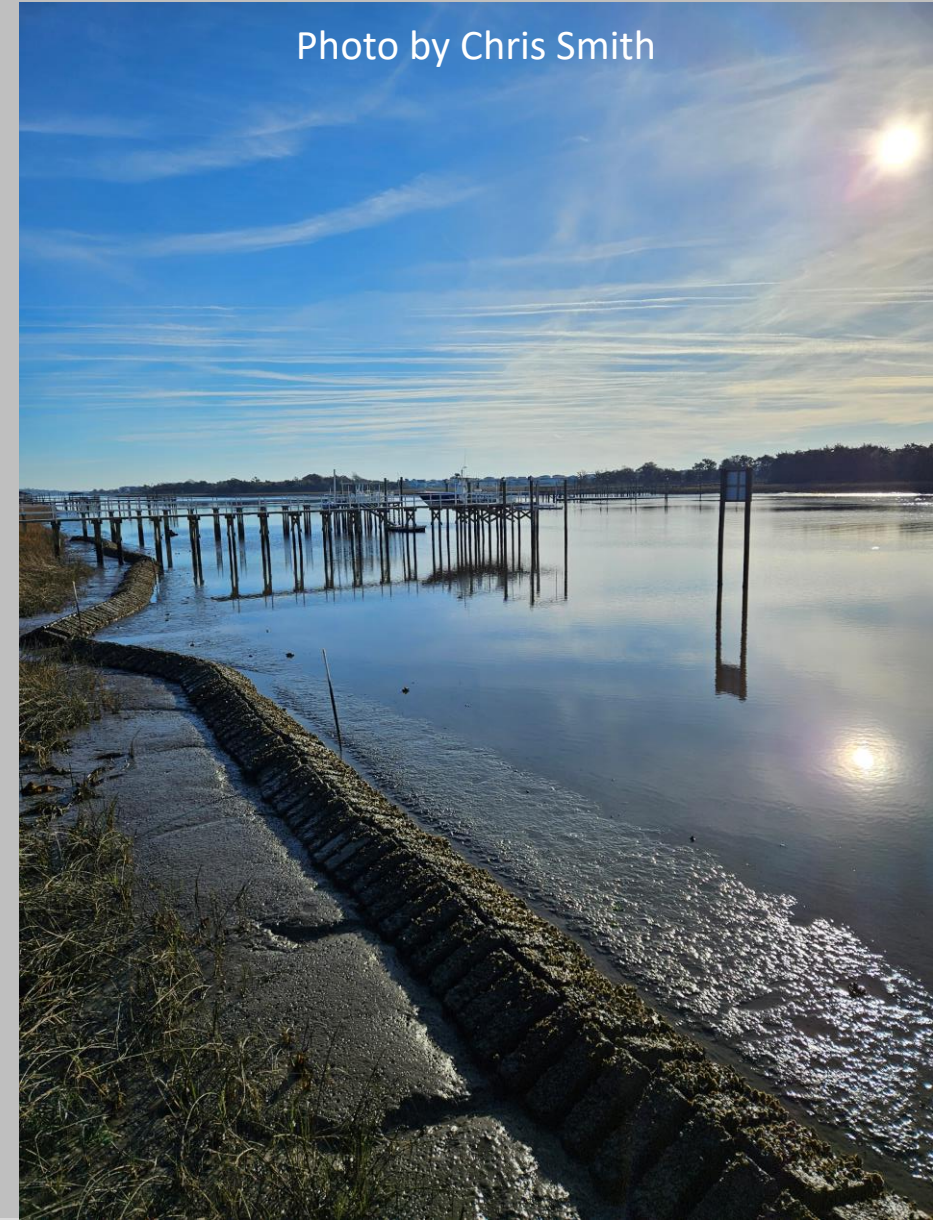
- Photo taken approximately 1-year after completion
- Excellent oyster growth on the breakwaters
- Excellent accretion/accumulation of “marsh muck” and soil on both sides of the breakwater
- Vegetation reestablishing
- Marsh habitat restored and increased

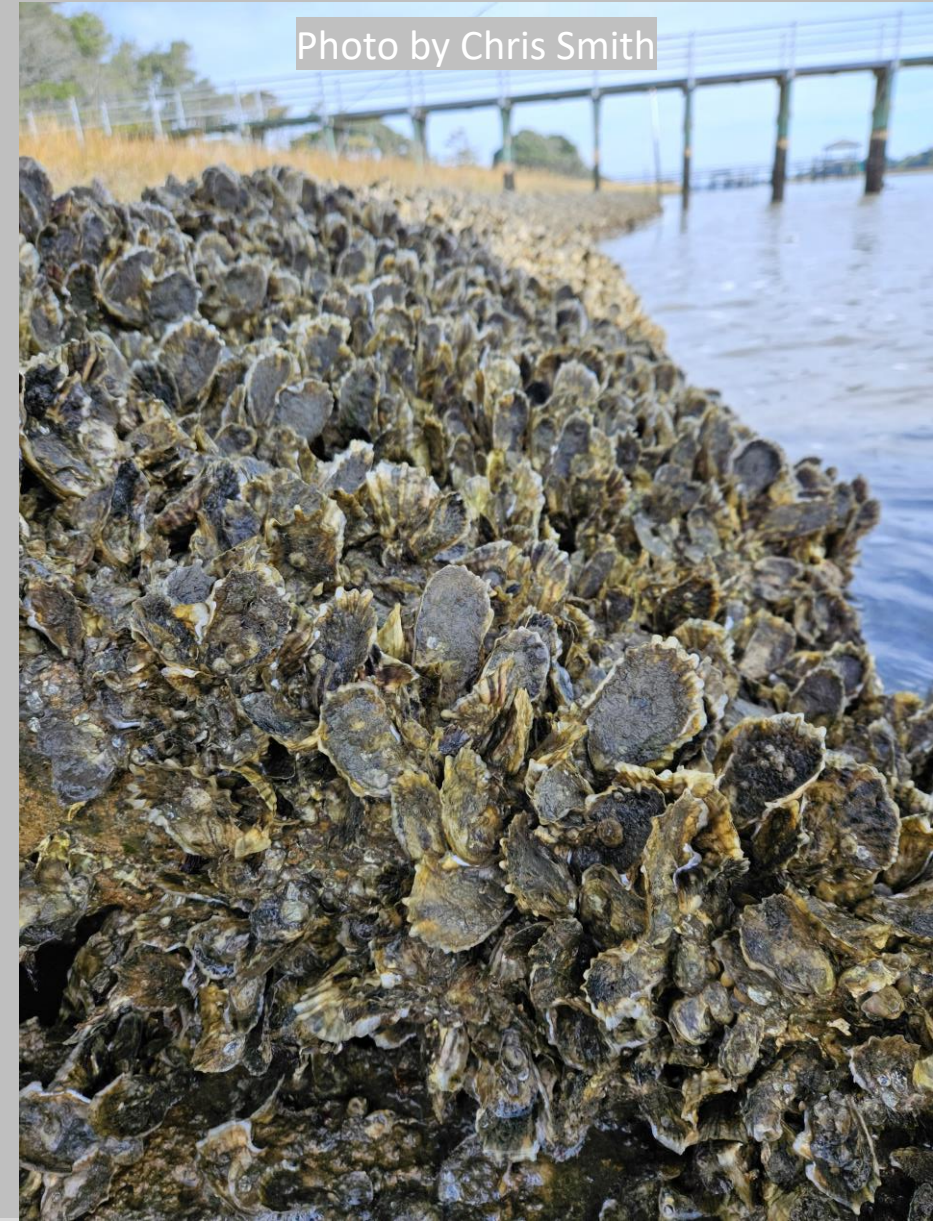
- This project restored and created significant marsh habitat in high-quality shellfish waters
- Shore erosion was minimized and utilized in development of the marsh
- Natural marsh processes were aided with carefully planned and implemented human-influenced solutions to the identified problem
- Dedicated, knowledgeable project team
- Continued successes
