# **Stream Restoration Post-Implementation Annual Monitoring Report**

## **Year 1: 2012**

Project #10-0493:

“DuPont State Forest Lake Julia Outfall Stream Restoration”

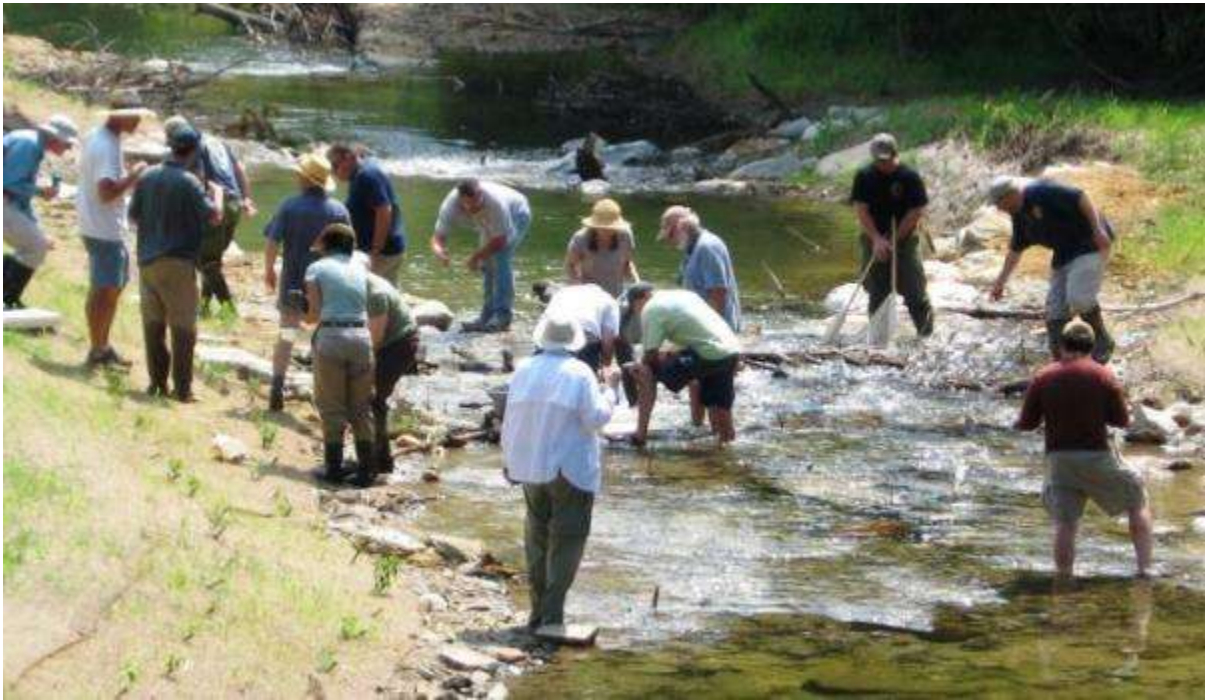
In June 2011, a joint field trip to the site was conducted by regional staff from the USEPA and US Forest Service, co-hosted by the NCFS and NCSU. The design and construction techniques used for this project were highlighted and attendees were given the chance to more closely examine the aquatic life of the restored reach, shown in the photo above.
