Restoration and Stabilization along Lake Julia Outfall

Restoration work was done in May 2011

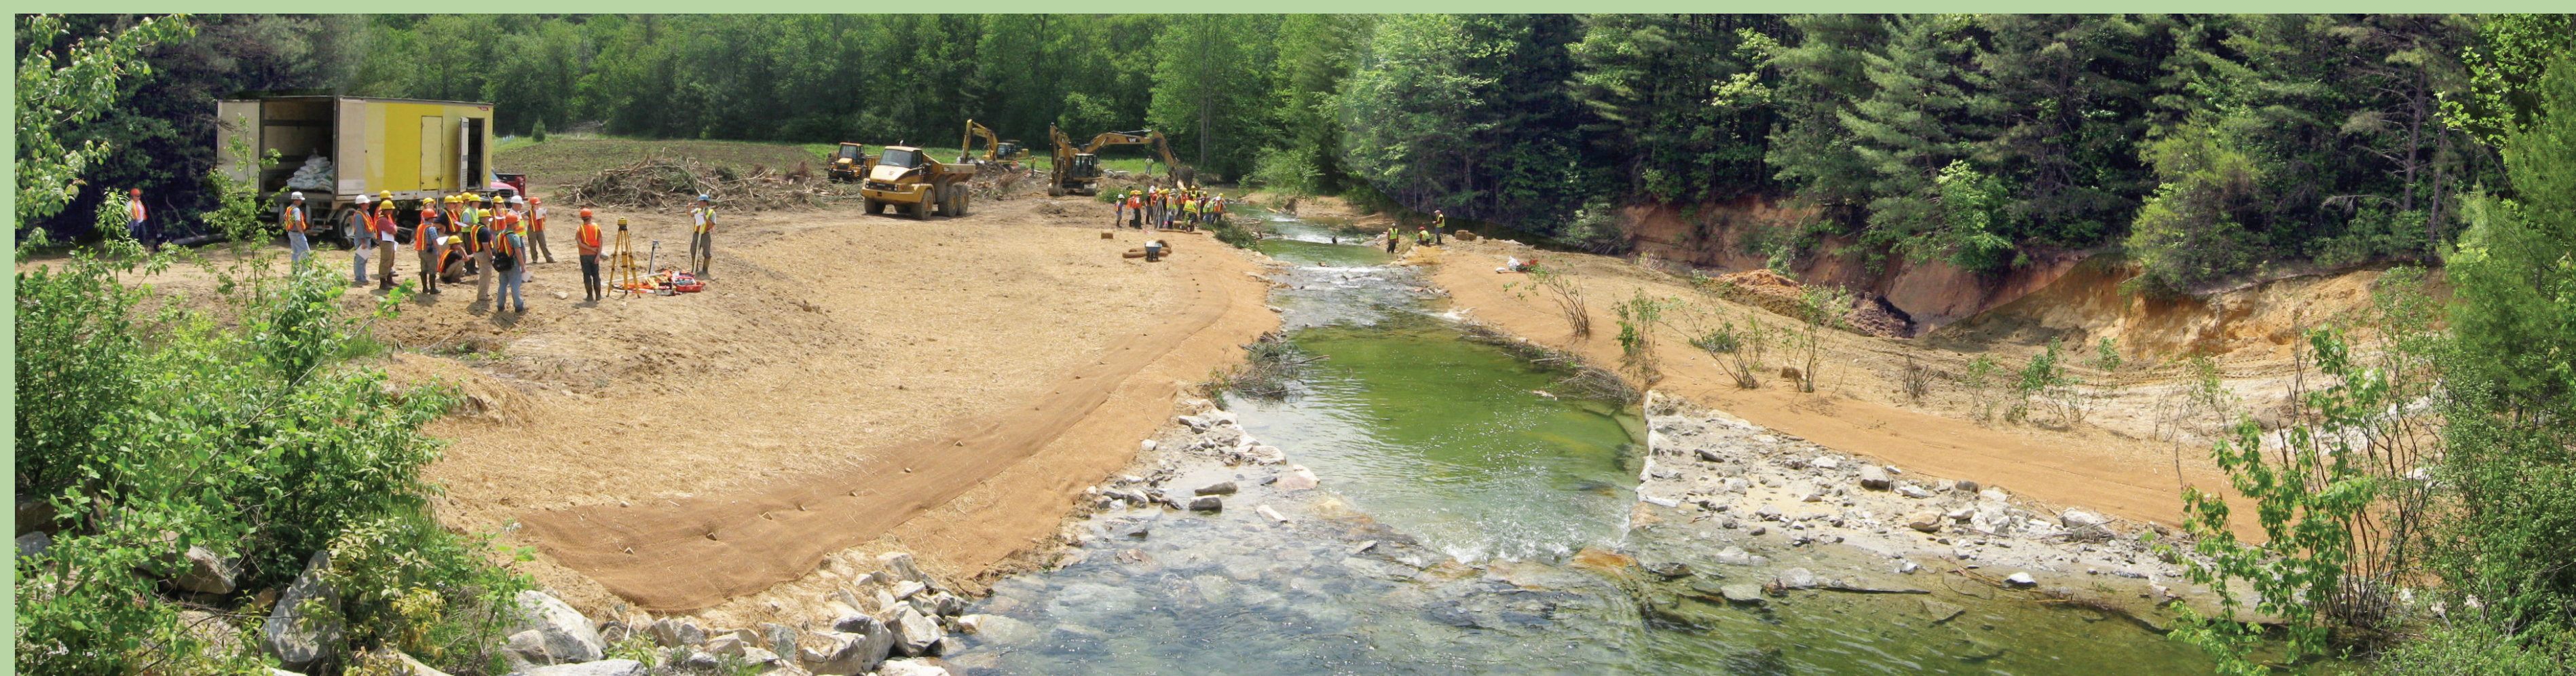
Our partners from NCSU held a workshop for stream restoration experts near completion of the work to show off the techniques used here.

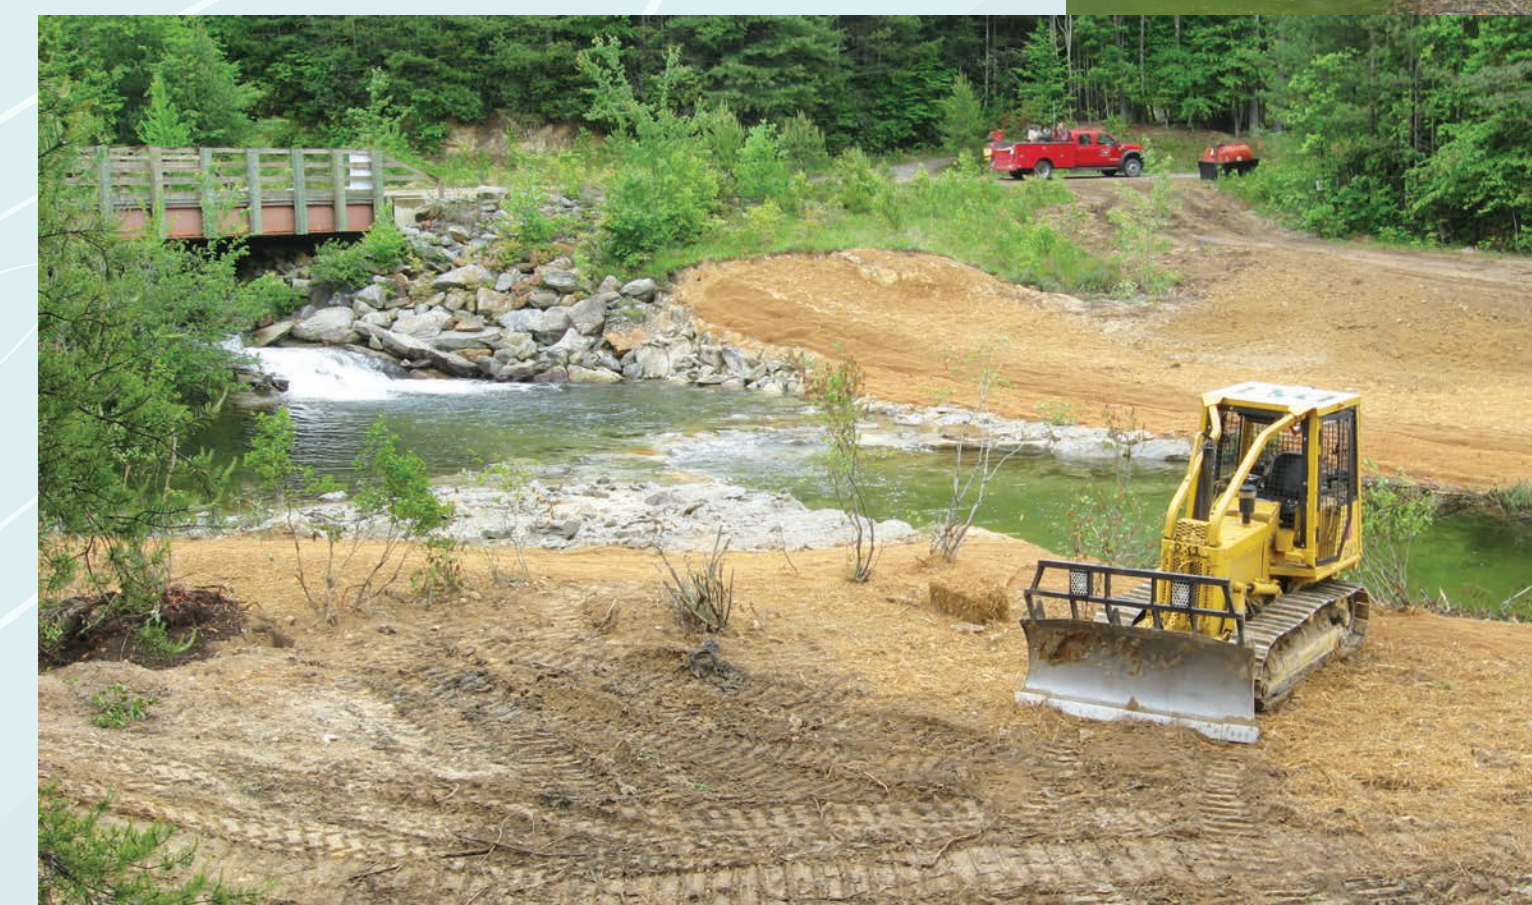
Almost done, awaiting grass seed.
