APPENDIX A

**Linville River Restoration Project
Gill State Forest
Avery County, North Carolina**

CONCEPTUAL DESIGN DRAWINGS

Appendix C: Conceptual Design Drawings Linville River Stream Restoration For North Carolina Forest Service (Not For Construction)

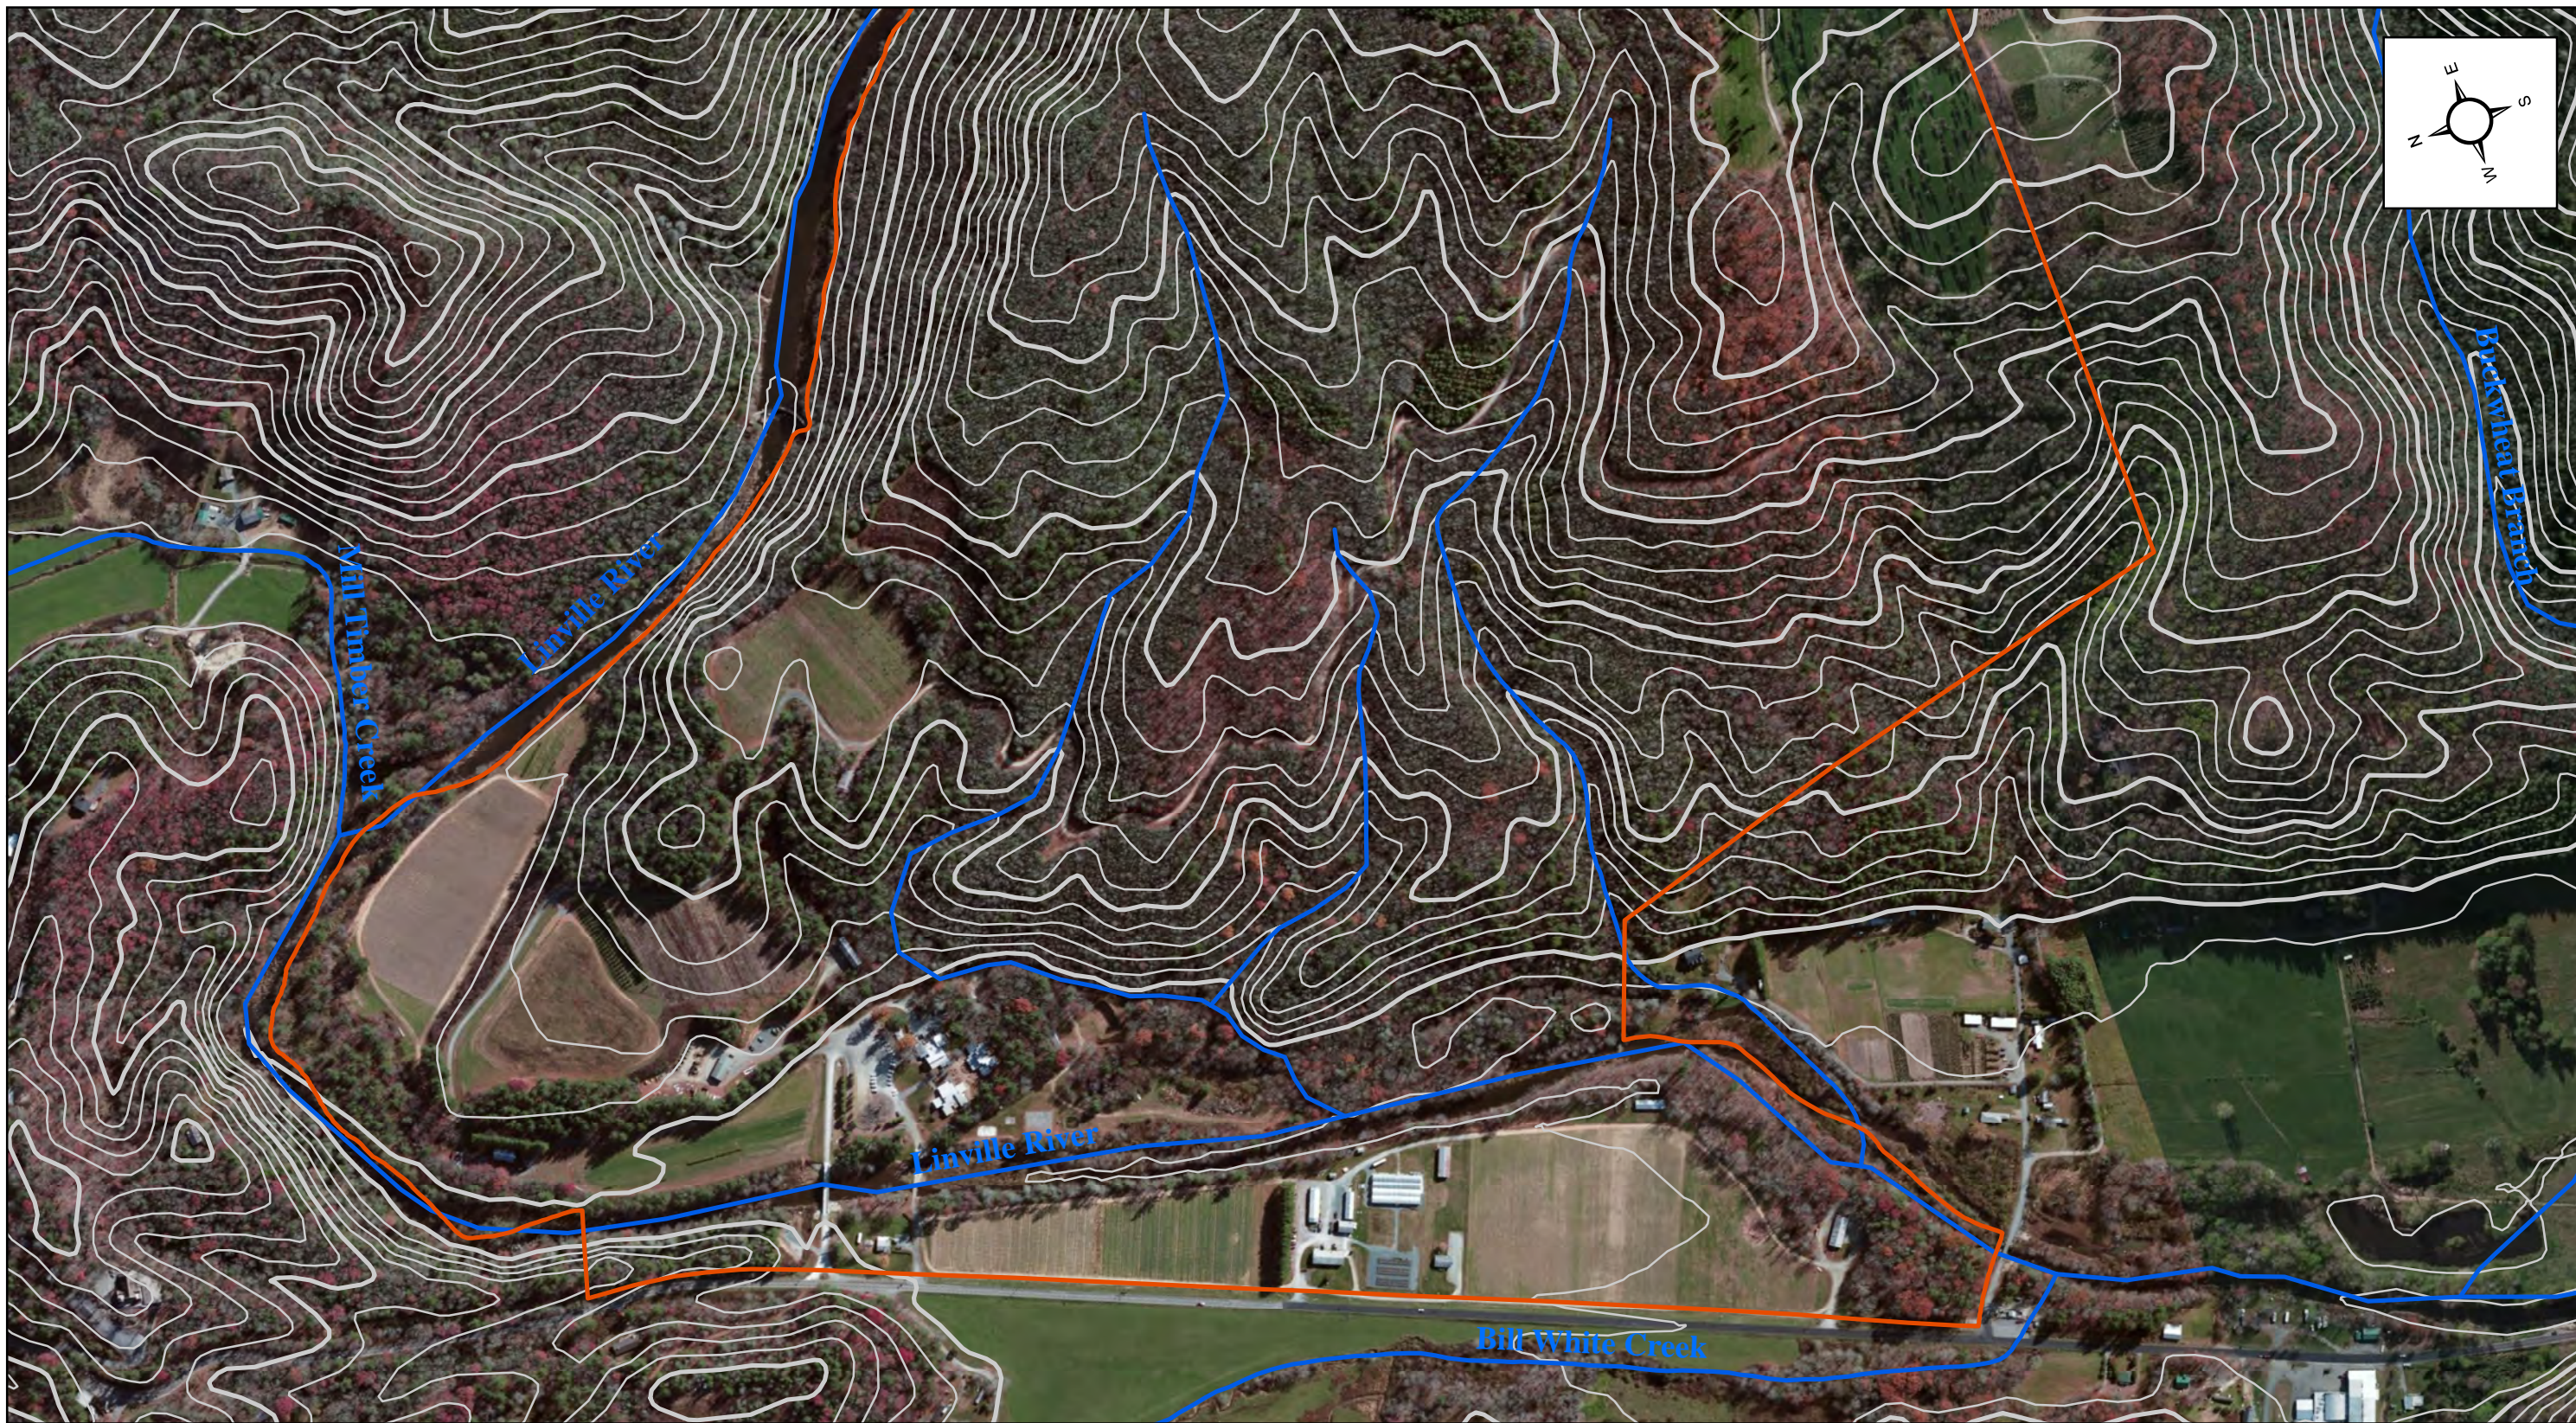
Sheet
A3

Site Topography

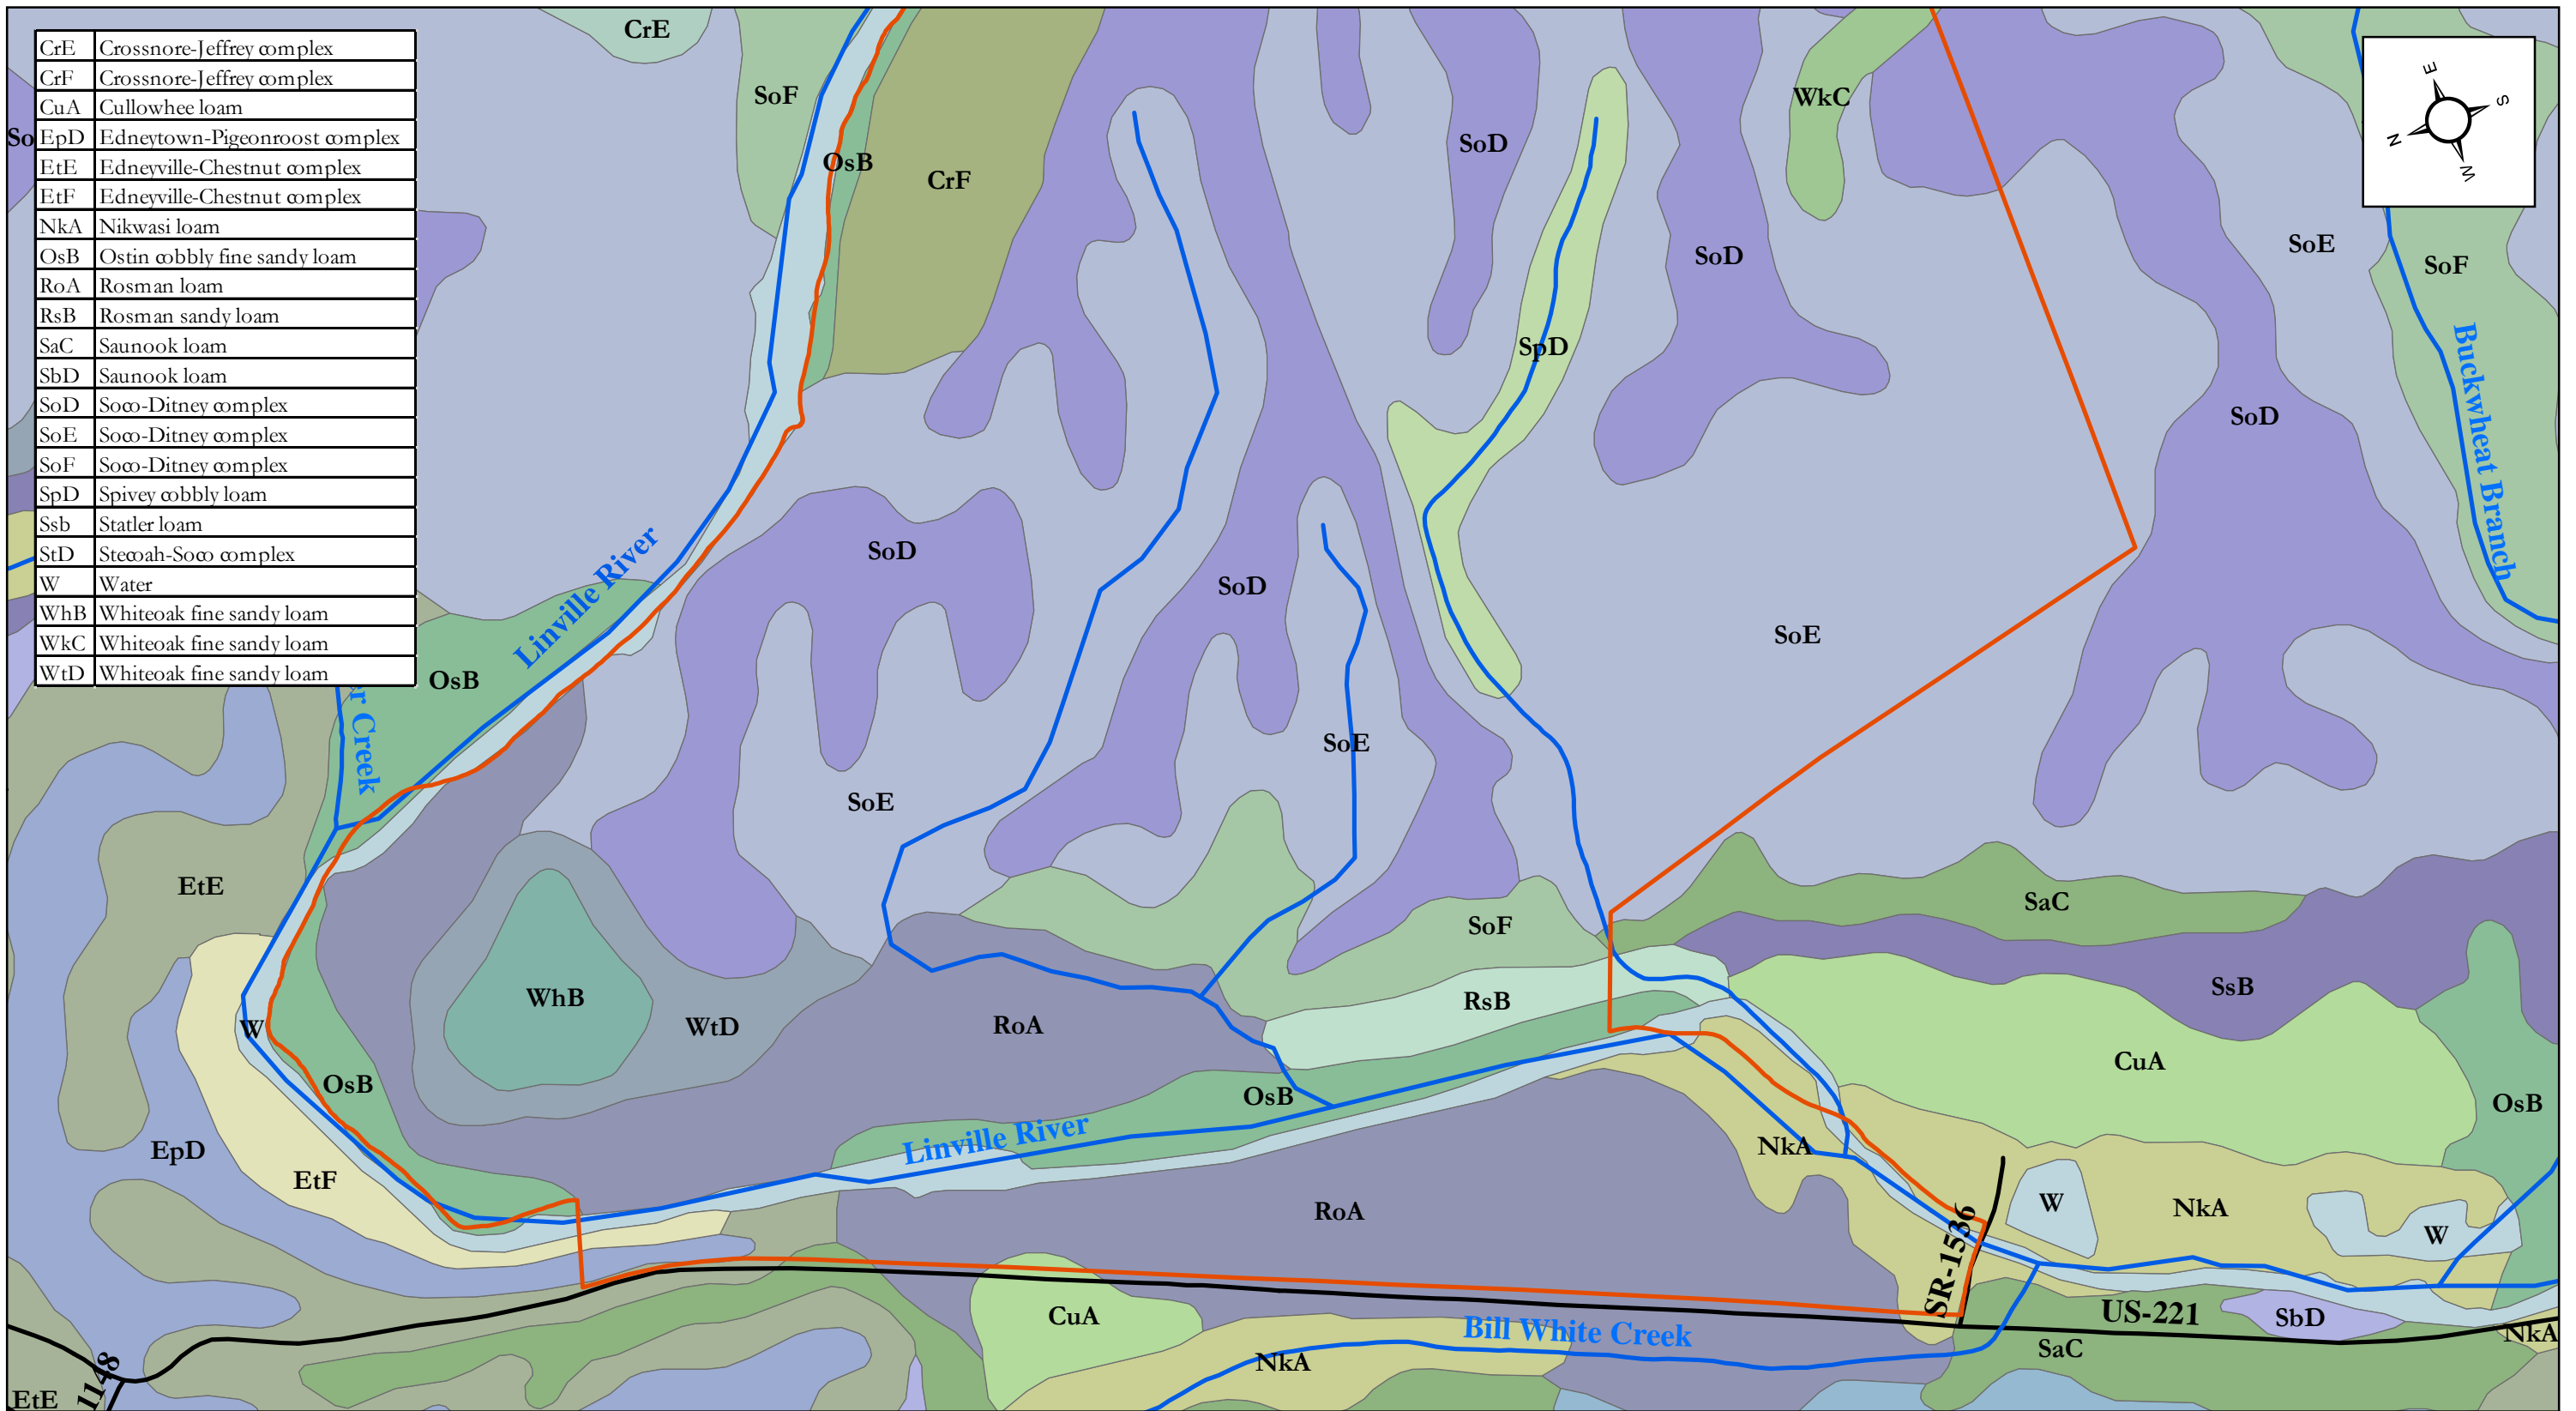
Sheet
A4

CrE	Crossnore-Jeffrey complex
CrF	Crossnore-Jeffrey complex
CuA	Culowhee loam
EpD	Edneytown-Pigeonroost complex
EtE	Edneyville-Chestnut complex
EtF	Edneyville-Chestnut complex
NkA	Nikwasi loam
OsB	Ostin cobbly fine sandy loam
RoA	Rosman loam
RsB	Rosman sandy loam
SaC	Saunook loam
SbD	Saunook loam
SoD	Soco-Ditney complex
SoE	Soco-Ditney complex
SoF	Soco-Ditney complex
SpD	Spivey cobbly loam
Ssb	Statler loam
StD	Steoah-Soco complex
W	Water
WhB	Whiteoak fine sandy loam
WkC	Whiteoak fine sandy loam
WtD	Whiteoak fine sandy loam

Soils

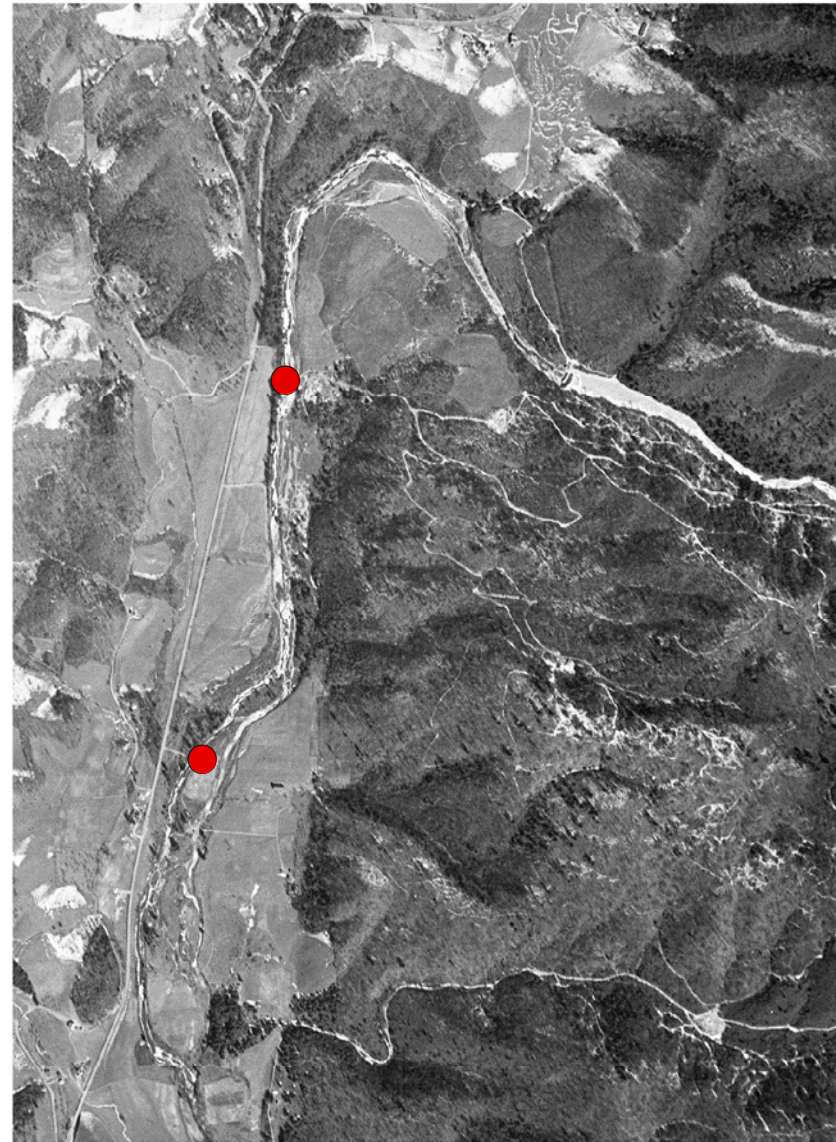
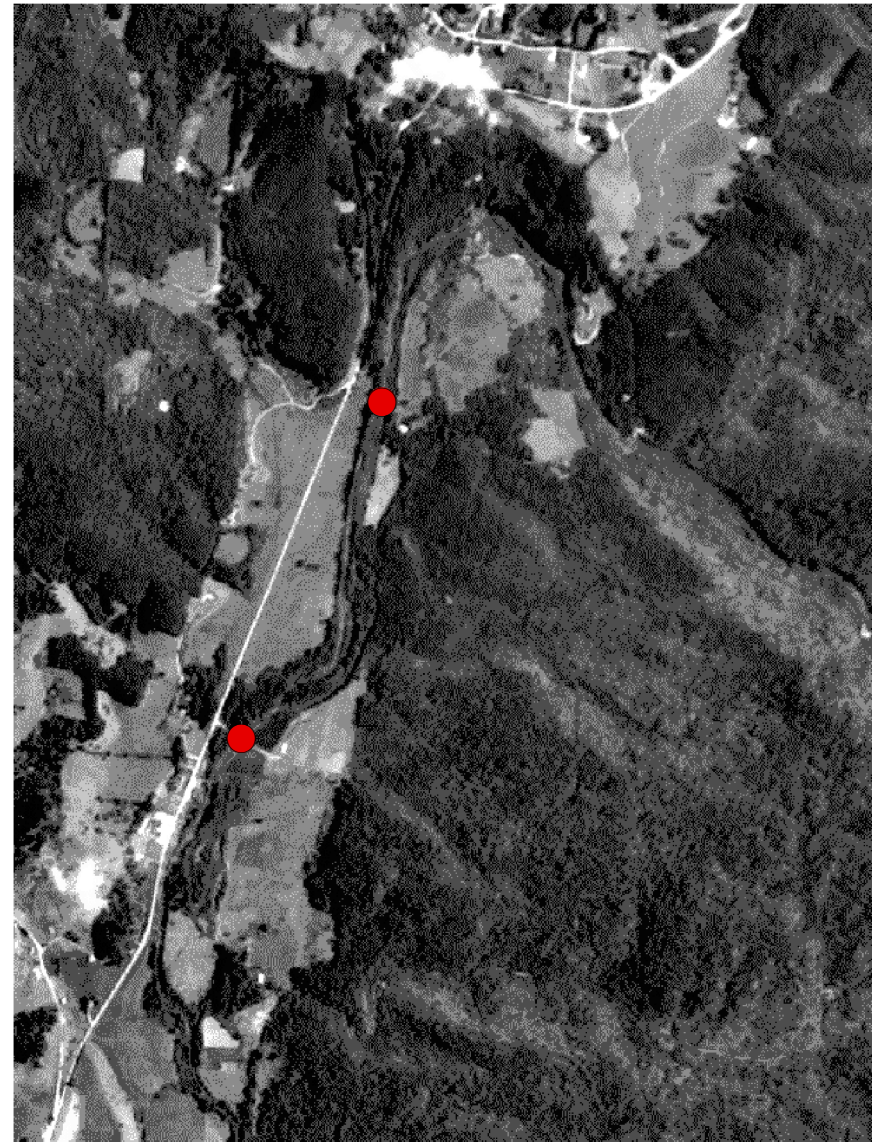
**Sheet
A5**

● Approximate positions of low-water and Greene Road bridges

Historical Aerial Imagery

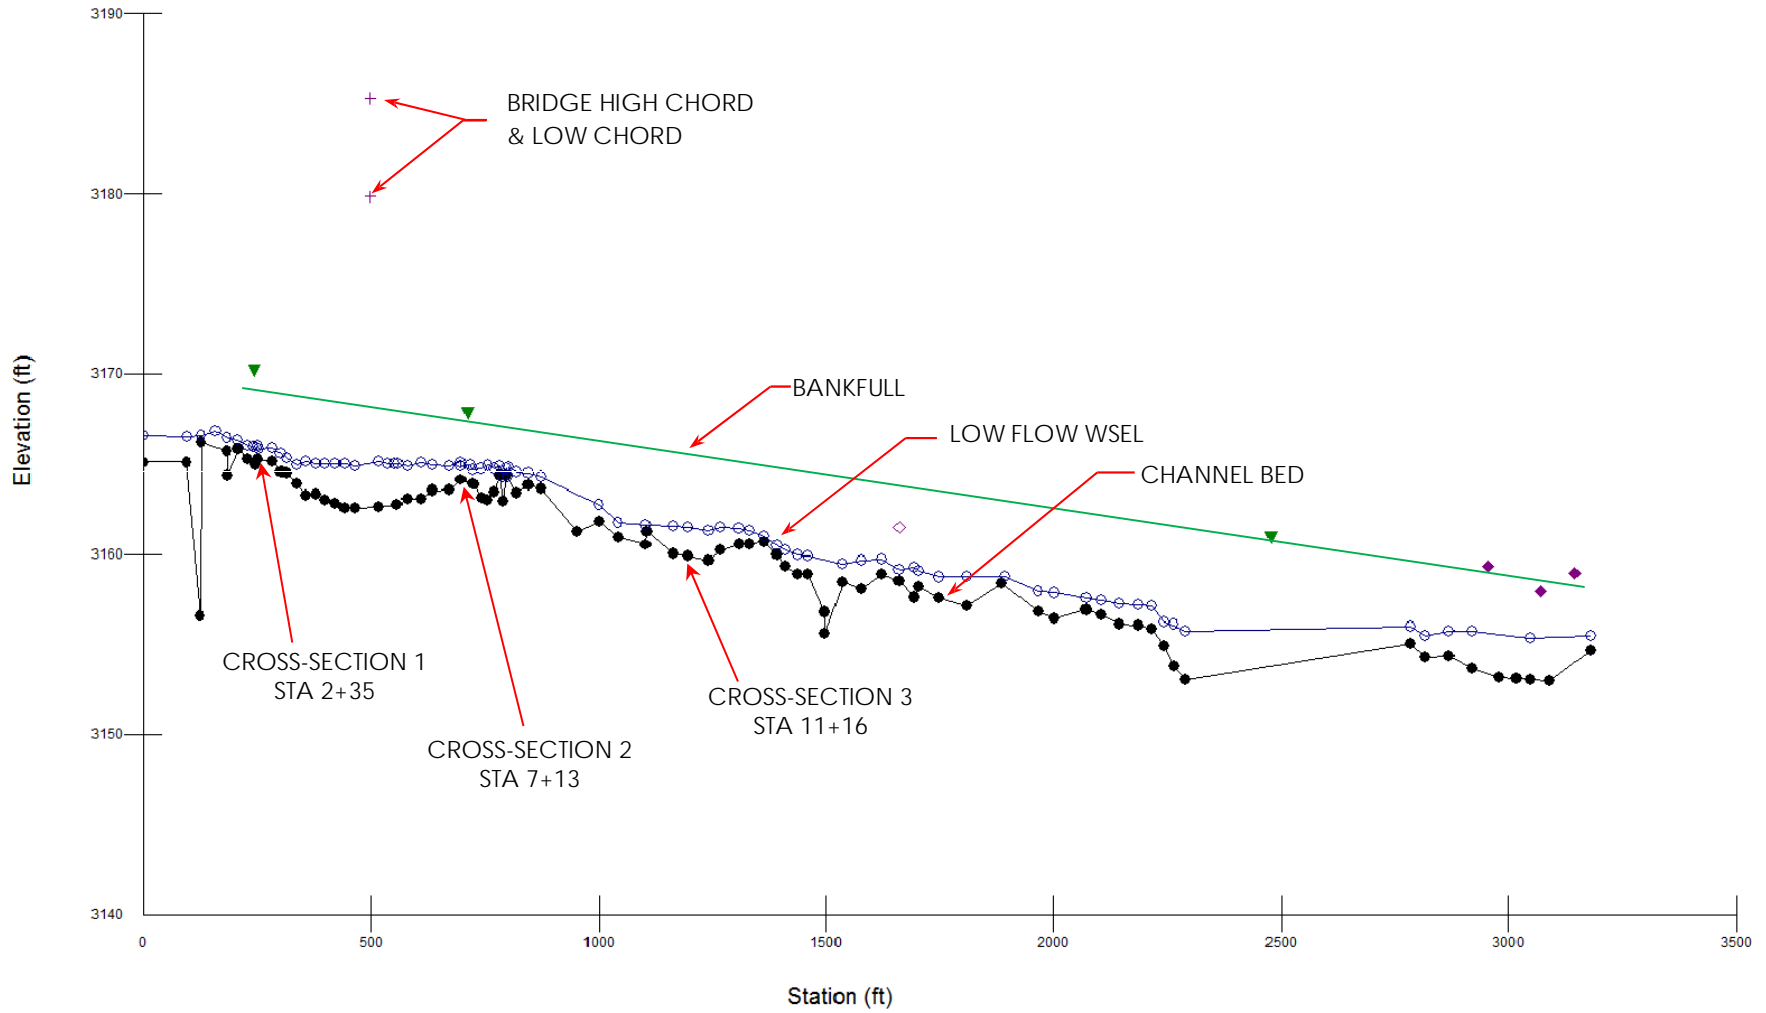
A6. Existing Longitudinal Profile

Linville River Existing Profile (Reach 2)

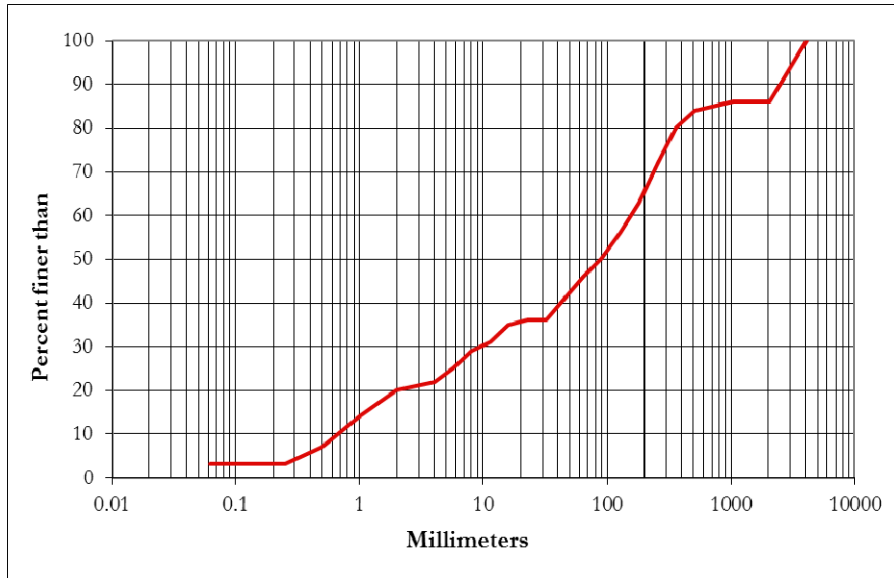
A8. Pebble Count Data

d_{16} (mm)	1.3
d_{35} (mm)	16
d_{50} (mm)	90
d_{84} (mm)	512
d_{95} (mm)	bedrock
d_{100} (mm)	bedrock

Class Name	Particle Size Class (mm)	Total	Cumulative %
Silt/Clay	<0.062	3	3
Very Fine Sand	0.062 - 0.125	0	3
Fine Sand	0.125 - 0.25	0	3
Medium Sand	0.25 - 0.5	4	7
Coarse Sand	0.5 - 1.0	7	14
Very Coarse Sand	1.0 - 2.0	6	20
Very Fine Gravel	2.0 - 4.0	2	22
Fine Gravel	4.0 - 5.7	3	25
Fine Gravel	5.7 - 8.0	4	29
Medium Gravel	8.0 - 11.3	2	31
Medium Gravel	11.3 - 16.0	4	35
Coarse Gravel	16.0 - 22.6	1	36
Coarse Gravel	22.6 - 32	0	36
Very Coarse Gravel	32 - 45	5	41
Very Coarse Gravel	45 - 64	5	46
Small Cobble	64 - 90	4	50
Small Cobble	90 - 128	6	56
Large Cobble	128 - 180	7	63
Large Cobble	180 - 256	9	72
Small Boulder	256 - 362	8	80
Small Boulder	362 - 512	4	84
Medium Boulder	512 - 1024	2	86
Large Boulder	1024 - 2048	0	86
Bedrock	>2048	14	100

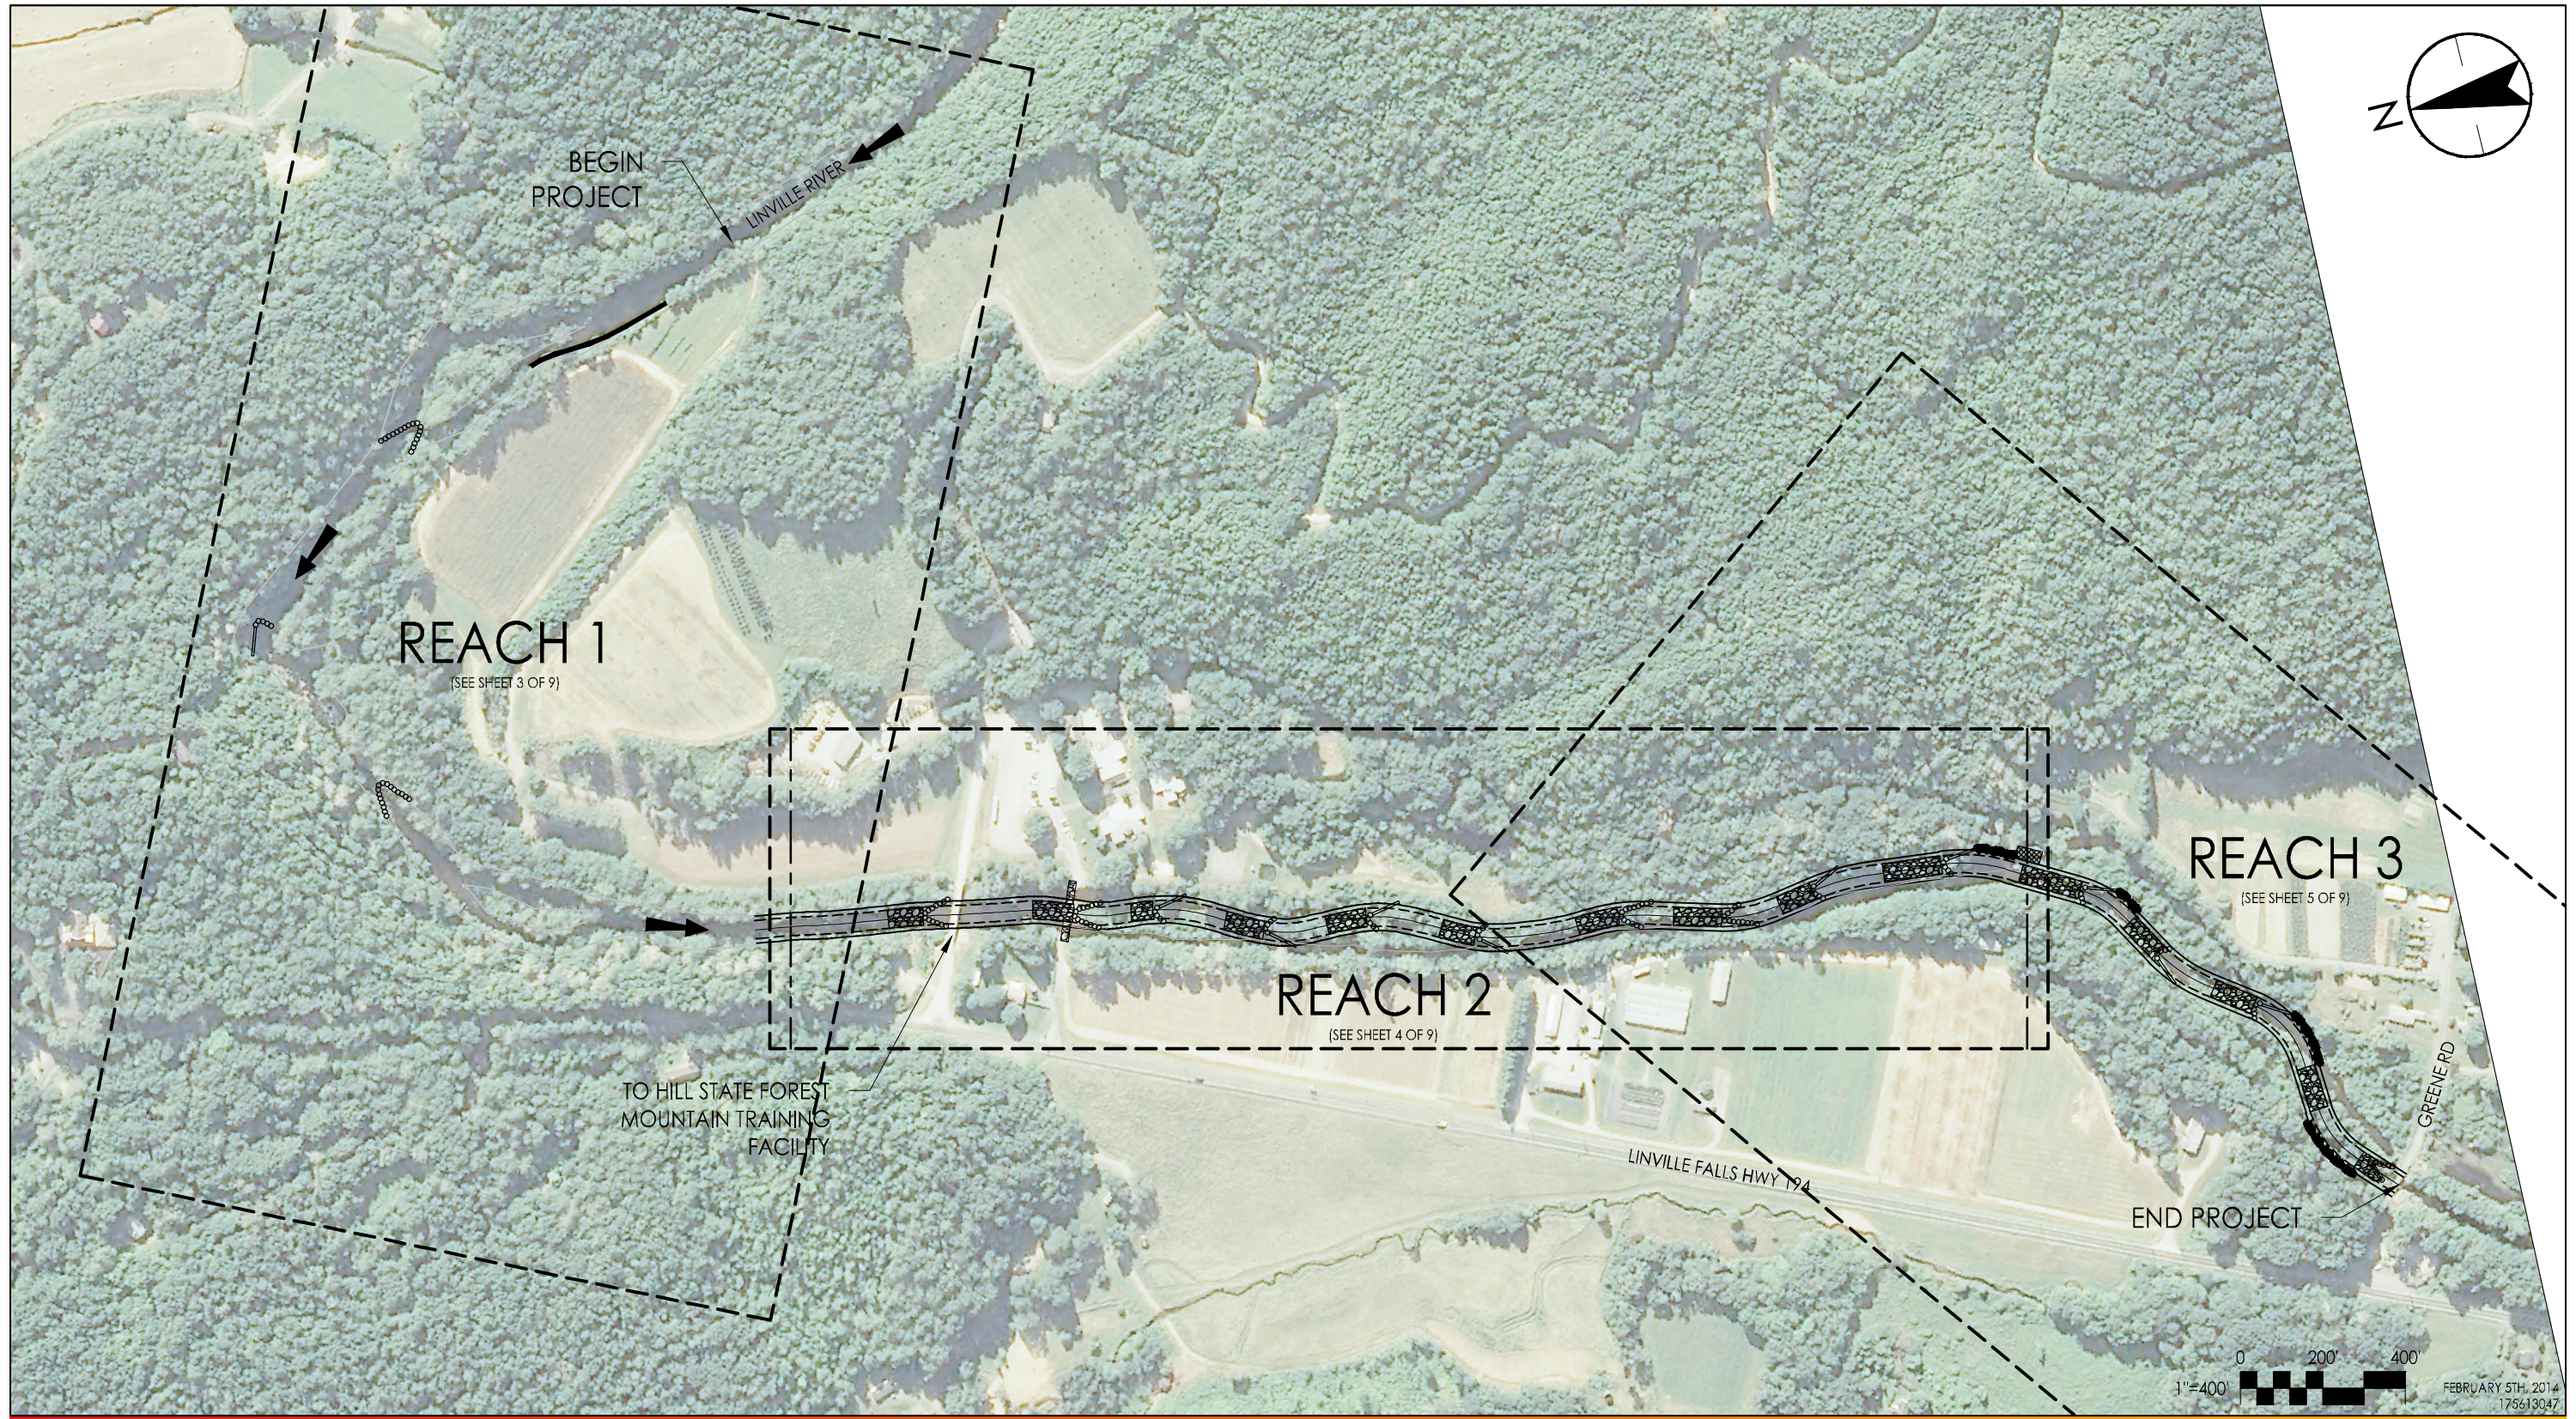
Client/Project
NCFS
LINVILLE RIVER RESTORATION
C2

- INNER BERM
- BANKFULL
- ▨ NATIVE MATERIAL RIFFLE
- ▧ CHANNEL PLUG
- ⋯ ROCK CROSS VANE
- ⊠ WOOD TOE HABITAT REVETMENT
- ⊢ LOG VANE WITH J-HOOK

Title
OVERALL PLAN

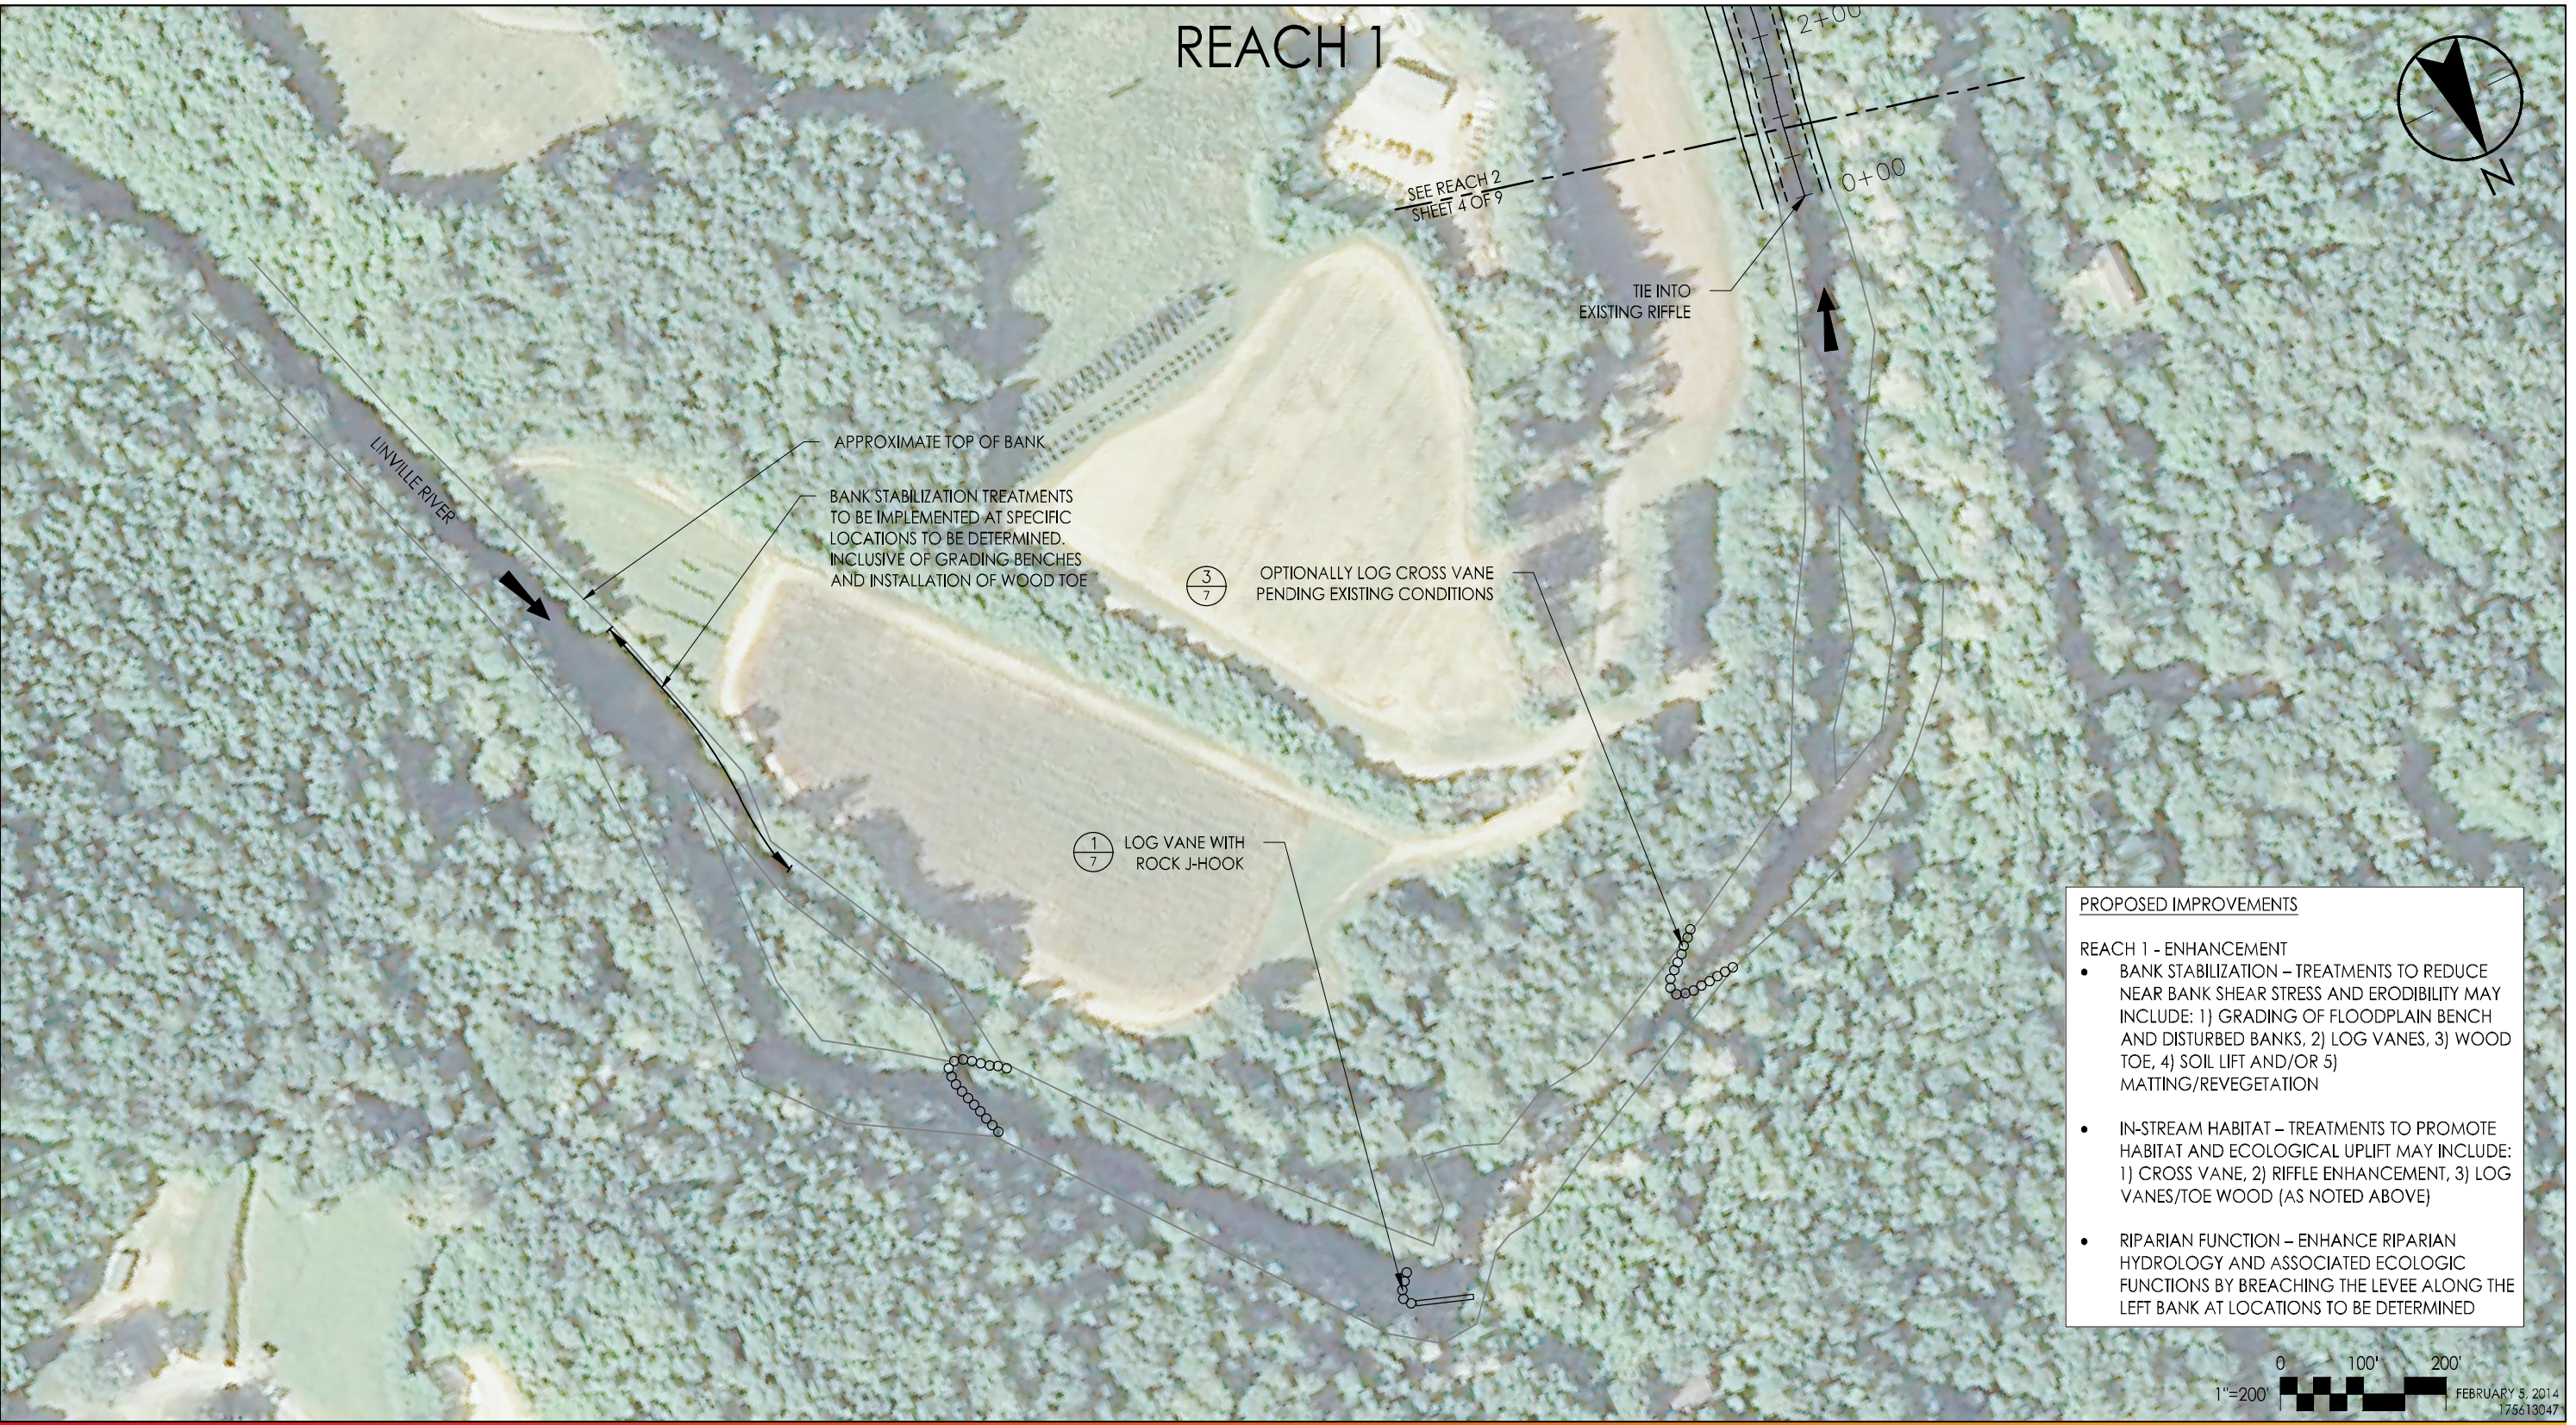
Client/Project
 NCFS
 LINVILLE RIVER RESTORATION
 C3

- PROPOSED IMPROVEMENTS**
- REACH 1 - ENHANCEMENT**
- **BANK STABILIZATION** – TREATMENTS TO REDUCE NEAR BANK SHEAR STRESS AND ERODIBILITY MAY INCLUDE: 1) GRADING OF FLOODPLAIN BENCH AND DISTURBED BANKS, 2) LOG VANES, 3) WOOD TOE, 4) SOIL LIFT AND/OR 5) MATTING/REVEGETATION
 - **IN-STREAM HABITAT** – TREATMENTS TO PROMOTE HABITAT AND ECOLOGICAL UPLIFT MAY INCLUDE: 1) CROSS VANE, 2) RIFFLE ENHANCEMENT, 3) LOG VANES/TOE WOOD (AS NOTED ABOVE)
 - **RIPARIAN FUNCTION** – ENHANCE RIPARIAN HYDROLOGY AND ASSOCIATED ECOLOGIC FUNCTIONS BY BREACHING THE LEVEE ALONG THE LEFT BANK AT LOCATIONS TO BE DETERMINED

DETAILED ASSESSMENT AND DESIGN HAVE NOT BEEN PERFORMED FOR REACHES 1 AND 3. SPECIFIC TREATMENTS AND LOCATIONS OF TREATMENTS ARE SUBJECT TO CHANGE.

Title
 CONCEPTUAL PLAN
 REACH 1

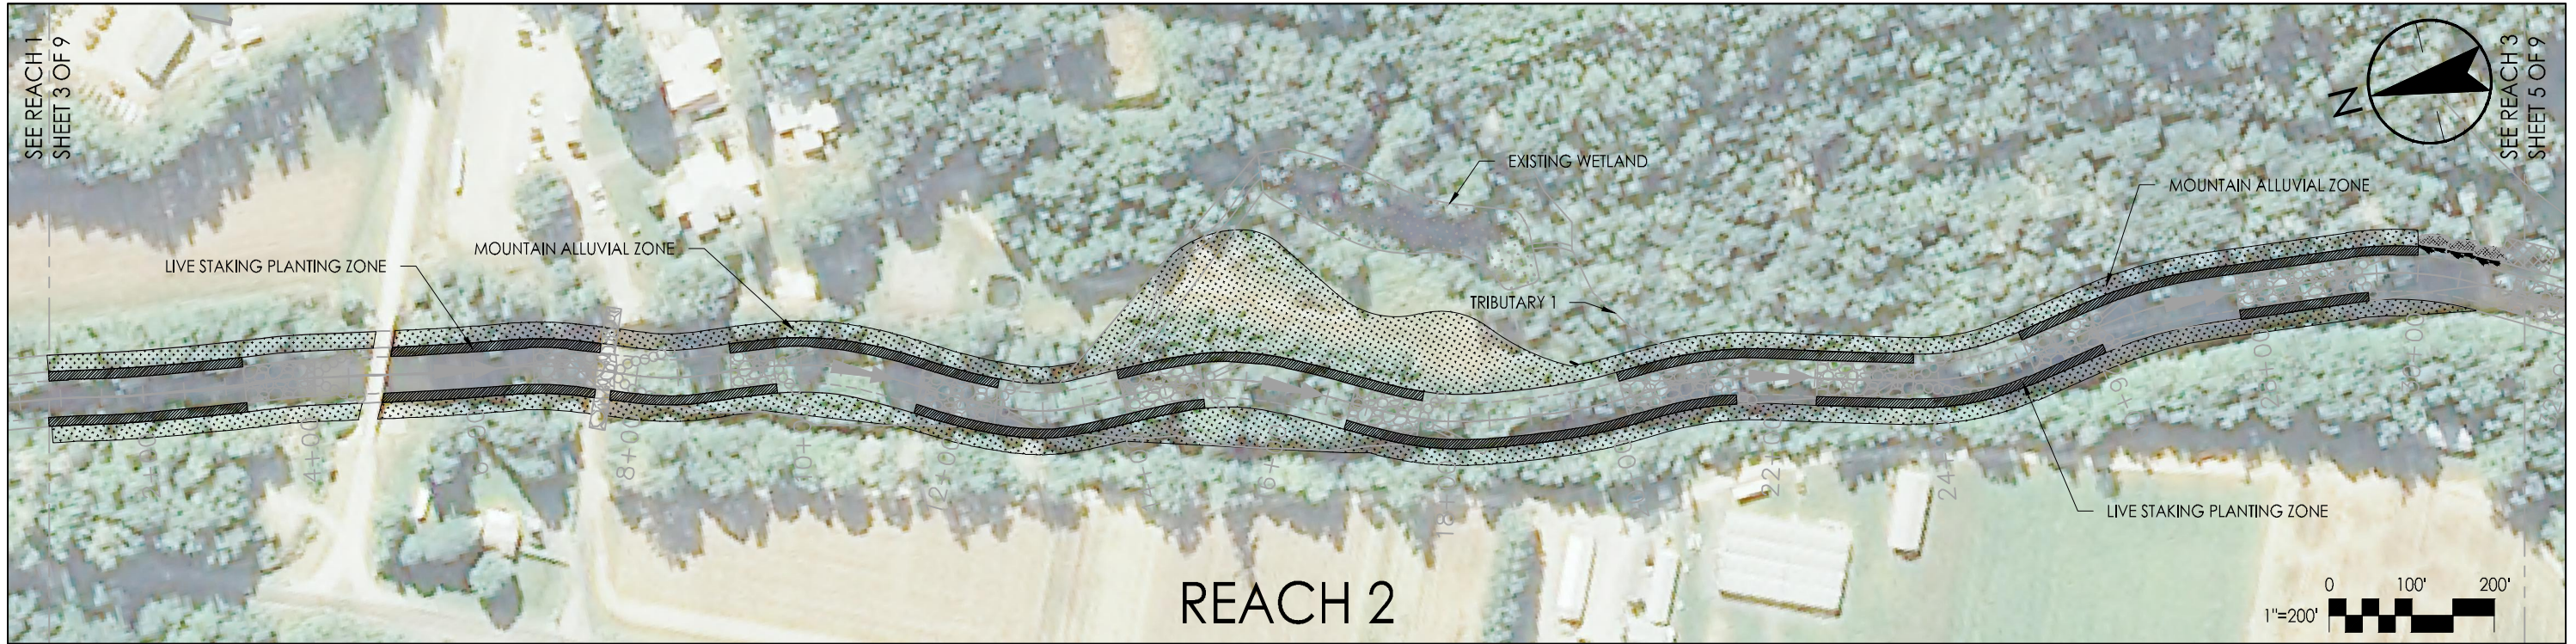
REACH 2

Zone	Common Name	Scientific Name
1 - Live Stakes	Silky willow	<i>Salix sericea</i>
	Buttonbush	<i>Cephalanthus occidentalis</i>
	Elderberry	<i>Sambucus nigra ssp. canadensis</i>
	Tag Alder	<i>Alnus serrulata</i>
2 - Bottomland Hardwood	River Birch	<i>Betula nigra</i>
	Sycamore	<i>Platanus occidentalis</i>
	Tulip poplar	<i>Liriodendron tulipifera</i>
	Green ash	<i>Fraxinus pennsylvanica</i>
	Ironwood	<i>Carpinus caroliniana</i>
	Eastern cottonwood	<i>Populus deltoides</i>
